Trafford Greenway Feasibility Assessment Report

Mayor's Cycling & Walking Challenge Fund

CO00201536/001 Revision 3

05/07/2023

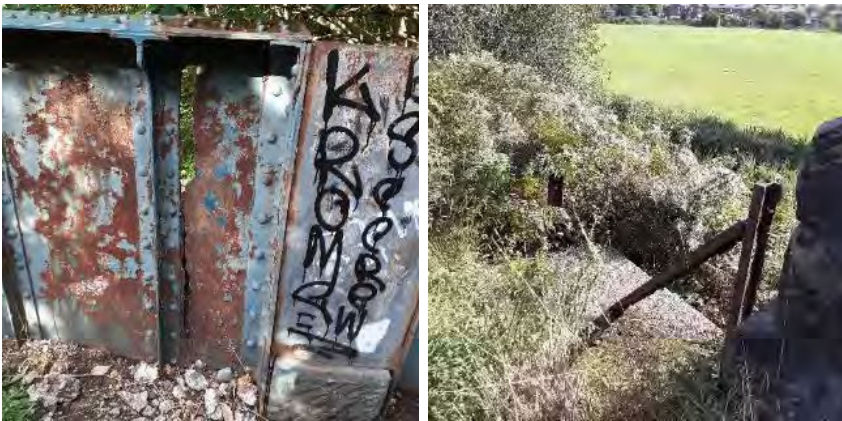
Critical Elements	Bridge decks, piers and abutments
	Parapet	The main longitudinal girders of the bridge also form the parapets of the structure. The existing parapet height is measured at 1.32m, which is below the requirement for edge protection for cyclist and pedestrian (1.4m) and equestrian usage (1.8m).
	Pier Impact	N/A
	Certification	Not available
	Calculations	Not available
	As built drawings	Not available
Comments on Assessment		
No existing design or assessment records are available.		
3	Evaluation	
	Inspection Date	Detailed exam: Nov 2020 Visual exam: Sep 2019
	Condition / Change in Condition	<p>The latest inspections reported that the structure is in fair to poor condition, with extensive paint failure and moderate to severe corrosion to the steelwork.</p> <p>The steelwork has section loss across all four spans, including a large area of full section loss to the west girder web adjacent to a pier bearing stiffener, which may affect the load carrying capacity of the bridge.</p> <p>Areas of masonry weathering with 5-10mm section losses, and open joints with mortar loss up to 40mm deep were found on the stone substructure, with light vegetation growth.</p> <p>The existing surfacing comprises loose gravel and dirt. There is extensive vegetation adjacent to the parapets along both sides of the footpath.</p> <p>The approach fencing is missing at both ends of the bridge with an approximately 1.5m drop.</p>

<p>Figure 5 – Area of full section loss at longitudinal girder, and missing edge protection at bridge approach</p>

4	<p>Recommendation</p> <p>Considering the areas of section loss identified on the steel girders, and the more onerous loading requirements for the bridge to support the Greenway, it is recommended that a further quantitative assessment of the bridge deck to be undertaken in accordance with CS 454 and CS 456.</p> <p>Due to the lack of as-built records, an inspection for assessment will be required to obtain dimensional and condition information on the structure. Access to within touching distance to the bridge deck will be needed to enable the inspectors to take the necessary measurements. It should be noted that rope access was used in the 2020 Details Examination, and similar arrangement is envisaged for the inspection for assessment.</p>

Condition of the hidden connection between the longitudinal steel girders and trough decking should also be confirmed by trial holes over the bridge deck, and considered by the assessment. Recommended maintenance works are as listed below to bring the structure up to a safe and serviceable standard as a Greenway:

- Bridge assessment
- Steelwork repairs and localised patch painting with necessary strengthening works as identified by the structural assessment
- Vegetation clearance on the footpath over the bridge deck, along both girders / parapets
- Footpath surfacing improvement to an acceptable standard for Greenway usage
- Safety fencing reinstatement at approaches to the structure

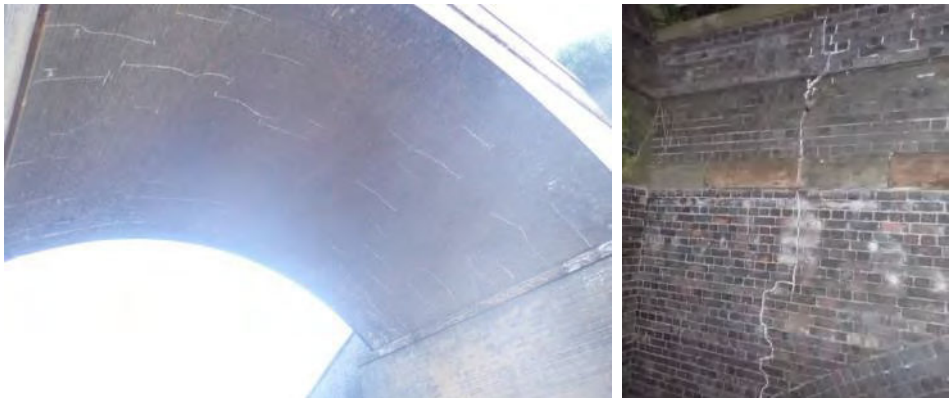
Assessment Date	Not known	Report Number	N/A
Current Assessed Capacity			
HA/ALL	Assumed historical railway loading	SV/STGO/SO	N/A
Critical Elements	Bridge deck and abutments		
Parapet	The existing parapet consists of a masonry wall with Key Clamp barrier extension on top. It has a total height of 1.85m which is suitable for all pedestrian traffic including equestrians.		
Pier Impact	N/A		
Certification	Not available		
Calculations	Not available		
As built drawings	Not available		
Comments on Assessment			
No existing design or assessment records are available.			
3	Evaluation		
Inspection Date	Detailed exam: Mar 2020 Visual exam: Nov 2018		
Condition / Change in Condition	<p>The structure overall is in fair condition. The latest inspections identified a number of longitudinal fractures to the arch barrel, and vertical fractures at spandrel, abutment and parapet walls, typically ranging from hairline to 1mm wide, with minor areas of open mortar joints, brick losses and weathering. There are areas of water seepage throughout the arch barrel, indicating there is no existing waterproofing or possible failure of the waterproofing or drainage system.</p>

<p>Figure 7 - Open joints and cracks to intrados and spandrel wall</p> <p>The parapet Key Clamp extension rails exhibit areas of moderate corrosion with lengths of missing and loose rails. The existing footpath surfacing over the bridge comprises loose gravel, with extensive vegetation growth throughout including mature trees.</p>

<p>adequate restraint system in place over the >9m high embankment, which would deem unsafe for Greenway usage.</p> <p>The existing footpath over the bridge comprises loose gravel, which is not adequate for wheelchair users. Extensive vegetation and trees along the footpath should be removed.</p>
4	Recommendation	
	<p>The bridge is considered to be suitable for the loading requirements of the Greenway. Recommended maintenance works are as listed below to bring the structure up to a safe and serviceable standard as a Greenway:</p> <p>Essential works, estimated cost: £30,000</p> <ul style="list-style-type: none"> ▪ Replace the parapet extensions to the masonry parapets ▪ Vegetation clearance – remove vegetation and trees and treat roots on the footpath over the bridge deck ▪ Footpath surfacing improvement to an acceptable standard for Greenway usage ▪ Remove existing palisade fences and locked gates. Suitability of retaining existing palisade fences as restraint system for NMU over the embankments should be assessed ▪ Install approach fencing at the 4 corners of the structure <p>Works that can be deferred, estimated cost: £27,500</p> <ul style="list-style-type: none"> ▪ Masonry repairs and repointing throughout– replace missing and weathered bricks, and repoint open mortared joints and cracks. Cracks should be monitored during future inspections following repointing works, and crack stitching repair should be considered if they reoccur and are widened.

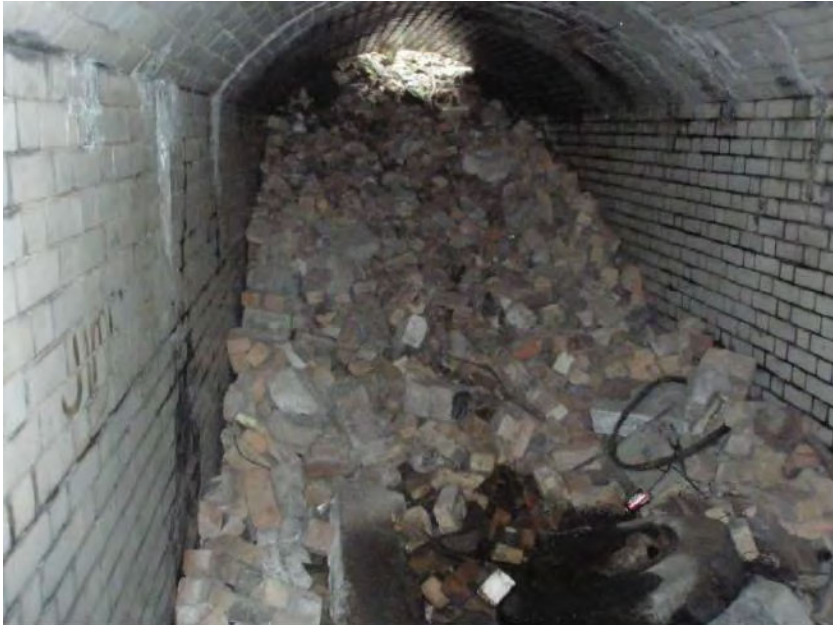
<p>Figure 22 - View inside the partially infilled structure</p> <p>There are missing and loose bricks to the headwalls at both ends of the structure. During the last detailed examination, isolated areas of staining and calcites were identified to the sidewalls and soffit. This may have progressed since this inspection.</p>

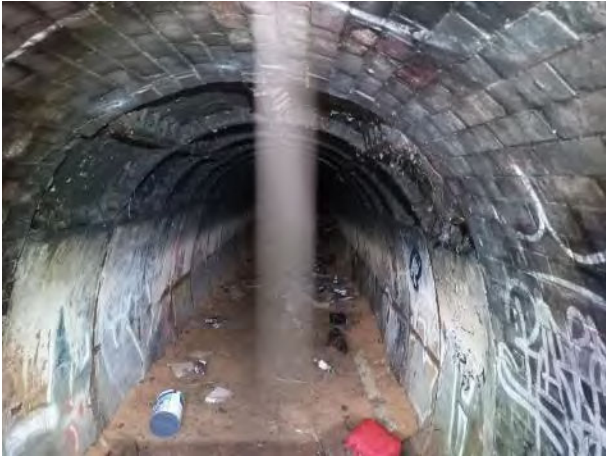
<p style="text-align: center;">Figure 24 - View inside the structure</p> <p>There are trees and vegetation growing behind the wingwalls.</p> <p>There is also an exposed gas pipe to the north side adjacent the wingwalls.</p> <p>It was identified during the most recent site visit that the lock is missing to the access gate.</p> <p>Sections of the existing timber fencing are damaged or missing.</p>

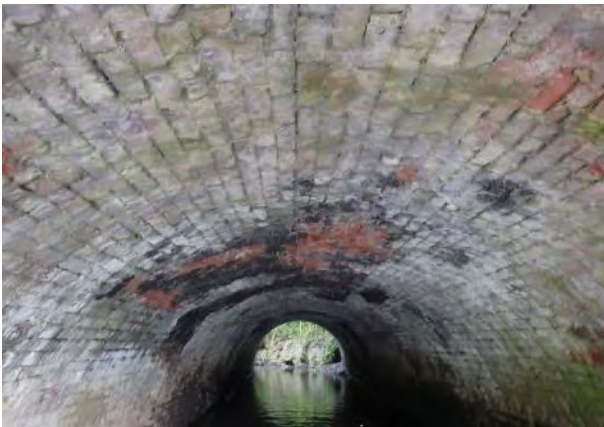
<p>Figure 42 - View under the structure</p> <p>Displaced copings and spandrels pushing out. The structure has been inaccessible since the last detailed examination due to excessive vegetation growth throughout the structure. The parapets are below the required height for all users. The original railway track bed, railings and sleepers are still in place.</p>

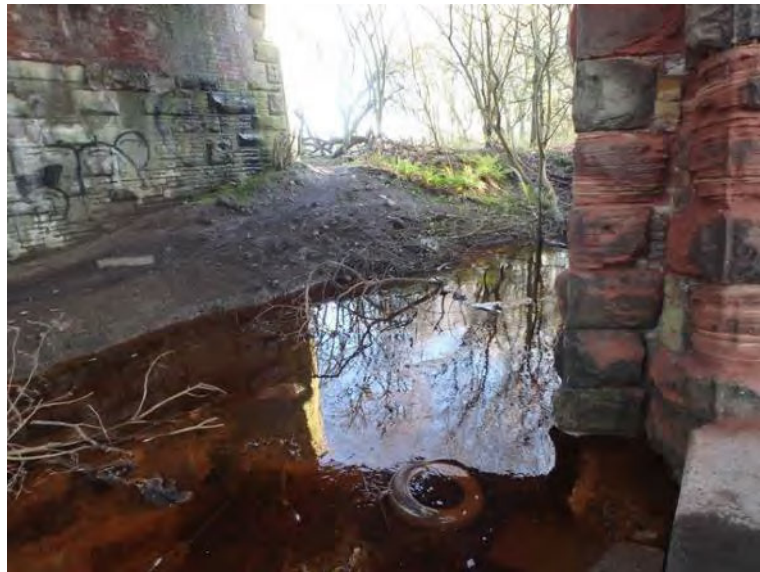
Figure 48 - Water ponding (under span 1)

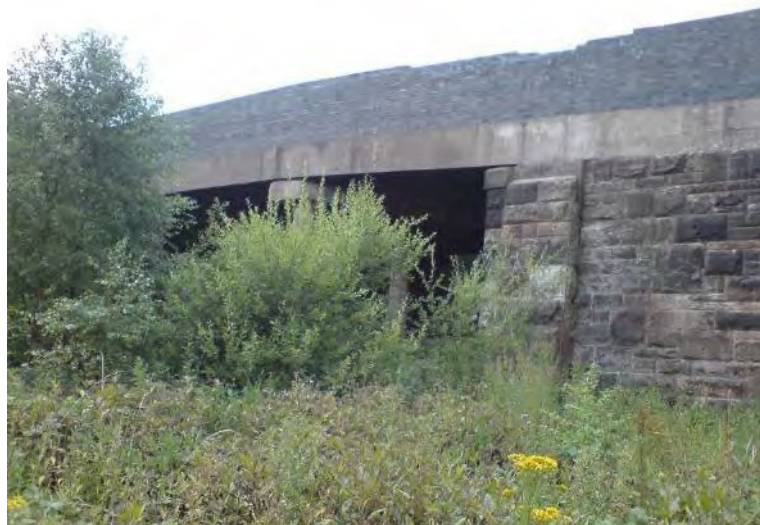
Figure 49 - Missing brick to parapet (over span 1)

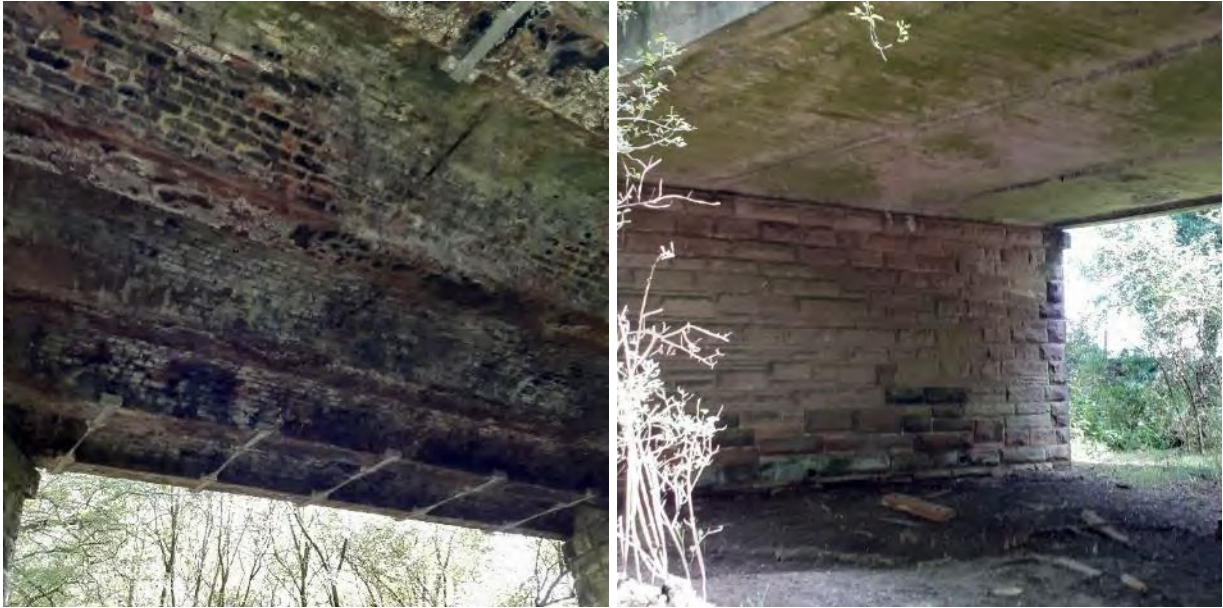
<p>Figure 50 - Dunham Road (view under bridge deck)</p>		
2	Evaluation	
	Inspection Date	Visual Examination: Nov 2019
	Inspection Summary	<p>The structure was found to be in fair condition.</p> <p>Defects found on the structure include:</p> <ul style="list-style-type: none"> ▪ Flooding under the structure (not found during 2022 site walkover) ▪ Corrosion to the girders and tie bars ▪ Broken tie bars ▪ Open joints to the jack arches on span 2

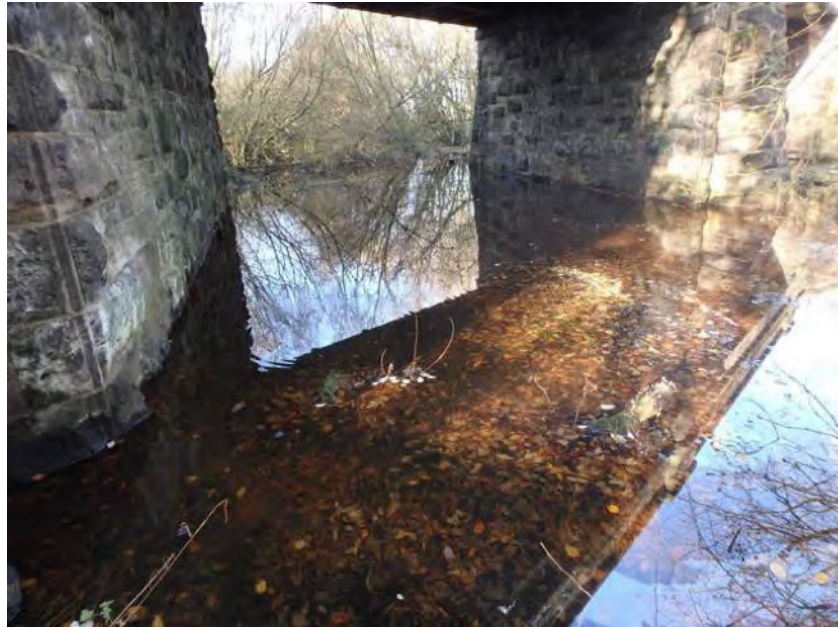
Figure 51 - Flooding under the structure in Nov 2019

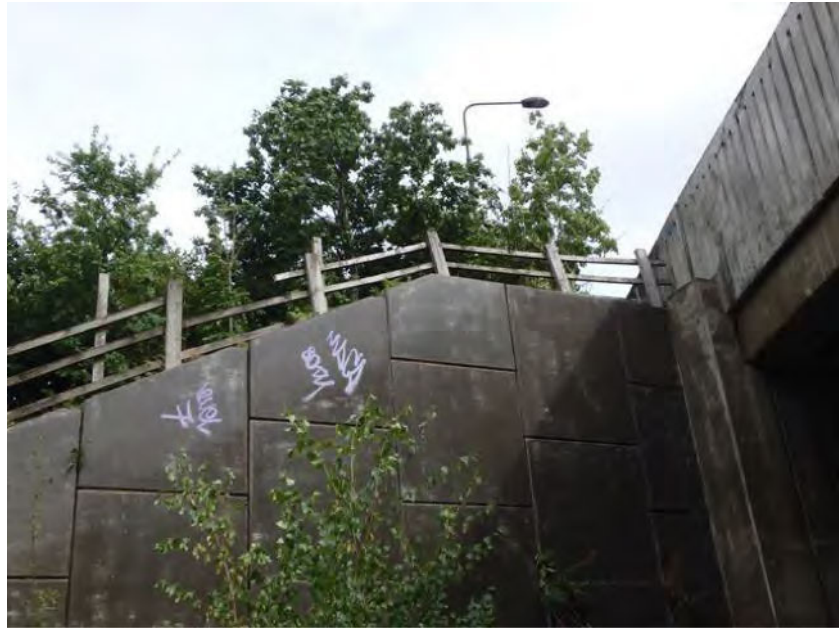
Figure 55 - Damaged and unstable fences above wing walls

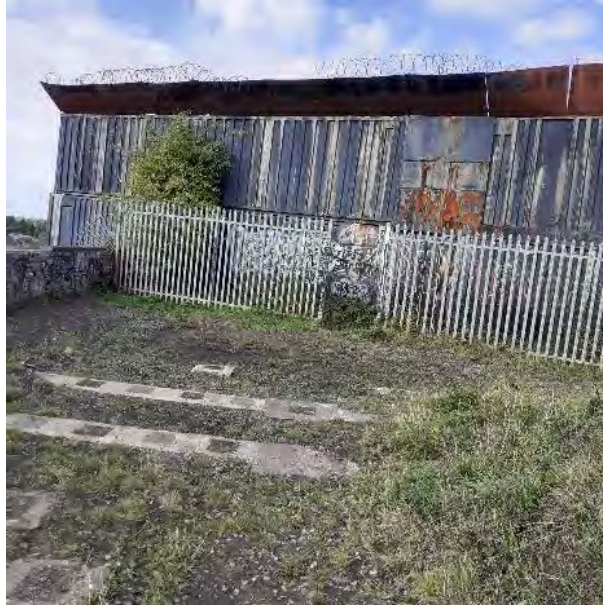
Figure 56 - Photo showing placement of shipping containers to prevent access to unsafe areas of the structure

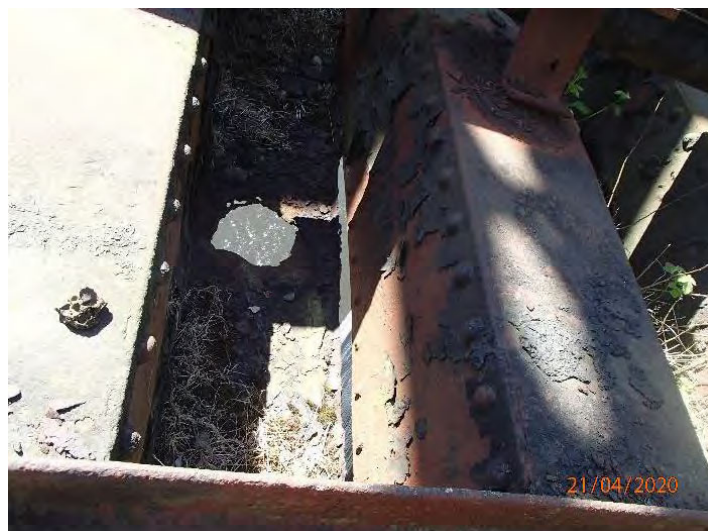
Figure 57 - Typical example of the more severe corrosion damage to trough decking. Note the complete loss of section at the bottom of the trough (typical)
