George Street Conservation Area – Supplementary Planning Document SPD5.1

TRAFFORD
COUNCIL

Conservation Area Appraisal – October 2014

George Street Conservation Area Altrincham Conservation Area Appraisal October 2014

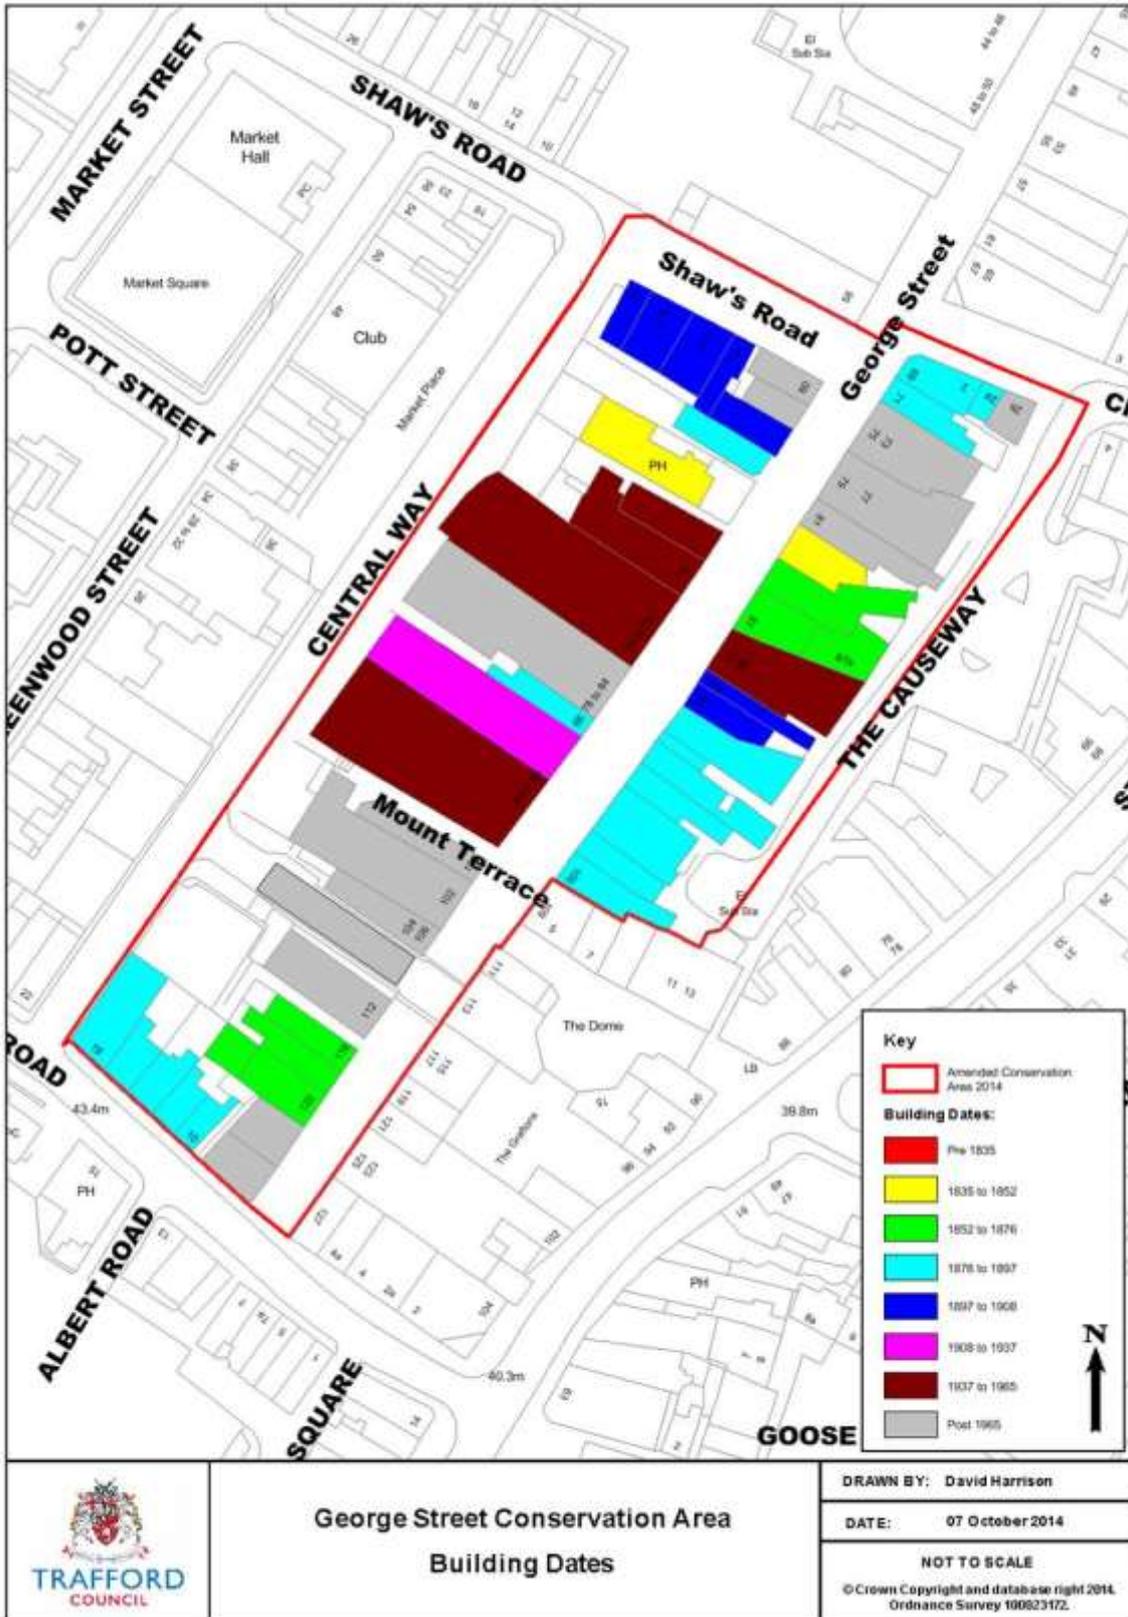
Map 12: Ages of Buildings

- 4.3.1. The ages of buildings within the Conservation Area have been identified through both a basic visual inspection and map regression (see Map 12). Buildings have been dated to the earliest known part of the building evident from the aforementioned research, although many may have later extensions, or in some cases later facades or conceal earlier origins. The buildings have been allocated into general date ranges based upon available maps which provide sufficient detail to allow assessment. Maps assessed include the Cheshire Tithe map (dated 1835) 1852 Board of Health Plan, Ordnance Survey plan surveyed in 1876 (published in 1878) and subsequent Ordnance Survey maps. Whilst this analysis attempts to provide an approximate date to buildings and properties, it is not in lieu of a comprehensive building survey which should be undertaken using appropriate expertise.

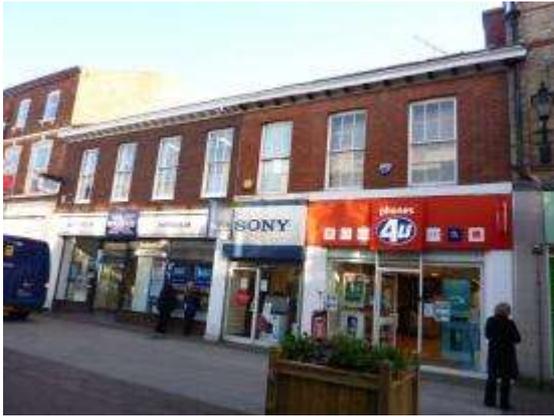
Photograph 4: Classically styled properties evident from the upper storeys

- 4.3.24. With the exception of the Bricklayers Arms Public House, there is a continuous building line of properties of varying dates, forming the east side of George Street. Buildings are predominately Victorian with at least two known late Georgian properties, the Bricklayers Arms and 83 George Street. A number of properties, for example no.69 George Street (photograph 6) exhibit a classical style indicated by the proportions of the building and also architectural details such as stone string courses, dentillated eaves, prominent cornice, plain stone cills and multi-pane timber sash windows (Photograph 4).

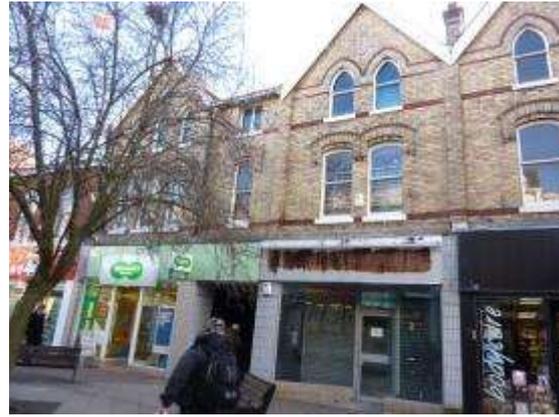
Photograph 5: Victorian property with paired gothic pointed arched windows at second floor and steeply pitched gables

- 4.3.25. Some of the Victorian shops use contrasting brick to highlight architectural detail and have a more gothic than classical appearance, although features are often intermixed. They tend to be over three storeys as opposed to two and present a gable end to the street. Many have decorative timber barge boards. Number 66 George Street is a late Victorian building designed by Manchester architects Tate and Popplewell in a domestic revival style with striking black and white mock timber framing.

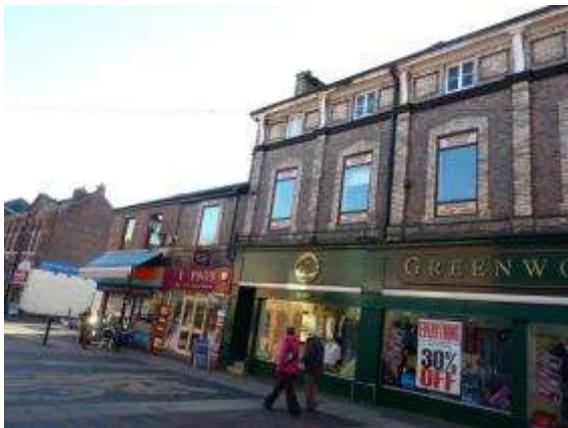
Photograph 6: 69 George Street, an example of classical revival with polychromatic brick pilasters and façade divided into classical proportions

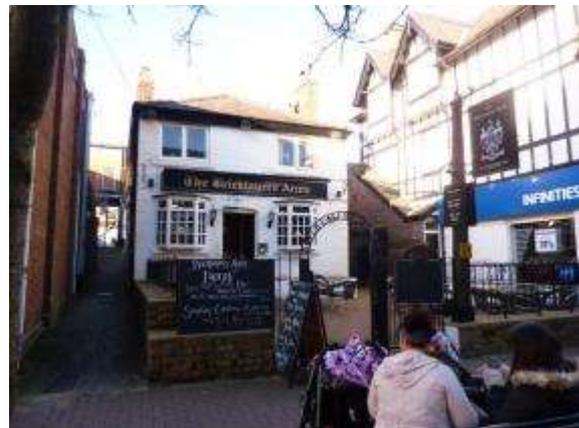
Photograph 7: Bricklayers Arms Public House

- 4.3.26. Very few properties are rendered, with the exception of the Bricklayer's Arms which is rendered and painted white (Photograph 7). Next to the Bricklayers Arms, number 66 has black and white timber detailing. Within the proposed boundary extension there are several buildings with painted brickwork including number 86.

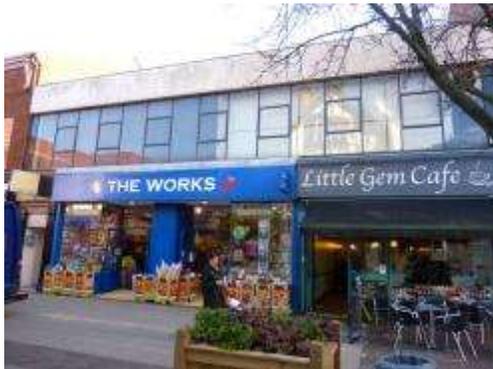
Photograph 8: Inappropriate signage & shop front, No. 77 George Street

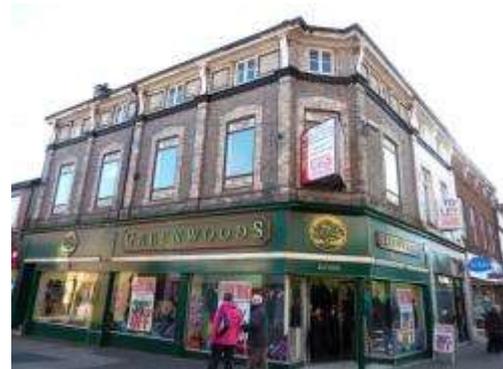
Photograph 9: Appropriate shop front design, No. 69 George Street

- 4.3.27. There are very few examples of shop fronts with historic character within the current Conservation Area boundary. Many shops within the existing designation have signage that is of an inappropriate design, material and lighting. Examples of shop fronts that have some historic character include number 83 and 69-71 George Street (Photographs 9 & 10). Within the proposed extension to the Conservation Area the shops along Regent Road, specifically number 10, has a shop front of appropriate historic character with timber pillars and moulded fascia. Numbers 86 and 66 also display historic detailing.

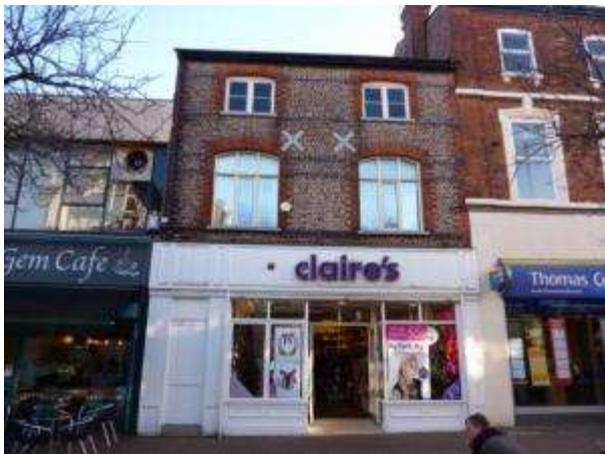
Photograph 10: No. 83 George Street; appropriatereplacement shop front with exception of the signage which is considered intrusive

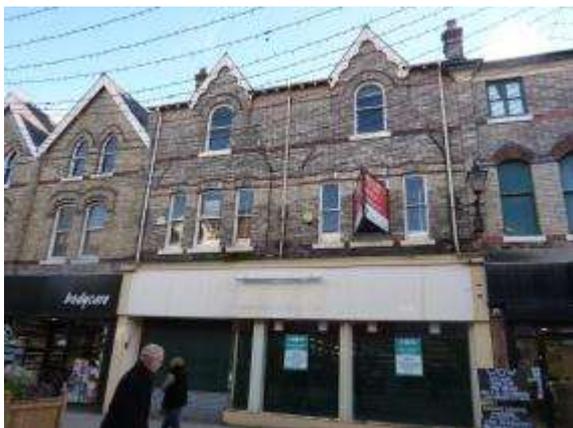
- 4.3.28. There are issues with vacant shops within the Conservation Area, as some now have to let boards or the shop fronts are displaying signs of decay such as nos. 97 and 101-103 (Photographs 13 & 14).

Photograph 12: Vacant shop with intrusive 'to let' board.

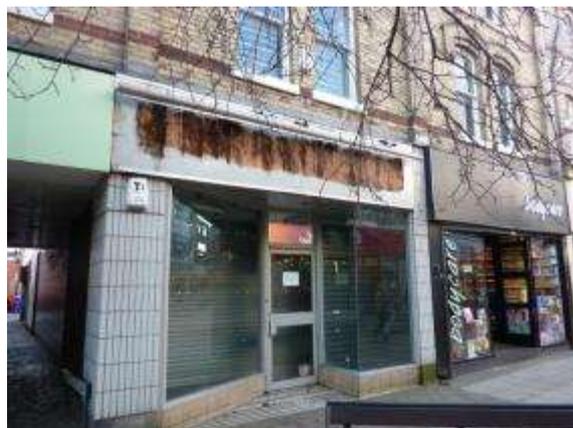
Photograph 13: Vacant shop/deteriorating signage

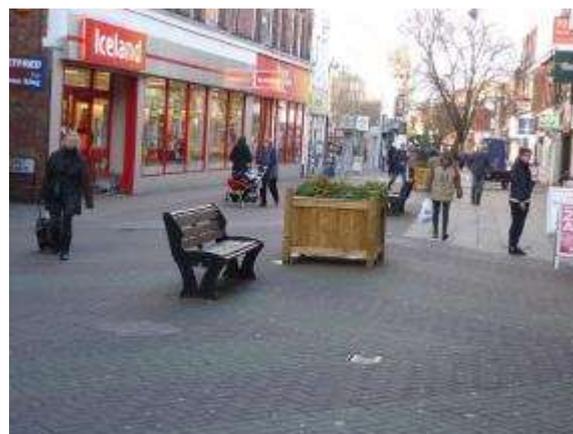
Photograph 15: View towards Upper George Street

- 4.3.29. There is one small area of setts not covered in tarmac to the rear of the ginnel between 116 and 112, and setts to The Causeway ginnel. Most other ground surface treatments in the Conservation Area or proposed boundary extension are not historic, with a mixture of concrete paving slabs and brick.
- 4.3.30. Along George Street contrasting bricks are used to create a pattern of concentric diamonds, and on Cross Street, a Lion (Photograph 14). Lamp posts and litter bins are modern and painted black. There are benches and timber flower planters in the centre of the pedestrianised street. Numerous advertisement boards are found along the length of George Street resulting in street clutter (Photograph 15) as well as intrusive advertisements found on a number of telephone boxes.

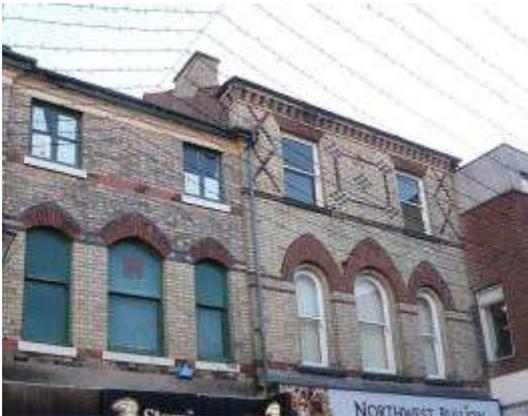
the façades of the structures (Photograph 16). Classical details such as the segmental arches over windows and doors are also repeated throughout the Conservation Area. The windows vary in style and there have been some late 20th century replacements.

Photograph 16: Decorative brick patterns

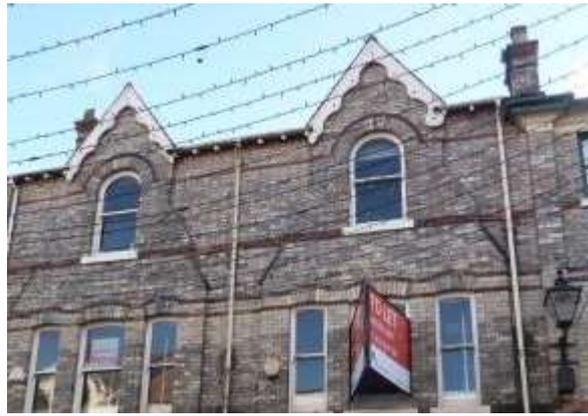
Photograph 17: Decorative barge boards

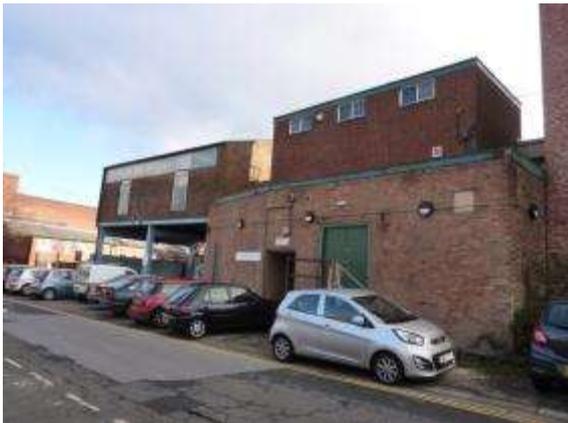
Photograph 22: Mid to late 20th century building on Central Way

6.2.12. Inappropriate 20th century development of poor quality new design that does not respect the historic character of the Conservation Area has had an effect on the character of the area. Examples include numbers 79, 81 and 74-78. The mid to late 20th century building raised on concrete posts located on Central Way, to the rear of no. 72 George Street, is particularly intrusive (Photograph 22), as is the space below it (Photograph 25). Multiple extensions, extensions in low quality materials such as corrugated plastic sheeting and alterations to the rears of properties give the structures an inappropriate unkempt appearance that does not reflect the historic character of the area (Photograph 24). Views from Regent Road to the north are interrupted by the intrusive concrete bridge. The views at the southern end of the conservation area are dominated by the intrusive mid to late 20th century development of the Graftons and tower block (Photograph 24).

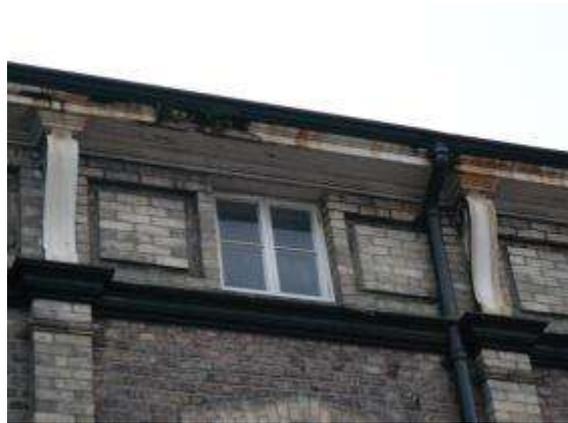
6.2.2. There are also signs of decay and areas in need of repair, such as the water damage to the eaves of buildings (Photograph 23).

Photograph 23: Water damage to eaves No. 69 George Street

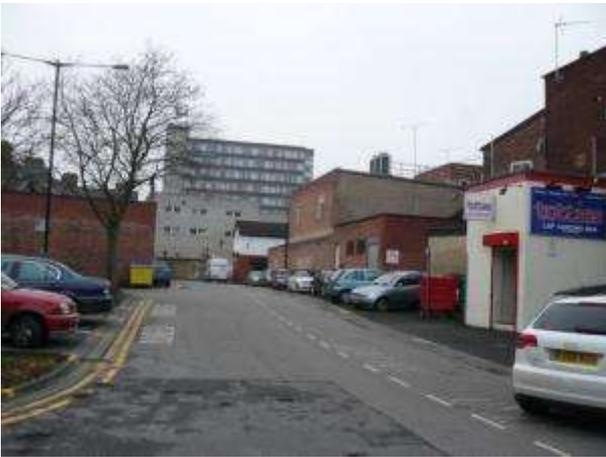
Photograph 24: Extensions facing onto The Causeway

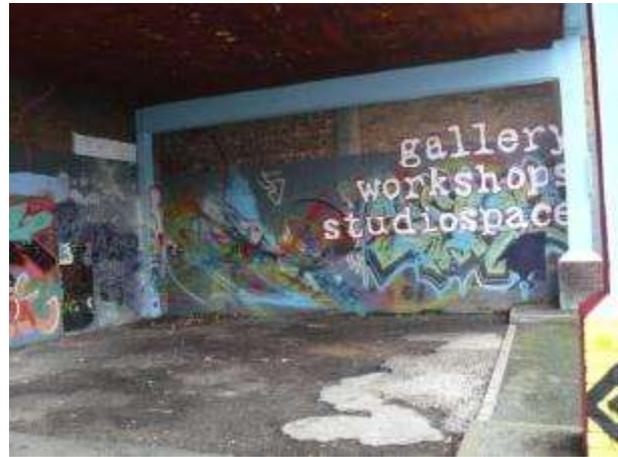
Photograph 25: Space underneath the intrusive structure to rear of 72 George Street

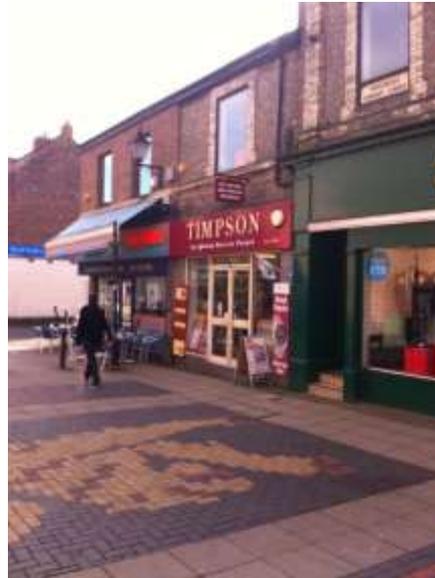
Address: 2a Cross Street

Built: 1876-1897, Condition: Fair

Description: This building reflects a substantial number of other elements in the Conservation Area in age, style, materials and form. The building reflects the traditional functional character and former uses in the area. This 2 storey terraced building is built from handmade Cheshire which is laid in a header brick bond, the roof of the building is pitched and cladded with blue slate. The ground floor windows at the property have been altered to accommodate the business purpose, whereas the first floor window is a tall shaped aluminium casement window which has cream brick detailing, a stone sill and a cream brick header. The ground floor has replacement shop frontage, which has a part metal, part clear-glazed doorway. The building has a regular form and a symmetrical composition. It illustrates the development of the settlement in which it stands.

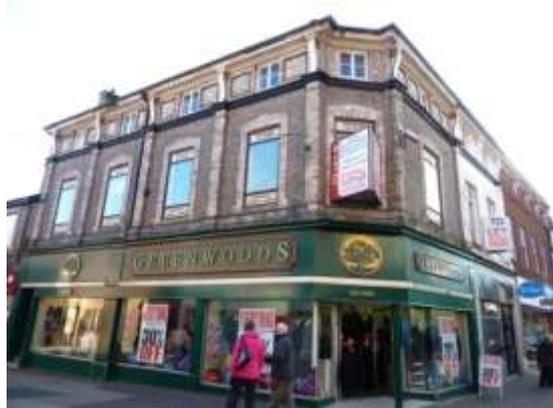
Address: 2 Cross Street and 69 George Street

Built: 1876-1897, **Condition:** *Good*

Description: This building reflects a substantial number of other elements in the Conservation Area in age, style, materials and form. The building reflects the traditional functional character and former uses in the area. This 3 storey terraced is built from handmade Cheshire brick which is laid in a header brick bond. The roof is pitched cladded with blue slate and features external brick chimneys. The ground floor windows at both properties have been altered to accommodate the businesses purpose, whereas the first floor windows are tall shaped aluminium casement windows which have cream brick detailing, stone sills and cream brick headers. The second floor has a series of wooded square windows which have stone sills. The ground floor has traditional-styled shop frontage, which has a modern part metal, part clear-glazed doorway. Other architectural elements include decorative patterned brickwork and corbel detailing to the second floor. The building has an irregular form and an asymmetrical composition. It illustrates the development of the settlement in which it stands.

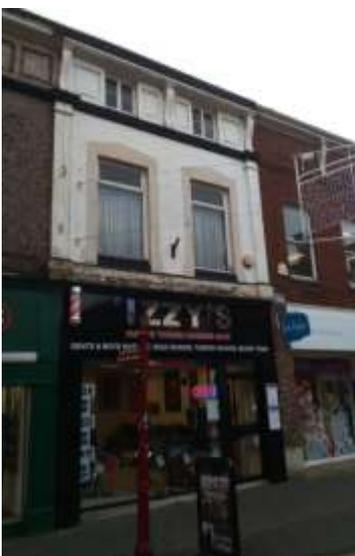
Address: 71 George Street

Built:1876-1897, **Condition:** *Fair*

Description: This building reflects a substantial number of other elements in the Conservation Area in age, style, materials and form. The building reflects the traditional functional character and former uses in the area. This 3 storey terraced is built from brick which has been painted on the first and second floors. The roof is pitched cladded with blue slate and features external brick chimneys. The ground floor windows at both properties have been altered to accommodate the businesses purpose, whereas the first and second floor windows are replacement painted timber casements. Other architectural elements include painted brickwork surrounds to window openings and corbel detailing to the second floor replicating that of 69 George Street. The building has an regular form and an symmetrical composition. It illustrates the development of the settlement in which it stands.

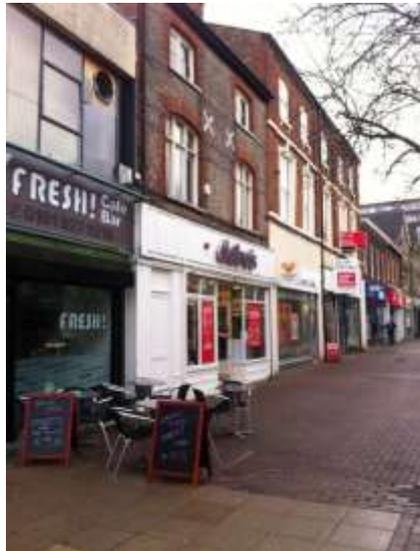
Address: 83 George Street

Built: 1835-1876, **Condition:** *Good*

Description: These buildings reflect a substantial number of other elements in the Conservation Area in age, style, materials and form. They reflect the traditional functional character and former uses in the area. This 3 storey terrace is constructed from handmade Cheshire brick which is laid in a header brick bond. The roof is pitched cladded with blue slate and features external brick chimneys. The ground floor windows at the property have been altered to accommodate the businesses purpose, whereas the upper floor windows have tall curved top casement windows. The ground floor has traditional-styled shop frontage, which has a modern part-timbered, part clear-glazed doorway with a fanlight. Other architectural features include gauged brickwork, red brick detailing and a stone string-course. The building has a regular form and a symmetrical composition. As a group they illustrate the development of the settlement in which they stand.

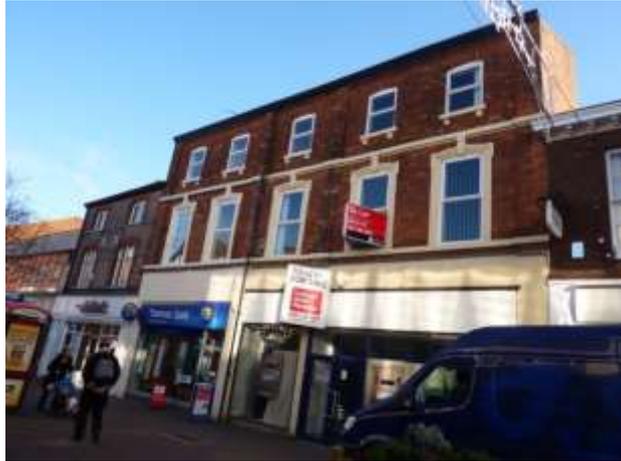
Address: 85-87 George Street

Built: 1835-1876, **Condition:** *Good*

Description: These buildings reflect a substantial number of other elements in the Conservation Area in age, style, materials and form. They reflect the traditional functional character and former uses in the area. These 3 storey terraced buildings are built from red stock brick which is laid in a Flemish brick bond, in-addition both ground floors of these properties have a rendered finish to them. The roof is pitched cladded with blue slate and features external brick chimneys. The ground floor windows at the property have been altered to accommodate the businesses purpose, whereas the upper floors have curved top vertical sliding sash windows which have stone sills on the first floor and stone sills and brick headers on the second floor. Other architectural features include gauged brickwork, a stone string-course and an architrave with a keystone around the first floor windows. The ground floor of the buildings have modern-styled shop frontage, which has a modern part metal, part clear-glazed doorways. The buildings have an irregular form and elements of symmetry to the upper floors. As a group they illustrate the development of the settlement in which they stand.

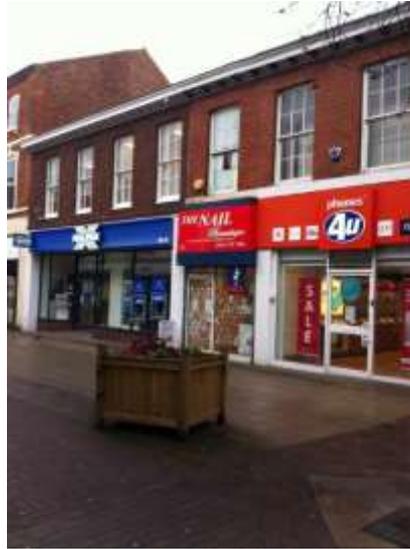
Address: 89-93 George Street

Built: 1876-1897, **Condition:** *Good*

Description: These buildings reflect a substantial number of other elements in the Conservation Area in age, style, materials and form. They reflect the traditional functional character and former uses in the area. These 2 storey terraced buildings are built from red stock brick which are laid in a Flemish brick bond. The roof is pitched cladded with blue slate and features external brick chimneys and eaves brackets. The ground floor windows at both properties have been altered to accommodate the businesses purpose, whereas the windows on the first floor are tall shaped vertical sliding sash windows that have brick sills and brick headers, some of which are not visible at properties 91a-93. The ground floors of the buildings have modern-styled shop frontages, which has a modern part metal, part clear-glazed doorway. The building has a regular form and elements of symmetry to the upper floors. As a group they illustrate the development of the settlement in which they stand.

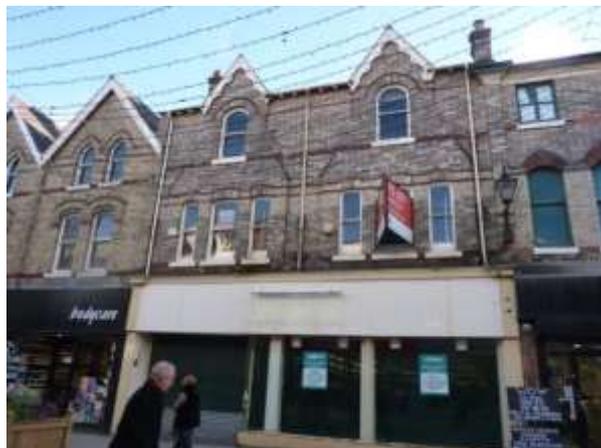
Built: 1876-1897, **Condition:** *Fair, some issues with vacancy which have led to neglect and disrepair.*

Description: These buildings reflect a substantial number of other elements in the Conservation Area in age, style, materials and form. They reflect the traditional functional character and former uses in the area. These 3 storey terraced buildings are built from cream with red stock brick detailing at properties 95-99 and cream and blue brick at property 101, these properties are laid in a Flemish brick bond. The roof is pitched cladded with blue slate and features external brick chimneys and at properties 95-99 there are a series of gablettes and decorative ridge tiles. The ground floor windows at the properties have been altered to accommodate the businesses purpose, whereas at first floor windows all the properties have tall curved top windows which have stone sills and brick headers. The second floor however, has a mixture of arched and squared shaped windows at properties 95-99 and semi-circular topped windows at property 101. All the upper-floor windows are vertical sliding sashes which have stone sills and brick headers. The ground floor of the buildings have modern-styled shop frontage, which has a modern part metal, part clear-glazed doorways. Other architectural elements include decorative bargeboards, red brick detailing and a red brick string-course. The buildings have an irregular form and elements of symmetry to the upper floors at the properties 95-97, 99 and 101. As a group they illustrate the development of the settlement in which they stand.

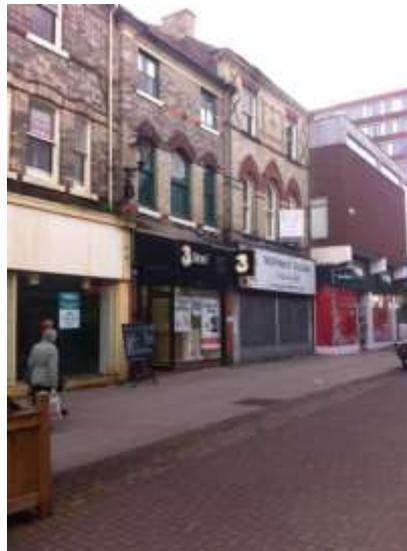
Built: 1876-1897, **Condition:** *Fair*

Description: These buildings reflect a substantial number of other elements in the Conservation Area in age, style, materials and form. These 3 storey terraced buildings are built from cream brick which is laid in a Flemish brick bond. The roof is pitched cladded with blue slate and features external brick chimneys. The ground floor windows at both properties have been altered to accommodate the businesses purpose, whereas the first floor at property 103 the windows are arched in shape and at 105 they semi-circular topped in shape. The top floor windows at 103 are squared in shape and at 105 they are tall in shape, the first and second floor windows are all vertical sliding sash windows which have stone sills and brick headers. In addition the ground floor

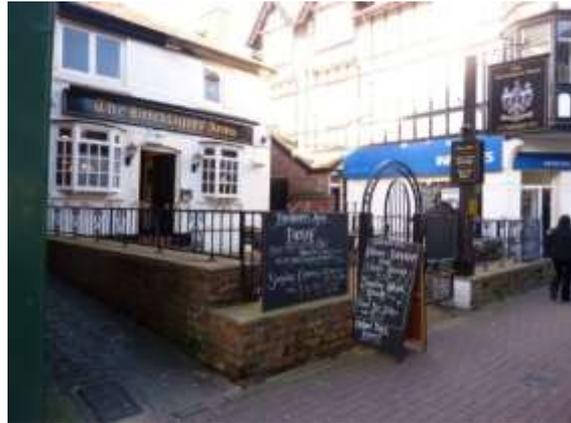
Address: 68 George Street; Bricklayers Arms

Built: 1835-1852, **Condition:** *Good*

Description: This building reflects a substantial number of other elements in the Conservation Area in age, style and materials. It illustrates the development of the settlement in which it stands. This 2 storey detached building has a rendered finish with stone detailing. The roof is hipped cladded with blue slate and features external brick chimneys. The ground floor of the building has oriel windows, whereas the first floor has rectangular shaped leaded light casement windows. The entrance doorway to the building features a solid panelled door, which is surrounded by a revival detailed doorway. It reflects the traditional former uses in the area.

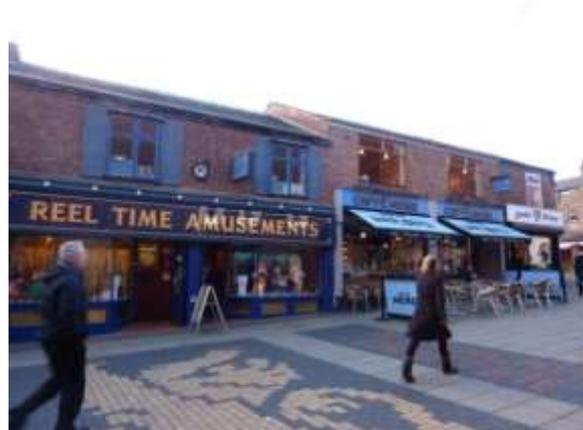
Proposed Extension, Address: 3-13 Shaws Road

Built: Pre 1835, **Condition:** *Fair*

Description: These buildings reflect a substantial number of other elements in the Conservation Area in age, style, materials and form. These 2 storey terraced buildings are built from Cheshire brick which is laid in a stretcher brick bond, property number 3 however has had the brick painted over in white. The roof is pitched cladded with blue slate and features external brick chimneys. The ground floor windows at the property have been altered to accommodate the businesses purpose whereas at first floor level properties 3-11 have tall shaped wooden windows and number 13 has had its original windows replaced with PVC. The ground floor has a series of replacement shop frontages; in-addition properties 5-11 have part-glazed, part timbered doorways whereas properties 3 and 13 have part metal, part glazed doorways. Other architectural elements of the property include traditional styled window shutters at 5-7 and additional security measures at property 13. The buildings have a regular form and an asymmetrical composition. As a group they illustrate the development of the settlement in which they stand.

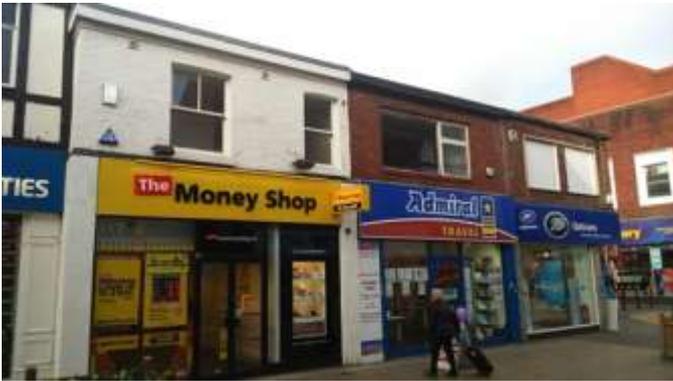
Address: 60-64 George Street

Built: 1835-1852 & post 1965, **Condition:** *Good*

These buildings reflect a substantial number of other elements in the Conservation Area in age, style and form, no.64 George Street also reflects age and materials. The terrace appears to be erected between 1835 and 1852 although 60-62 George Street have been substantially altered/rebuilt in late twentieth century. No. 64 George Street has been constructed from painted Cheshire brick with vertical timber sliding sash windows at first floor. The terrace is 2 storeys with pitched roof cladded with blue slate and a brick chimney at no.64. Windows openings at first floor level at 60-62 George Street do not replicate traditional openings at no.64. The ground floor has a series of replacement shop frontages. The buildings have a regular form and overall a symmetrical composition. As a group they illustrate the development of the settlement in which they stand and forma relationship with the terrace at 3-13 Shaws Road.

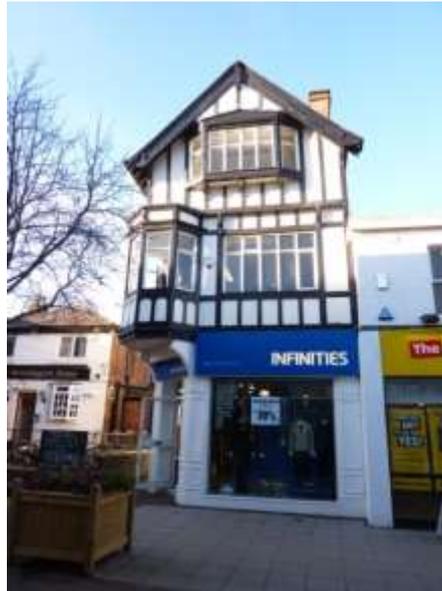
Address: 66 George Street

Built: 1876-1897, **Condition:** *Good*

Description: This building was erected in 1881 and is the work of Tate and Popplewell, architects of regional note. The design was featured in volume 40 of *The Builder* magazine in the same year. It has landmark quality. This building reflects a substantial number of other elements in the Conservation Area including age, use form, scale and materials. This 3 storey building has a rendered finish to the ground floor and black and white half-timbered detailing to floors one and two. The roof is pitched cladded with blue slate and features external brick chimneys and gablettes. The ground floor windows of the property have been altered to accommodate changes in occupation, whereas the upper floors have retained timber casement windows and an oriel window. The ground floor of the building has a traditional-styled shop frontage, which has a modern part metal, part clear-glazed doorway. Other architectural features the buildings have include a first storey canted bay, an irregular form and an asymmetrical composition. It illustrates the development of the settlement in which it stands and was erected as residential accommodation over a shop.

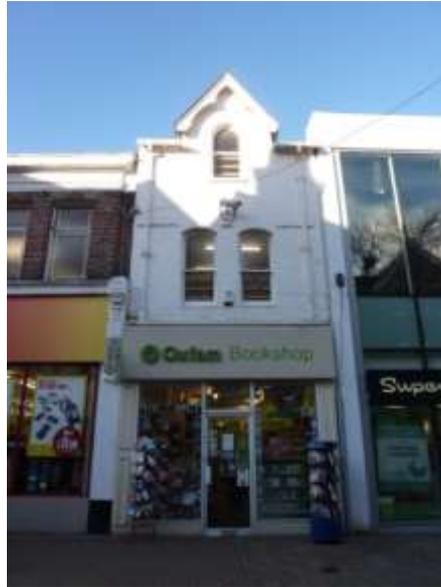
Address: 86 George Street

Built: 1876-1897, **Condition:** *Good*

Description: This building reflects a substantial number of other elements in the Conservation Area in age, style, materials and form. This 3 storey terraced building is built from brick which is laid in a Flemish brick bond. The roof is pitched cladded with blue slate and has external decorative ridge tiles. The ground floor windows at the property have been altered to accommodate the businesses purpose whereas the upper floors has a mixture of curved topped and semi-circular topped vertical sliding sash windows. The ground floor of the building has a modern-styled shop frontage, which has a modern part metal, part clear-glazed doorway. Other architectural features the buildings have include gauged brick work, a regular form and elements of symmetrical composition to the upper floors. The building reflects the traditional functional character and former uses in the area. It illustrates the development of the settlement in which it stands.

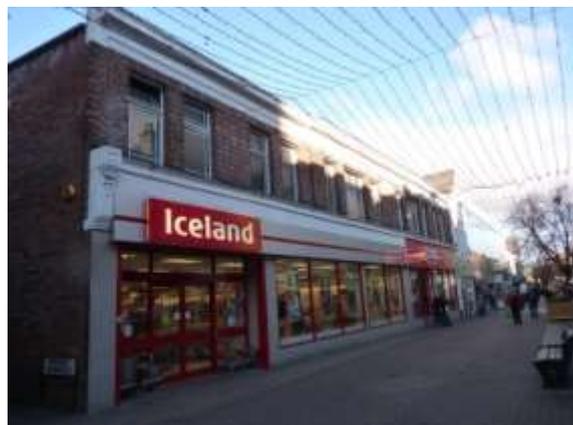
Address: 88-90 George Street

Built: 1908-1937, **Condition:** *Good*

This building illustrates the development of the settlement in which it stands. This 2 storey terraced building is built from red brick which is laid in a variation of brick bonds. The roof of the building is flat and the ground floor windows at the property have been altered to accommodate the businesses purpose whereas the upper floor has metal framed windows. The ground floor of the building has a modern-styled shop frontage, which has a modern part metal, part clear-glazed doorway. Other architectural features include corbels, parapet, an irregular form and an asymmetrical composition. The building reflects the traditional functional character and former uses in the area.

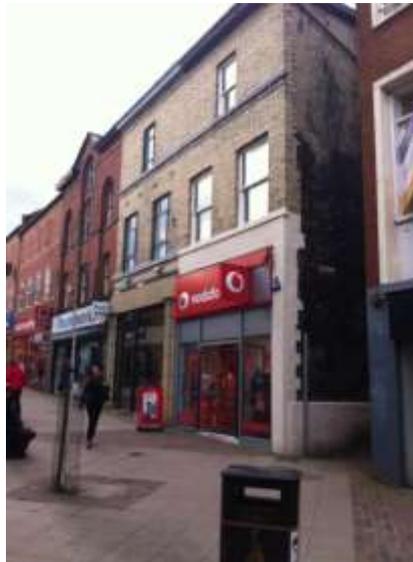
Address: 116-118 George Street

Built: 1852-1876, **Condition:** *Fair*

These buildings reflect a substantial number of other elements in the Conservation Area in age, style, materials and form. This 3 storey terraced building is built from cream brick which is laid in a Flemish brick bond, the ground floor at property 116 however, has a white rendered finish to it. The roof is hipped cladded with blue slate and features external chimneys. The ground floor windows at the property have been altered to accommodate the businesses purpose, whereas at property 116 the upper floors have vertical sliding sash windows with stone sills and brick headers. Property 118 has replaced its original windows with aluminium casement windows; these windows also have stone sills and brick headers. The ground floor of the building has a modern-styled shop frontage, which has modern part metal, part clear-glazed doorways. Other architectural features the buildings have include a stone string-course, a regular form and elements of symmetrical composition to the upper floors. They reflect the traditional functional character and former uses in the area. As a group they illustrate the development of the settlement in which they stand.

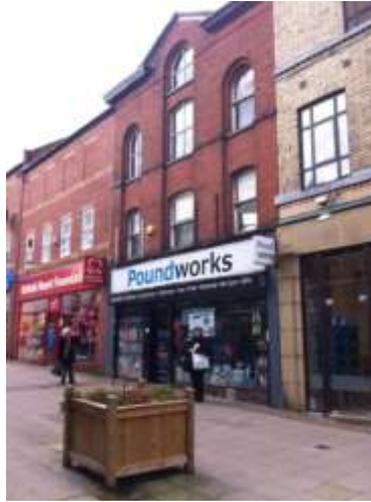
Address: 120 George Street

Built: 1852-1876, **Condition:** *Fair*

These buildings reflect a substantial number of other elements in the Conservation Area in age, style, materials and form. This 3 storey terraced building is built from red stock brick which is laid in a Flemish brick bond. The roof is pitched cladded with blue slate and features a gablette. The ground floor windows at the property have been altered to accommodate the businesses purpose whereas the upper floors have a mixture of curved topped and semi-circular topped vertical sliding sash windows. The ground floor of the building has a modern-styled shop frontage, which has a modern part metal, part clear-glazed doorway. Other architectural features the buildings have include a stone string-course, a regular form and elements of symmetrical composition to the upper floors. They reflect the traditional functional character and former uses in the area. As a group they illustrate the development of the settlement in which they stand.

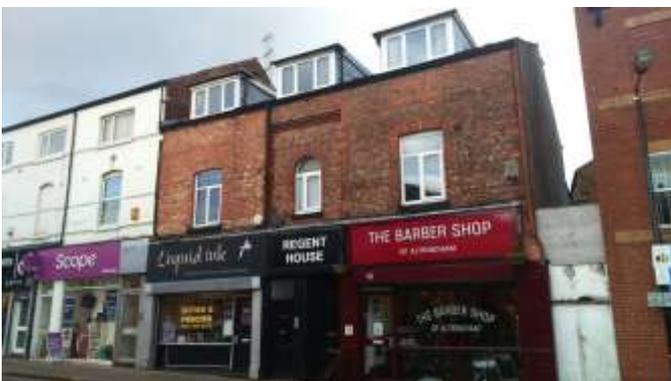
Address: 10-12 Regent Road

Built: 1876-1897 **Condition:** *Fair*

This building reflects a substantial number of other elements in the Conservation Area in age, style, materials and form. This 2 storey building, forms an end terrace, and is built from red brick laid in a header bond. The roof is pitched clad with blue slate and features 3 dormers. The ground floor accommodates 2 shop fronts which have been

replaced in the early 21st century and a slightly recessed central bay. There is a shared entrance centrally placed serving both premises. On the upper floor original window openings remain. The central window has an arched header with windows either side exhibiting cambered headers. Other architectural features include red stock brick string-courses and gauged brickwork present in the central bay. The building has a regular form and elements of symmetrical composition to the upper floors. The building reflects the traditional functional character and former uses in the area. As a group the building illustrates the development of the settlement in which it stands.

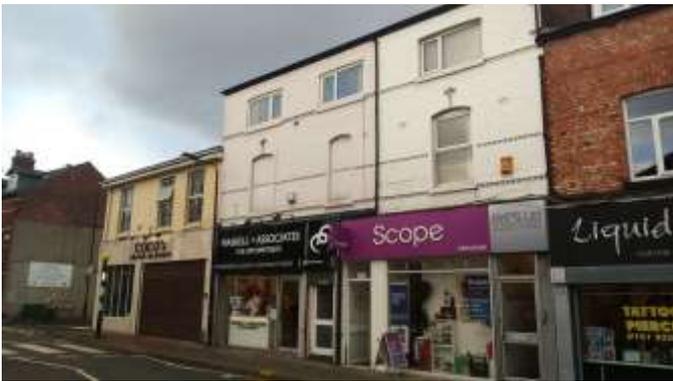
Address: 14-16 Regent Road

Built: 1876-1897 **Condition:** *Fair*

This building reflects a substantial number of other elements in the Conservation Area in age, style, materials and form. This 3 storey terrace is built from painted brick. The roof is pitched clad with blue slate. The ground floor accommodates 2 shop fronts which have been replaced in the early 21st century. Entrances serving both are centrally placed. The building is divided into 3 bays, one bay forming no.14 Regent Road and 2 bays forming no.16 Regent Road. On the first floor 3 original window openings remain with cills and cambered headers. On the second floor window openings have been altered. Other architectural features include a painted brick string-course. The building has a regular form and elements of symmetrical composition to the upper floors. The building reflects the traditional functional character and former uses in the area. As a group the building illustrates the development of the settlement in which it stands.

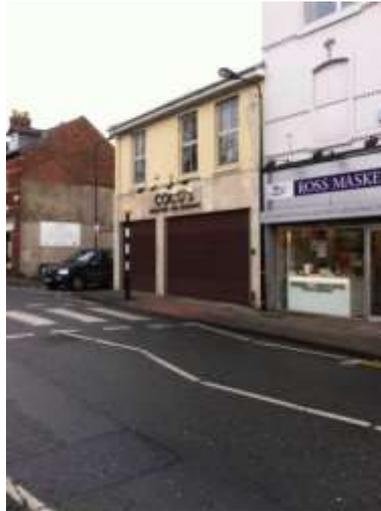
Address: 18 Regent Road

Built: 1876-1897, **Condition:** *Fair*

This building reflects a substantial number of other elements in the Conservation Area in age, style, materials and form. This 2 storey terrace is constructed from brick which is laid in a variation of brick bonds. The ground floor however has an added decorative patterned stone wall feature and the brickwork on the upper floor has been painted over. The roof is pitched cladded with blue slate and has no external features. The ground floor windows at the property have been altered to accommodate the businesses purpose, whereas at first floor level the windows are tall vertical sliding sash windows which have stone sills and brick headers. The ground floor of the building has a modern frontage, which has a modern part timbered, part clear-glazed doorway. The buildings have an irregular form and an asymmetrical composition. The building reflects the traditional functional character and former uses in the area. It illustrates the development of the settlement in which it stands.
