Warburton Village Conservation Area

Conservation Area Appraisal
Consultation Draft
June 2016

The Warburton Village Conservation Area Conservation Area Appraisal Consultation Draft: June 2016

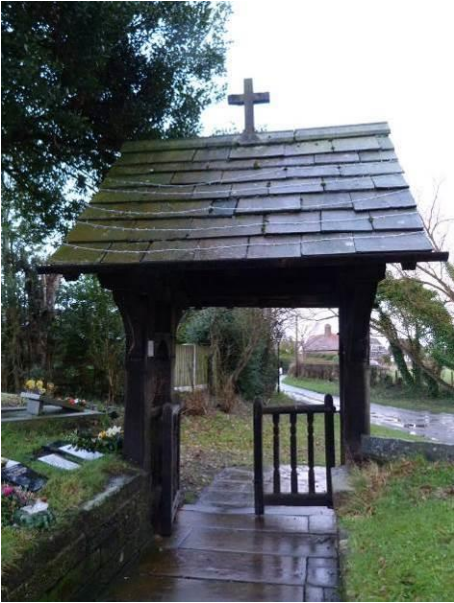
Lychgate, Old Church of St Werburgh, Wigsey Lane

Date: Late 19th century

Condition: Good

The timber-framed lychgate is believed to date from the late 19th century and stands over an early, probably original, entrance route into the churchyard. Its design echoes the Arts and Crafts style found throughout the village with its chunky timber beams and braces, slate roof and simple turned balusters.

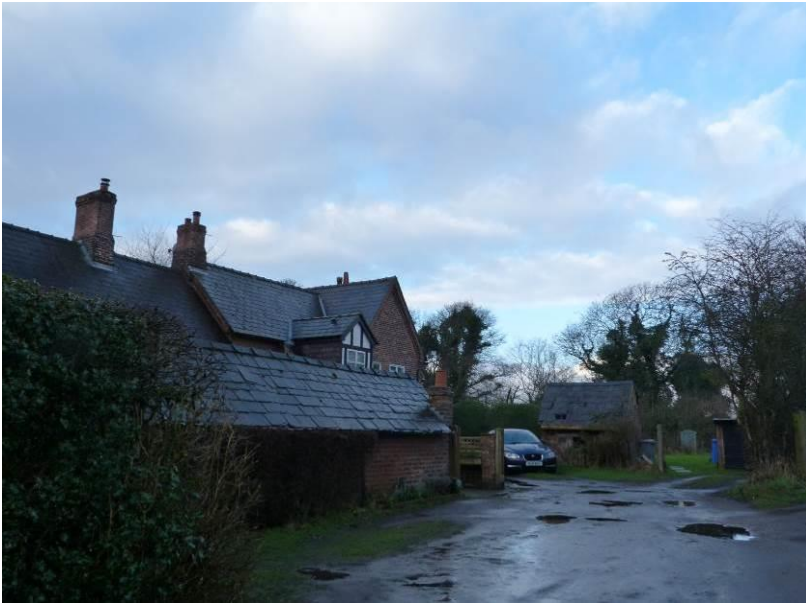
7-10 Church Green, Former Pipe & Punchbowl Alehouse

Date: 18th Century

Condition: Good

6.2.3 The terrace of four properties to the west of Wigsy Lane (Nos. 7-10) are occupied and reasonably well maintained. The windows have all been replaced with modern casements. The slate roof to the adjacent outbuilding is in poor condition with multiple slipped slates.

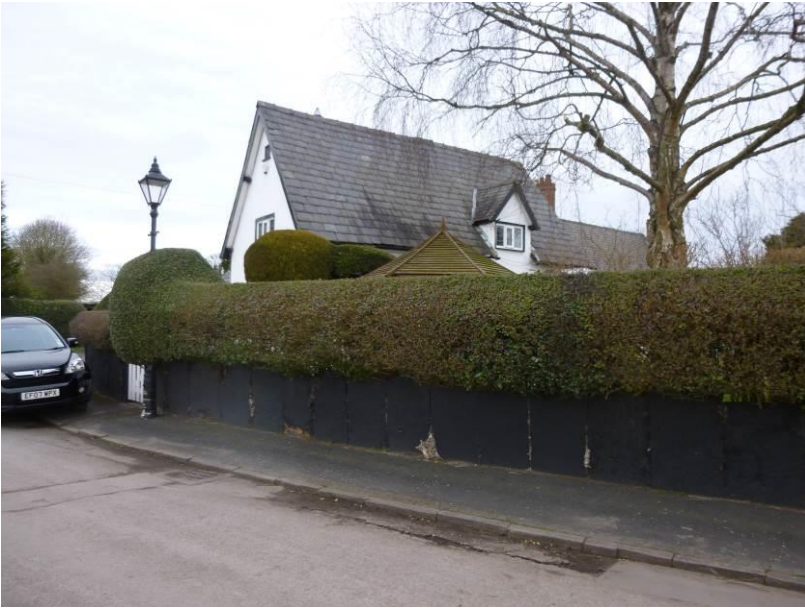
3 Wigsey Lane

Date: 18th Century

Condition: Good

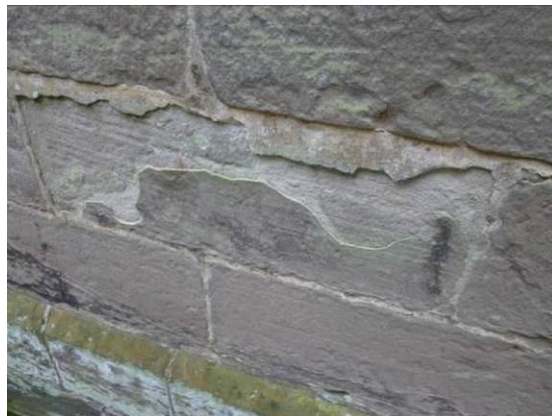
6.2.1 Saint Werburgh's Church generally appears well maintained. There are some slipped and cracked roof slates, with heavy moss build up to the north roof slopes. Elevations are well maintained but with moss and algae build up to the plinth level. There are some areas of cementitious re-pointing, including to window surrounds in the timber framing. The stone walling is de-laminating in many locations. The timber lychgate at the entrance to the church yard is in generally good condition, other than some braces which have shrunk and rotated.

Example of delamination to ashlar on St. Werburgh's Church

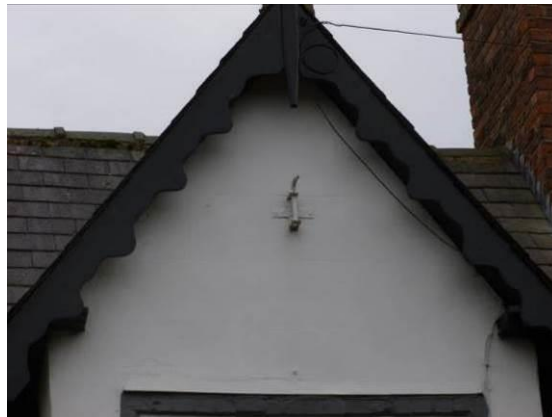
Incised joints to render of No.4 Church Green dormer gable

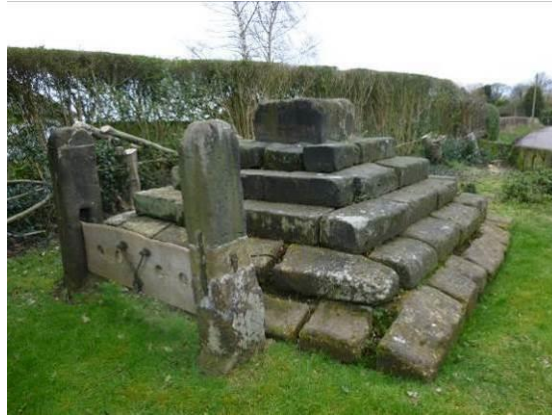
- 6.2.8 The steps of the historic stone cross base to corner of Wigsy lane and Townfield are in poor condition and require conservation, with moss growth, open joints and dislodged and cracked masonry noted. The historic stocks located in front of the steps have several visible fractures to the stone piers with various iron cramps to hold in them place. Modern steel has been strapped to stop the top of left hand side pier where there is a large vertical crack.

Dislodged steps to cross base and cracks to stocks

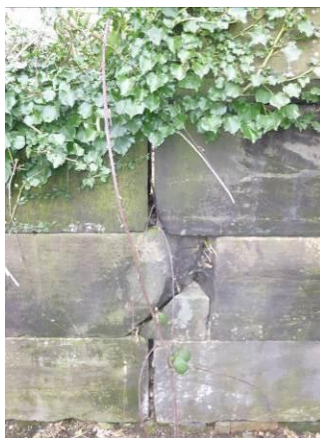
- 6.2.11 The two bridge to the north of the toll hosue have balustrade walls of large sandstone ashlar blocks and pitched copings. The majority of the walling is covered by vegetation. Where visible, cracking and damage was noted to blocks, as well as several dislodged blocks and eroded mortar joints generally. To the east side of the road there is a good quality iron railing running between the two bridges. Again this is mostly obscured by vegetation. However, where visible some fractures and some temporary repairs were noted. The ironwork urgently requires prepping and decorating and all vegetation should be stripped back.

Crack and vegetation to bridge balustrade wall

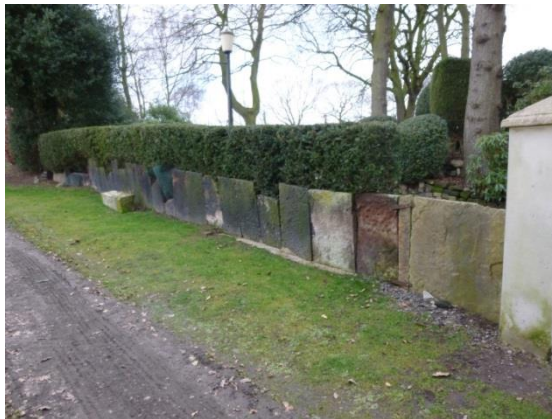
- 6.2.14 The ashlar stone wall to the church boundary has some damaged coping stones which require repair. The vertical stone slab wall to the Old Rectory boundary is in poor condition with several slabs cracked or broken.
- 6.2.15 Boundary walls to Wigsey Lane also of vertical stone flags. These are poorly maintained to No.1 and have gone to ruin towards the east edge. The flags have been cut in half to No. 1A. Those to the boundary of No. 3 are painted with a black paint, possibly bitumen, which may be causing damage.

Vertical sandstone flag boundary wall to rectory, with multiple fractured flags
