**Road Safety Audit
Stage 1**

**Housing Development
Warburton Lane, Trafford
Combined Site Accesses**

**Redrow Homes
Redrow House
St Davids Park
Ewloe
Flintshire
CH5 3RX**

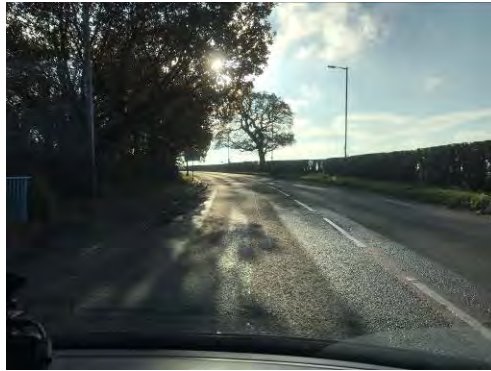
Photo 1: Existing Vegetation

Summary: Reduced or obstructed visibility splays can result in an increased risk of failure to give way type collisions.

Existing trees and vegetation line the eastern side of Warburton Lane **Photograph 1** below.

The vegetation will obstruct visibility between vehicles at the new site access any vehicles travelling along Warburton Lane resulting in an increased risk of failure to give way type collisions.

RECOMMENDATION: Remove all vegetation that can obstruct visibility or has the ability to grow and obstruct visibility in the future.
