Barton-Upon-Irwell

Conservation Area Appraisal
Consultation Draft June 2015

Barton-upon-Irwell Conservation Area Conservation Area Appraisal Draft: June 2015

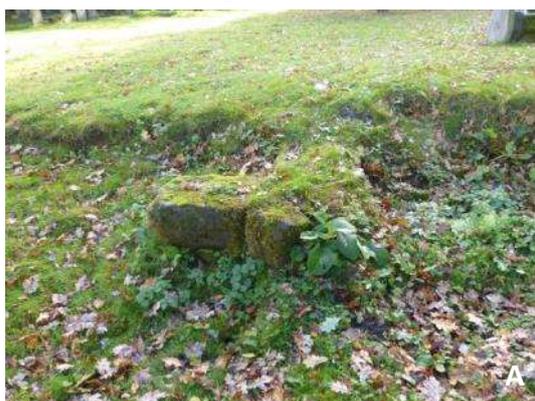
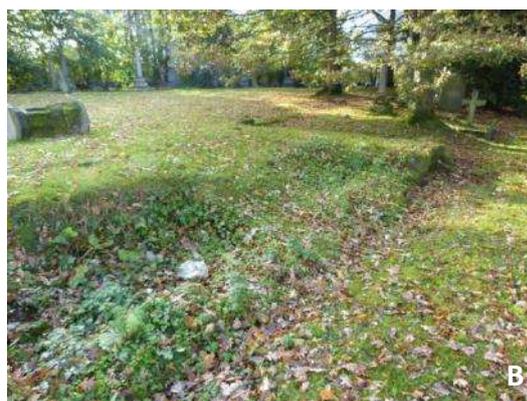
4.7.3 Remains that are easily visible include the foundations of St Catherine's Church within the centre of the graveyard. The footprint of the church is obvious and some stones are visible above ground.

A Remains of St Catherine's Church

B Remains of St Catherine's Church

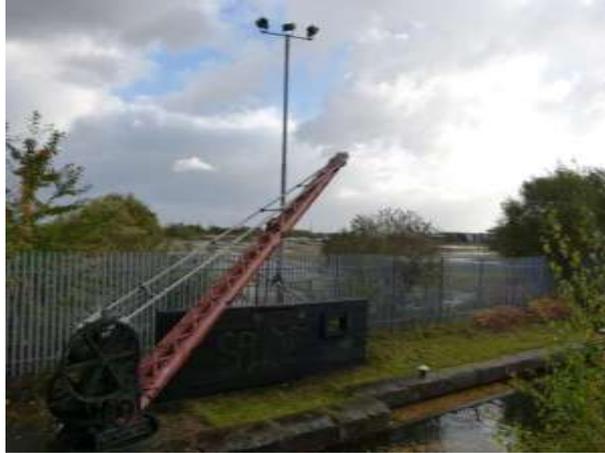
- 4.7.4 A former loading platform on the south bank of the Ship Canal is still evident and in good condition although all associated machinery and apparatus has been removed. A small crane sits on the eastern side of the Bridgewater Canal, to the immediate south of the aqueduct.

Crane at south end of aqueduct

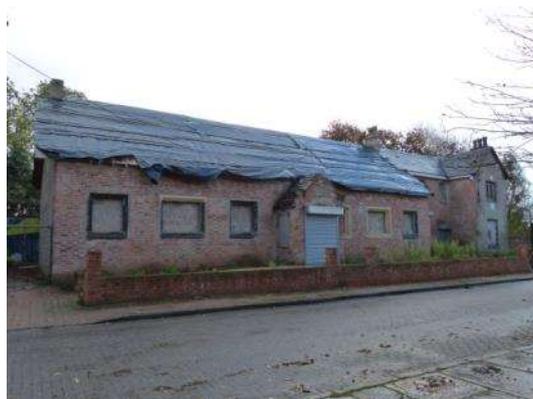
- 4.8.9 Abutting the south-west end of the School House is the Headmaster's House, which appears from the street as an L-shaped building. The gable end facing the street retains much of its render and has a large blocked up opening at ground floor level and window opening at first floor level. Recessed to the left of this gable is the front door and a window at ground floor level (both with metal roller shutters over) and two small windows at first floor level. A modern low brick wall (unfinished) sits at the boundary of the property and the pavement.

Old School House

- 6.2.11 The Old School House on Old Barton Road has been partially redeveloped, but is currently in poor condition and at risk. There are concerns about the quality of work and suitability for a historic building. Additionally, the work to finish the refurbishment is on hold. The external walls have previously been fully rendered but are now back to brick in most areas and the render is failing where still present. The slate roof has been fully stripped and membrane added, only a small area has been re-slatted. Windows have stone surrounds, generally painted, with evidence of original stone mullions which have been removed. Several have had new sections pieced in to the surrounds, but have used cast stone rather than natural sandstone. All window openings have been blocked up internally and no casements survive. The gable wall has been reconstructed in blockwork.

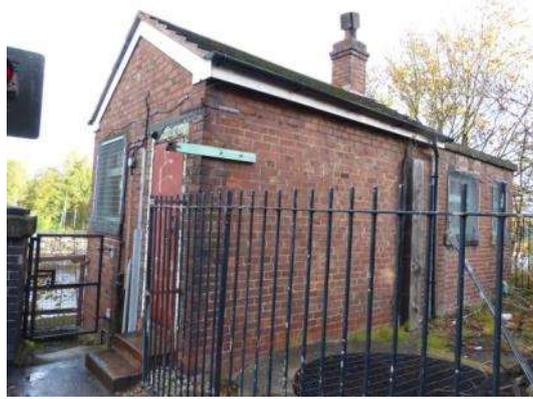
- 4.8.10 The remaining buildings on the south bank of the Ship Canal are of less significance, all demonstrating red brick and slate roofs with few embellishments. Firstly, a small, single storey ancillary brick building with pitched roof is situated at the south end of the road bridge, on the corner of Redclyffe Road and Chapel Place. On its west elevation, facing the road, is a doorway with window next to it. The north elevation faces onto the Manchester Ship Canal and has a similar window. A flat roof extension sits to the east and has two windows on its south elevation.

Ancillary Building at south end of bridge

- 6.2.6 There is a small single storey building at the south end of the road bridge, likely to be or have been associated with the management of the bridge. It is constructed of brickwork walls, with a tiled roof to the front half and a flat asphalt roof to the rear. Whilst it appears to be of generally sound condition, it looks to be unoccupied and could deteriorate. There is evidence of a former canopy to the entrance door, with redundant fixings either side and remnants of a flashing above. Staining to the brickwork at the rear suggests the flat roof may have failed.

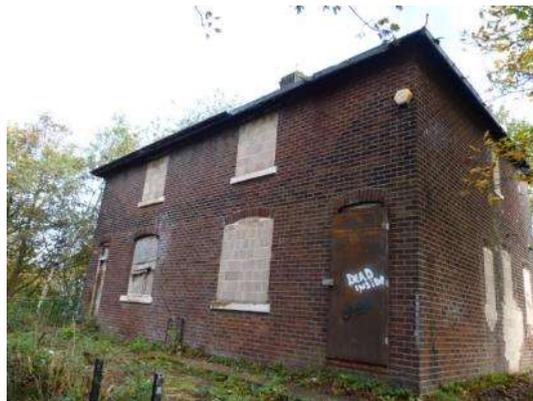
- 4.8.11 The empty pair of cottages is the only remaining building on Chapel Place. It is a brick building with hipped roof dating from between 1910 and 1930 which is now vacant and derelict. All of its openings have been blocked up, the chimney has collapsed, and roof slates and sections of guttering are missing. The west elevation is the principal elevation and has a doorway at each end flanking two bays with large window openings at ground and first floor level. The four bay, east elevation to the rear faces onto the Bridgewater Canal and has a partly demolished garden wall. The north and south elevations each have three bricked up window openings at ground floor level and one on the first floor.

Vacant building on Chapel Place

- 6.2.5 The cottages on Chapel Place are derelict and in very poor condition. The brickwork walls appear in reasonable condition externally. However, the roof slates are almost entirely missing and the timbers below in terrible condition. There are few gutters remaining and widespread vegetation growing from the tops of the walls. Most windows have been removed and openings infilled with blockwork. Those that remain are boarded over and have had all glazing removed. The single brickwork chimney is partially collapsed. There is also evidence of fire damage to the exposed structure.

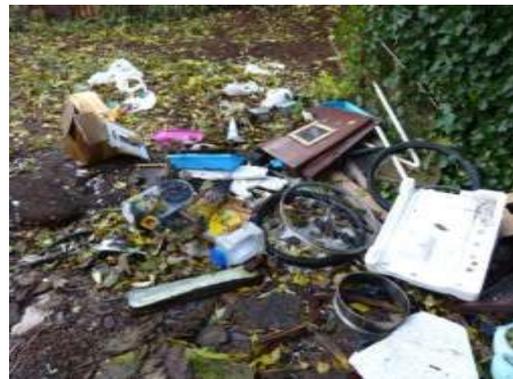
- 4.8.16 The public realm is extensive and there is a variety of hard landscaping in the Conservation Area. Herringbone block paving has been used to surface Old Barton Road and Chapel Place. Chapel Place was landscaped in the 1980s and the pathway, which follows the line of the former street and provides access to the Bridgewater Canal, has brick paving with seating and a metal gazebo. However, the area is adversely affected by fly tipping and vandalism.

Fly tipping off Chapel Place

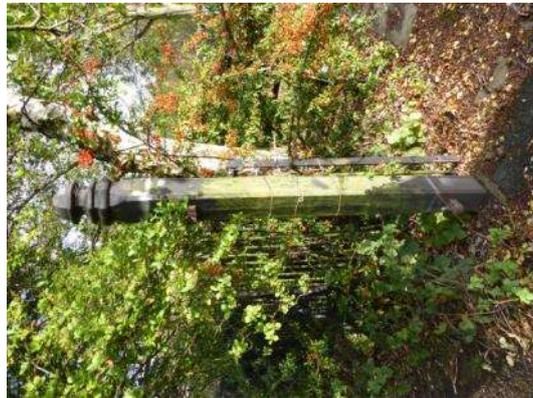
- 4.8.18 The remnants of older gate posts and fence posts can still be seen throughout the public realm areas although these are gradually deteriorating and returning to nature.

Old gate post off Old Barton Road

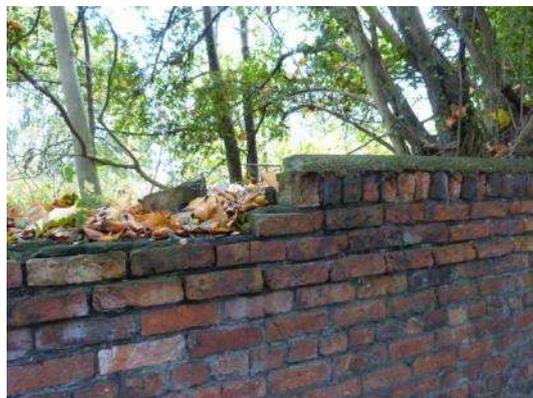
Boundary wall

- 4.8.19 Red brick walls line the east side of Redclyffe Road and these are in relatively poor condition. Sections have failed; some repairs have been carried out and the wall has a cement cap along much of its length.

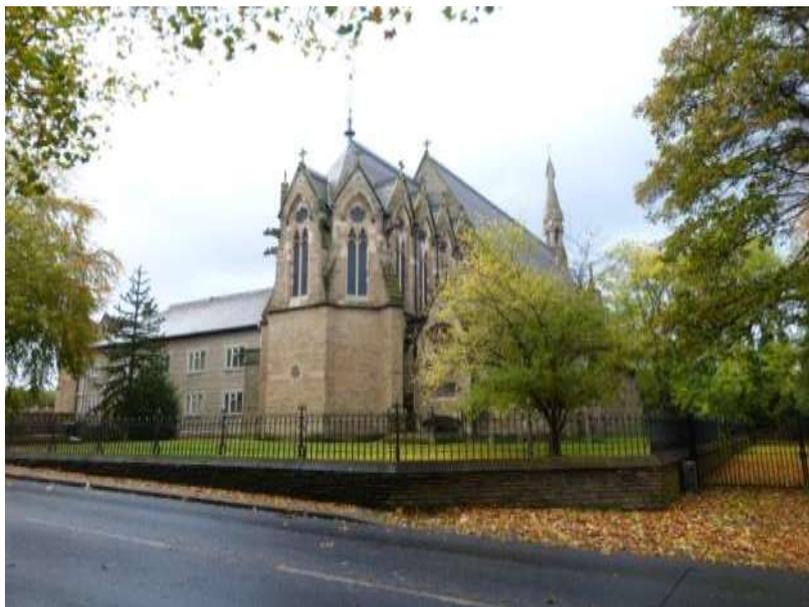
All Saints Church

Date: 1867-68

Condition: Good

- 6.2.7 All Saints' Church is a large sandstone building in the Gothic Revival style, with slate roofs set out in decorative banding. The building is in private ownership so could only be inspected at distance, but appears to be well maintained. There is evidence of recent masonry repairs to the east elevation. There was build-up of moss noted to some ledges

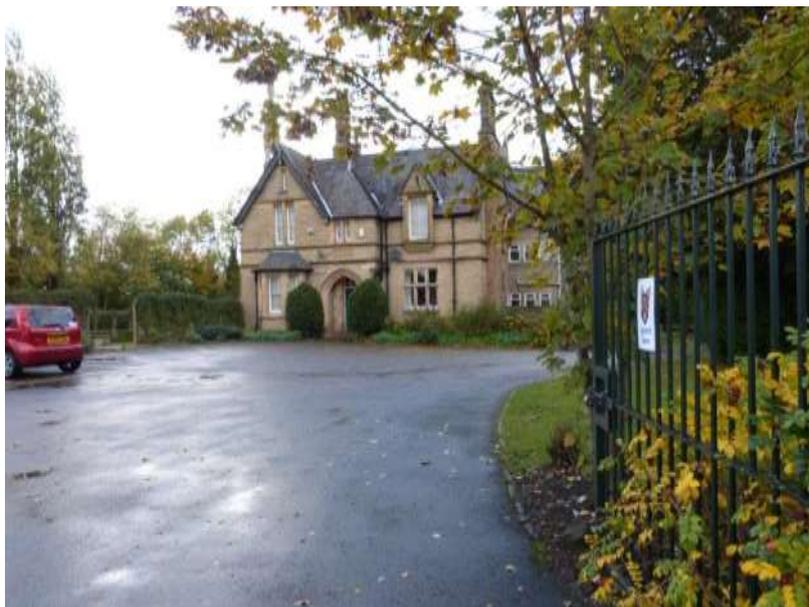
All Saints Presbytery

Date: 1867-68

Condition: Good

- 6.2.8 All Saints' presbytery is a two storey sandstone building with slate roofs, in similar style to the associated church but of simpler detailing. The building is also in private ownership and appears to be well maintained. One ridge tile insert is missing and one chimney pot. Both should be reinstated. There is some unsuitable piping running up the front elevation and roof valley which is detrimental to the building.
- 6.2.9 There is a small outbuilding to the presbytery, possibly a garage, of which only the rear elevations and gables could be seen; these elevations are of matching sandstone. The slate roof, with a central band of fishscale slates, and gable parapets have a heavy moss build up due to an overhanging tree. The moss should be removed and the tree pruned if feasible. The gutters are plastic and heavily blocked.

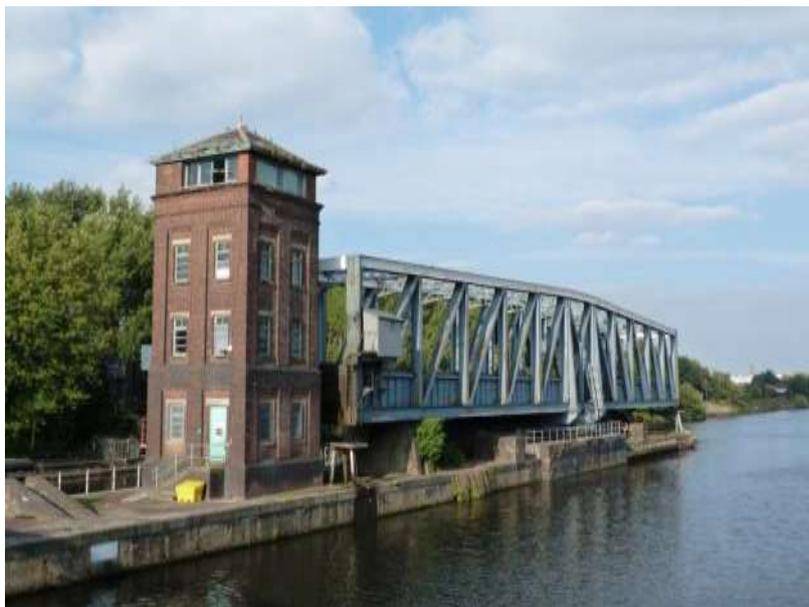
Barton Bridge, Barton Aqueduct and Control Tower

Date: c1894

Condition: Good

- 6.2.3 Both the road and canal bridges are in working order. However, areas of heavy corrosion were noted which appear to have been exposed to the elements for some time. Both structures should be subject to a comprehensive condition survey by a bridge engineer.

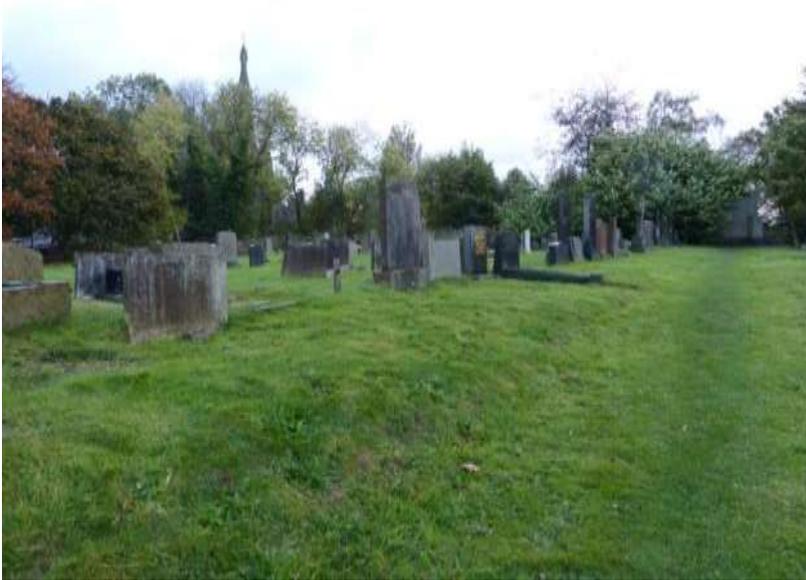
Gravestones in St. Catharine's Graveyard

Date: Various

Condition: Fair

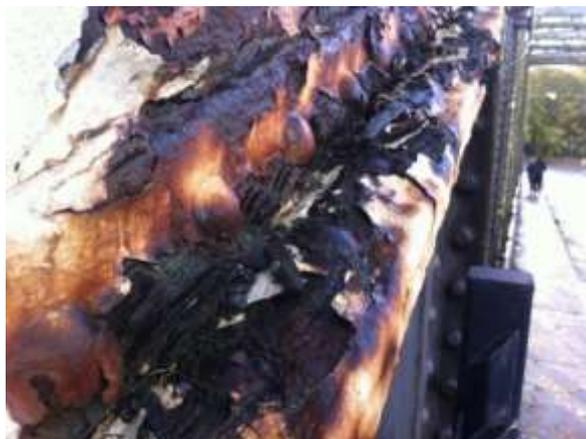
Extensive corrosion to the road bridge ironwork

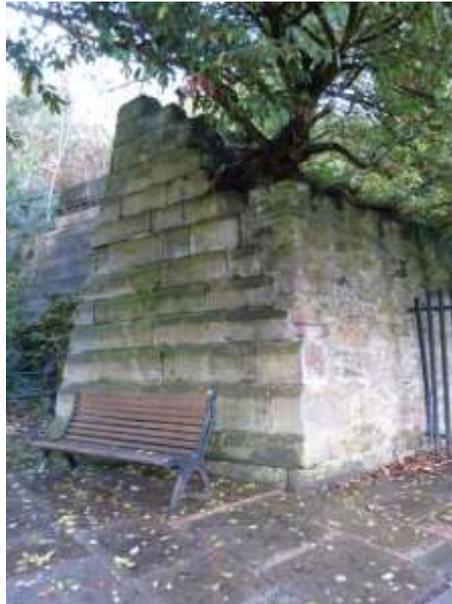
- 6.2.4 The footing to the former stone aqueduct can still be seen on the north bank of the river and is an important structure. The sides are battered and constructed of dressed sandstone ashlar blocks, with rubble stone walling to the front section which is likely a section of core which has been made good following demolition. The masonry is in poor condition, with multiple self-seeded trees growing from the top and from joints to the elevations, which is further opening joints and jacking masonry. There are also areas of eroded pointing, cracked masonry, climbing plants and graffiti which are all adding to the decay of the structure.

Self-seeded vegetation causing extensive damage to the former Brindley aqueduct on the north side of the canal

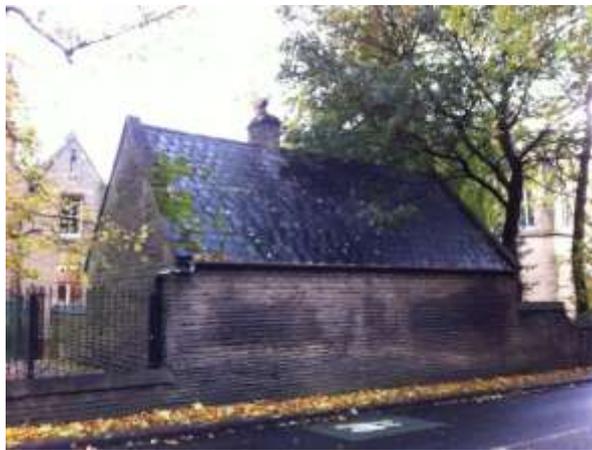
Moss build up due to overhanging tree to Presbytery outbuilding

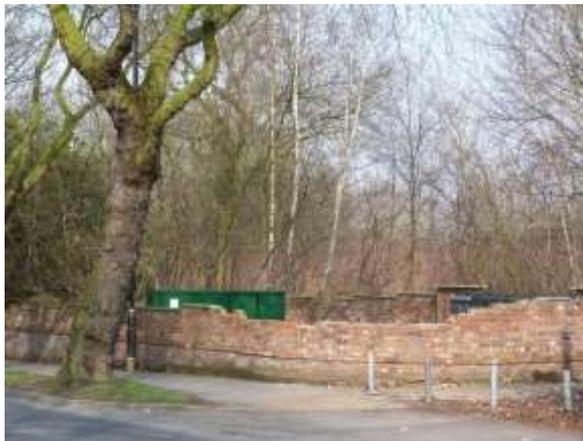
- 6.2.10 There is a substation located on the east side of Redclyffe Road has a damaged red brick wall surrounding the compound. This is an unattractive feature within the setting of the church.

Substation and damaged wall on the east side of Redclyffe Road

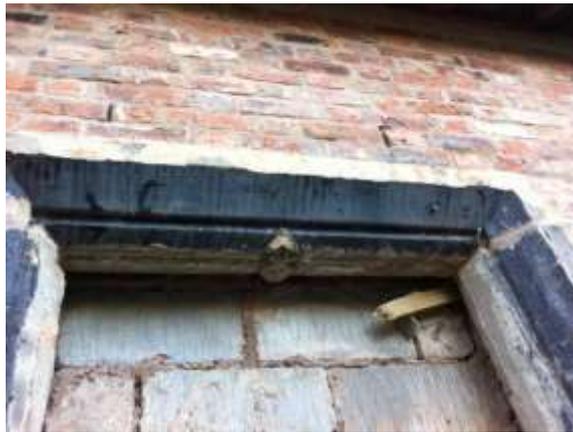
Painted stone window surround, with evidence of former central mullion

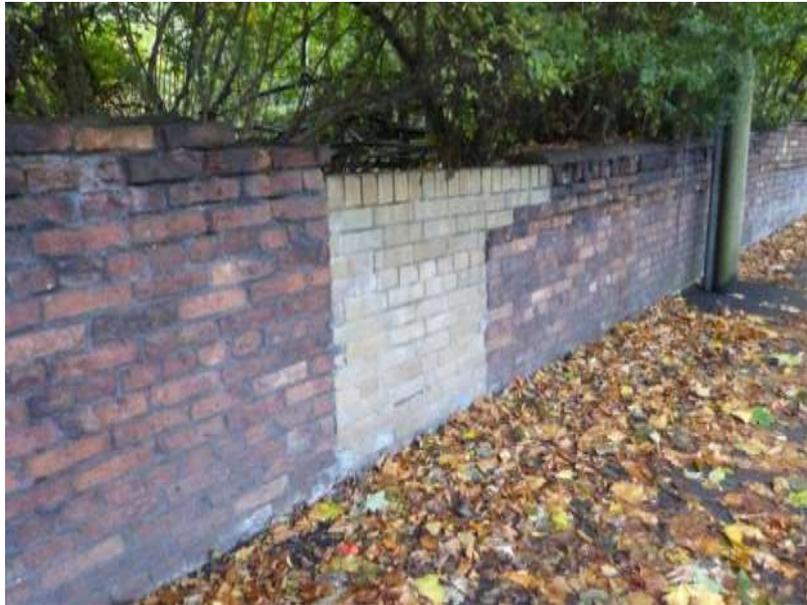
- 6.2.13 The brickwork boundary wall across Redclyffe Road from All Saints' Church is in a poor state of repair. There are multiple areas with spalling bricks, inappropriate re-pointing in hard cementitious mortar and modern cement haunching to the top. There are also several partially collapsed sections, as well as re-built areas in poorly matched brick and mortars.

Boundary wall to Redclyffe Road showing unstable sections, eroded pointing and unsuitable repairs
