Linotype Estate Conservation Area – Supplementary Planning Document SPD5.7

Conservation Area Appraisal - March 2016

Linotype Estate Conservation Area Conservation Area Appraisal

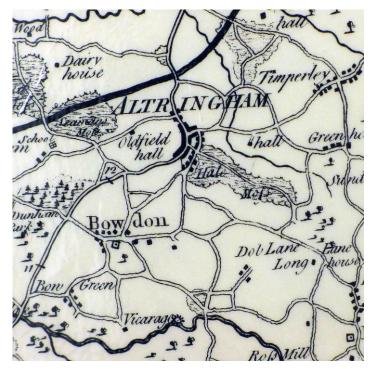
A detail of Altrincham from the Burdett map of Cheshire, 1777

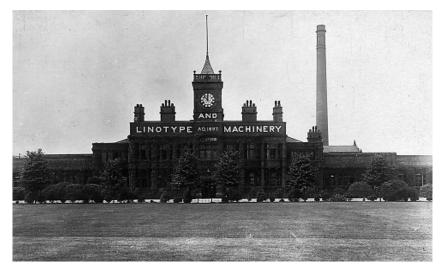
4.4.9 The main office building is seen in early photographs sitting in front of a wide open lawn (later built on with a new factory block called Woodfield House and now covered with housing). The tall boiler house chimney is a distinct feature in the background (now demolished).

Postcard of the Linotype Works, 1904 (TL2533a, Trafford Lifetimes)

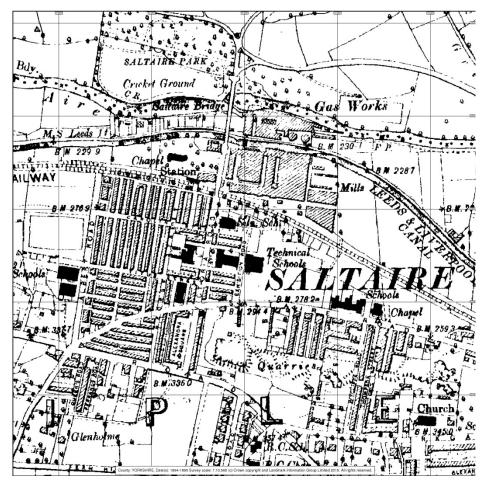
1894-95 OS Map of Saltaire

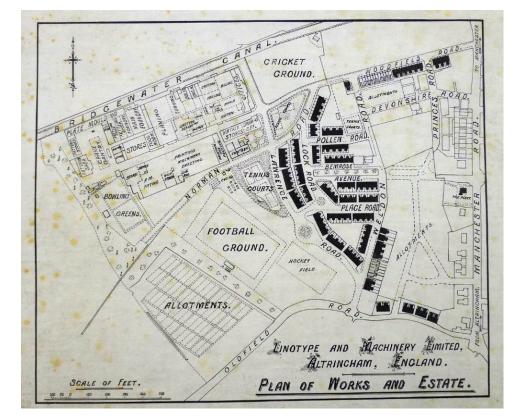
An undated plan of the Linotype Estate, showing the plan of the estate (PLA/1/6, Trafford Local Studies Centre)

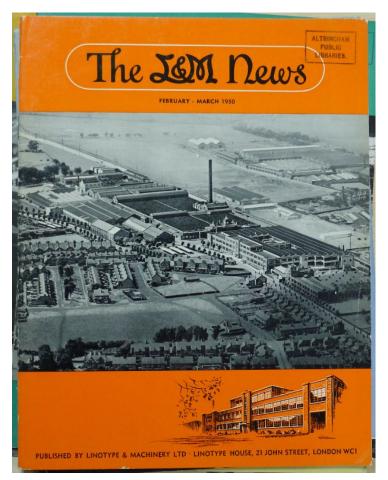
The front cover of The L&M News, 1950, showing a new addition to the Linotype Works complex (TRA 616/12/3/4, Trafford Local Studies Centre)

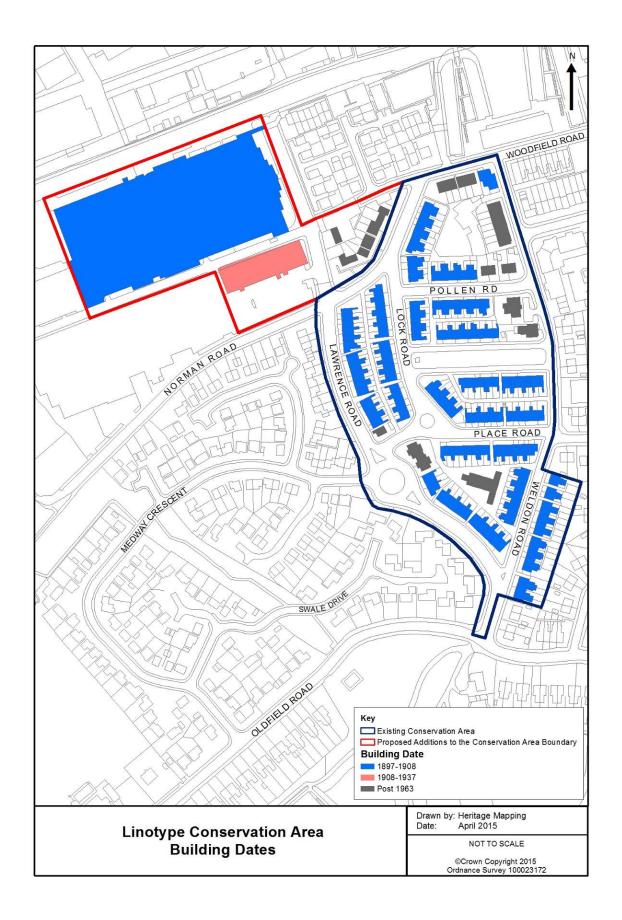
Map 8: Building Dates Plan

- 4.6.3 The buildings marked in grey on map 8 are not original to the 19thcentury estate and are not considered to be of particular interest. The two pairs of semi-detached houses on Lawrence Road are mid-20thcentury in date, the northern end of the neighbouring terrace having been destroyed by bombing in the Second World War. The two pairs of semidetached houses at the east end of Pollen Road are of a similar age and were built on the former tennis courts.

- 4.6.4 Within the boundary extension, the Linotype Works date from 1897, with the former Drawing Office from 1921. The housing in the triangle of land between the workers' cottages and the factory are 21st century.

- 4.6.1 The Linotype Estate Conservation Area is notable for its original creation in virtually a single phase: 1897-1901. The slightly differing architectural styles identified in section 4.5 may initially cause confusion for the casual viewer as the different styles may be perceived as the results of phased construction. The somewhat arbitrary location of the varying styles, however, makes it unlikely that this was the case. It is far more likely that the estate was originally conceived to deliberately look that way, thus creating a more layered and textured environment.

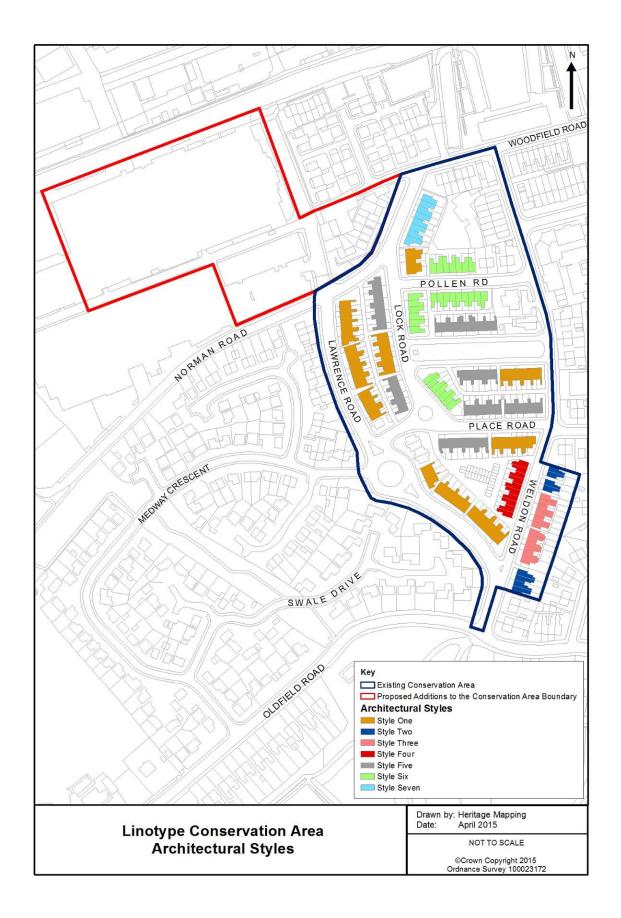
Map 9: Character Styles

- 4.8.1 There are seven discernible styles of the workers' cottages throughout the Conservation Area. These are shown on map 9 and discussed in further detail on the following pages. The houses within this Conservation Area are generally two or three storeys in height and constructed using red brick. Characteristic original features throughout the Conservation Area include multi-light windows (sometimes with small coloured panes in the upper section) and timber doors with glazing to the upper third section only. The principal brickwork also survives, including distinctive mottled and textured bricks which are contrasted with smooth pressed bricks.

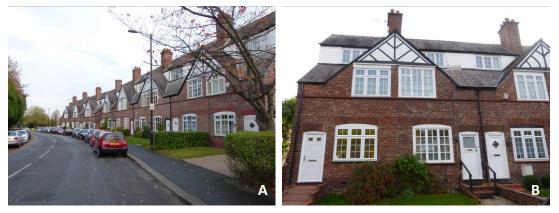
4.8.7 This style is constructed using a mottled and textured red brick laid in a stretcher bond with shallow arched red brick lintels over the ground floor windows and front entrances.

- A The terraces on Lawrence Road.
- *B* A detailed view of a principal elevation showing two different styles of mock-timber framing on the gable. The middle house door and windows are authentic to the original styles in the conservation area.

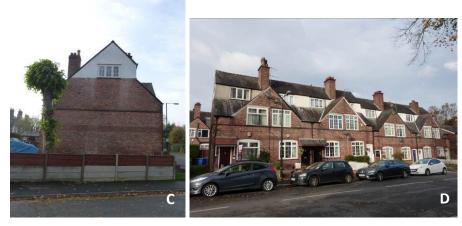
- *C* An end elevation showing the unusual section shape of the terrace.
- D The variant style on Lock Road.

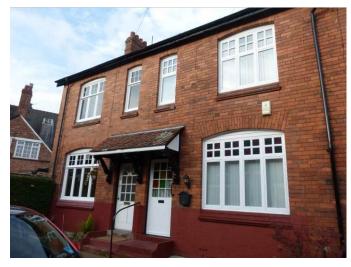
- 4.8.15 The original timber window designs, all of which survive on this terrace, are four, three or one bay wide with larger plain glass panes to the lower two thirds and groups of four small panes above. The original design appears to have had colour glass in the small upper panes to the ground floor windows, though some properties have lost these.

- 4.8.16 Original doors have three by four panes of coloured glass to the top half of the timber door, with diagonal boarding to the lower half. Three of the eight original doors have been replaced, while two others have had the smaller panes of glass replaced with one large glazed pane. No. 9 Weldon Road is a good example of surviving original windows and doors which retain the multi-coloured glass panes.

A typical example on Weldon Road

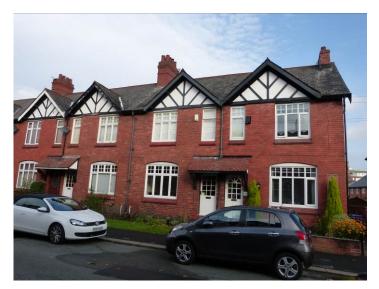
- 4.8.20 This style is very similar to Style Five, with larger gabled dormers and contrasting black timber detailing. It is concentrated in the northern half of the Conservation Area. The entrances have sloped porches roofed with scallop tiles and the windows are set under shallow arched brick lintels.
- 4.8.21 Original windows are the same as style four; four, three or one bay wide with larger plain glass panes to the lower two thirds and groups of four small panes above. Some good examples survive on Lock Road. Doors are also the same style as style four; three by four panes of coloured glass to the top half of the timber door, with diagonal boarding to the lower half.

A typical example on Pollen Road

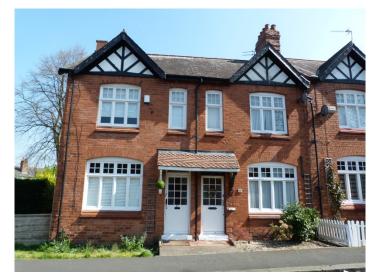
Good examples of surviving windows and doors at Nos. 57 and 59 Lock Road

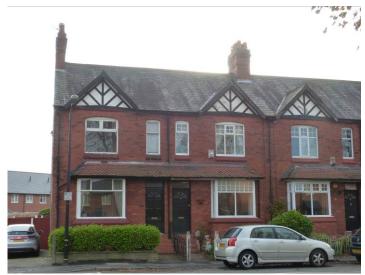
- 4.8.22 The two terraces on Norman Road are a further variant on Style Six. The same gabled dormers with black timber detailing are present but the sloped porches with scallop tiles extend right across the elevation to form the roof of the box bay windows at ground floor level. The same shallow arched brick lintels are set over the first floor windows.
- 4.8.23 Original door and window designs are the same as Style Six, except for the addition window panes on the returns of the ground floor bays. None of the original windows appear to have survived but most of the uPVC replacements are in the correct design, though with thicker glazing bars than the original designs. Some of the original doors have survived, though a few have had the small glazed panes to the top half replaced with large panes.

A typical example on Norman Road

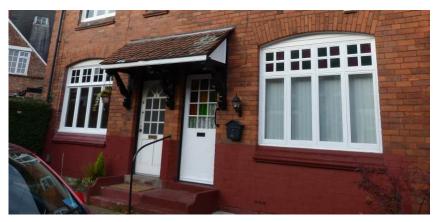
An example of coloured glass in replacement UPVC windows.

- 4.8.24 The houses in the Conservation Area originally had timber doors and window frames. These have survived in some instances but have commonly been replaced with UPVC alternatives which are either unsympathetic in design or have discernibly thick frames which affect the proportions of the fenestration. Typical original windows are multipaned, sometimes with coloured glass, and original doors having glazing in the upper section only.
- 4.8.25 Though difficult to tell in places because of the levels of replacement of windows, the side hung casements on ground floor windows appear to have typically been situated on the side of the window nearest to the door. This means that pairs of houses had window designs that had mirroring compositions.

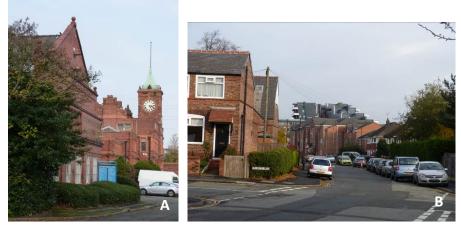
- A The clock tower of the Linotype Factory, viewed from Norman Road.
- *B* The view north up Weldon Road, with the Budenberg development dominating the background.
- 4.8.46 The variety and intermingling of architectural detailing adds a deep visual interest to the views inside the Conservation Area, with not one road entirely lined with the same type of house (Lawrence Road excluded, as only one side falls within the boundary of the Conservation Area). Views are particularly noteworthy where there are no later buildings within the streetscape:
 - A North and south on Lock Road;
 - B East and west on Place Road; and
 - C East and west along Bemrose Avenue.

- 4.8.44 Landmark features within the boundary extension of the Conservation Area include the Linotype Works office building, the clock tower of which stands tall over the later modern development between the business park and the Conservation Area. The factory's northern façade, with its distinctive lettering identifying the building, is also a key feature as seen from the canal.

- 4.8.45 The Budenberg Factory on Woodfield Road is another key historic building adjacent to the Conservation Area which reflects the industrial nature of the canal banks. Since redevelopment the modern Foster + Partners residential blocks flanking the original factory are very dominant in views northwards from the Conservation Area and contrast starkly with the modest domestic nature of the estate workers' cottages.

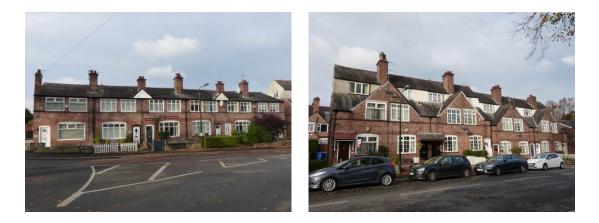
Terraces of houses throughout the Conservation Area :

Nos. 21-63 (odd) Lawrence Road Nos. 79-111 (odd) Lawrence Road Nos. 1-19 (odd) Weldon Road Nos. 10-48 (even) Weldon Road Nos. 1-31 (odd) Place Road Nos. 2-24 (even) Place Road Nos. 7-21 (odd) Norman Road Nos. 30-72 (even) Lock Road Nos. 37-55 (odd) Lock Road Nos. 1-17 (odd) Pollen Road Nos. 10-22 (even) Pollen Road Nos. 1-27 (odd) Bemrose Avenue Nos. 2-20 (even) Bemrose Avenue

Date: 1897-1901

Condition: Good
