Empress Conservation Area – Supplementary Planning Document SPD5.17

Conservation Area Appraisal – October 2016

# The Empress Conservation Area Conservation Area Appraisal October 2016

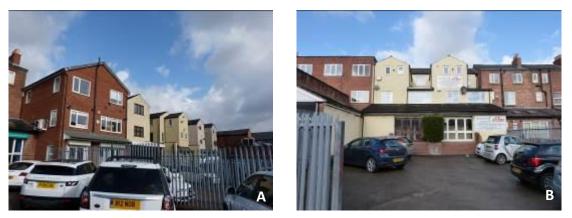
- A. Rear building line showing the extensions to the rear of the Chester Road terracesB. Example of multiple rear additions with modern render facing
- 4.7.7 At the northern end of this character zone is a modern (1997) residential block, Deva Court, which is included in this character zone for its continuation of the historic residential concentration in this area. The Chester Road elevation is notable for its attempts to emulate the style of the 19th-century terraces: Flemish bond brickwork, fanlights, brick lintels and sash windows. The building remains undeniably modern, however, the faux sash windows (which open as casement windows) and modern interpretation of the features being all too obvious.

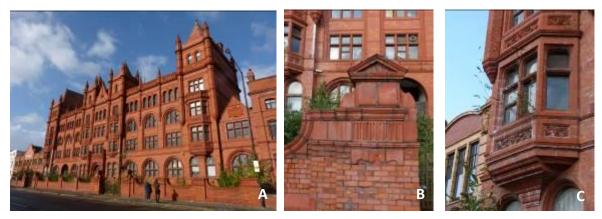
- A. The Chester Road elevation of the Essence Factory.
- B. Terracotta detailing on the Chester Road boundary wall.
- *C.* A detailed view of the Essence Factory oriel windows with vegetation rooted in and growing out of the windowsills
- 4.7.21 The building adjoining the Essence Factory, 384 Chester Road, is much simpler in its ornamentation but continues the use of the warm red brick and is in a better state of repair due to the fact that it remains occupied. The rear section fronting onto Empress Street retains its late 19th-century/early 20th-century warehouse appearance, with large windows to maximise light levels inside and an archway for vehicular access. There is also evidence that the interior of this building has been extended up into the roof.

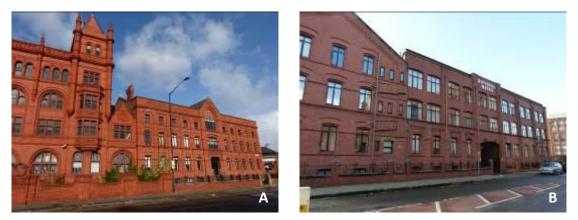
- A. 384 Chester Road, adjoining the north-east side of the Essence Factory.
- B. The Empress Street elevation of 384 Chester Road (the National Works building).

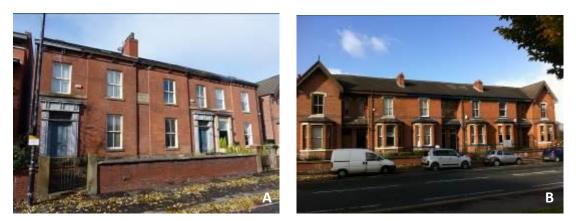
*A.* The Chester Road elevation of Chester Terrace. A fourth house formerly adjoined the terrace on the left hand side of this photograph.

#### B. The Chester Road elevation of Birkdale Terrace, which observes a Palladian-style symmetry.

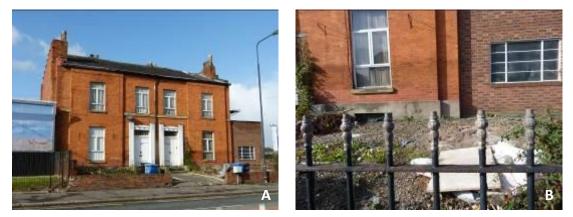
A. The Chester Road elevation of Cornbrook Terrace and the adjoining advertisement hoardingsB. Some surviving remnants of ornate ironmongery on the Cornbrook Terrace railings.

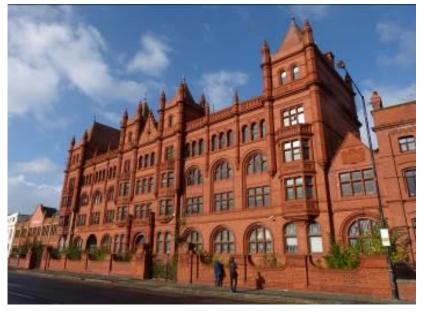
## **Essence Factory (Duckworth Building)**

# Date: 1896 Condition: Fair to Poor Grade: II

The Essence Factory is the only listed building within the boundary of the Empress Conservation Area. It was listed at Grade II in 1994. 92% of all listed buildings in England are listed at Grade II, and are considered nationally important and of special interest.<sup>22</sup> The accompanying list description for the Essence Factory is reproduced in Appendix A.

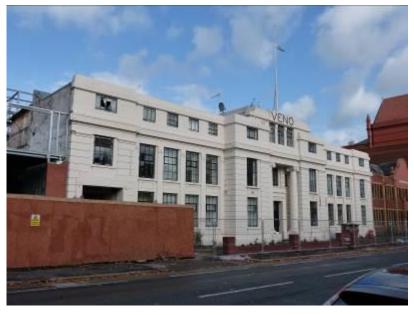
### Veno Building (façade)

**Date:** Early 20<sup>th</sup> century **Condition:** Fair

**Reason**: Included for the retention of its architecturally valuable and visually stimulating façade, which makes a strong positive contribution to the streetscape, especially following its restoration. There is potential for this to be increased further with the removal of the security fences and the completion of the redevelopment behind the façade, the stalled status of which leaves the building vulnerable.

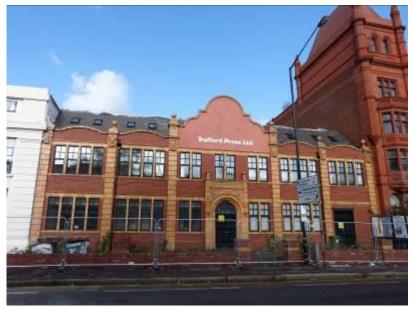
### Trafford Press Building – Original Veno (façade)

Date: Early 20<sup>th</sup> century Condition: Fair

**Reason**: Included for its strong positive contribution to the streetscape. The distinctive style of the façade with its eye-catching central gable pediment contrasts the clean classical style of the adjacent Veno façade and the highly decorative relief of the Essence Factory. There is potential for its positive contribution to be increased pending the removal of the security fences and the completion of the redevelopment, the stalled status of which leaves the building vulnerable.

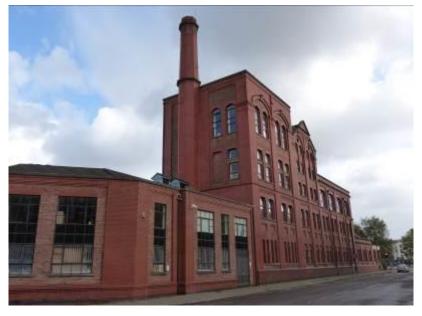
### **Empress Building**

#### Date: 1896 Condition: Good

**Reason**: The Empress Building is included for its retention of historic features including the winch platform and chimney tower, which add visual interest and refer to the building's former use as a brewery. Although it has been extended to create the Empress Business Centre courtyard, the scale of the original brewery building is still clearly discernible. The reduced levels of ornamentation and smaller size of the building are indicative of its historic role as headquarters of a less substantial business compared to those on Chester Road.

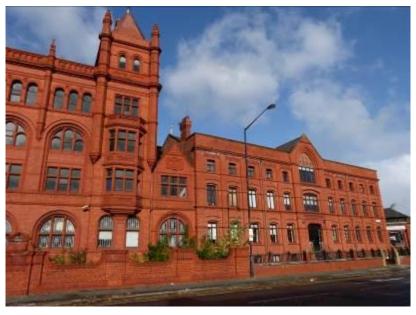
### 384 Chester Road

Date: Late 19<sup>th</sup>/Early 20<sup>th</sup> century

## Condition: Good

**Reason**: Included for its well-maintained condition and continuation of the intense red brick in the adjoining Essence Factory. Its architectural style is less ornate than its neighbour but is well-balanced in its proportions and detailing. The building makes a good termination to the corner of Chester Road and Empress Street.

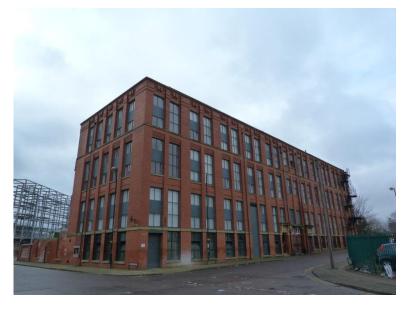
### **Empress Mill (in boundary extension)**

Date: Between 1896 and 1922

### Condition: Good

- 7.1.5 Area B: Empress Mill, No.1 Lund Street and associated warehouses, No.16 Hadfield Street, J Parkers Hadfield Street, AC House Lund Street, 19<sup>th</sup> and early 20<sup>th</sup> century industrial buildings. At the south end this includes Empress Mill, built in sometime between 1896 and 1922 (it is first shown on the 1922 1:2,500 OS Map). This building had been recently converted to a residential block. The site (still in final development), also includes open space to the south-west where factory sheds were demolished. A good quality set of gate piers also survives on the corner where Wright Street turns south-west. Inclusion within the Conservation Area should ensure the quality of the development is not eroded in the future.

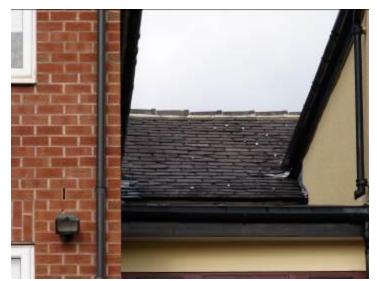
- 6.2.2 Manchester Street runs to the rear of properties lining the south of Chester Road, where all properties have modern extensions, typically two storeys. Though in good condition, these are typically low quality and not in keeping with the area. Their design and massing, as well as utilitarian metal fences, are inappropriate to the character of the Conservation Area. Sections of slate roof to the original terraces are visible between extensions in places, generally in poor condition with cracked, slipped and missing slates noted. The street is faced with industrial steel security fences throughout.

Cracked and slipped slates to rear roof slope, visible between modern extensions

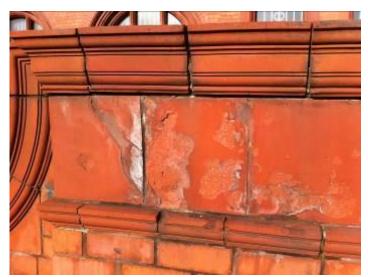
- 6.2.5 The Essence Factory has been empty for some time and is at risk of deteriorating if regular maintenance is not undertaken. Damage noted to terracotta dressings, some have been repaired with inappropriate mortar - extensive to the gate posts. Vegetation growing to façade at multiple ledges, cills and parapets, which has the potential to cause damage if not addressed. The glazing is broken to some windows, allowing birds access to the building. Damage noted to brickwork from signage fixings and pointing required to open joints where Trafford Press building roof flashing has been chased into gable. There is efflorescence to the brickwork of the west bay. There is rust to the iron gates facing onto Chester Road, though not severe. The lead finial to one of the central towers is skewed and requires straightening. Timber window surrounds are in need of decorating and there is exposed timber in many locations. The rear elevation is in poor condition, with multiple bricked up window openings, multiple extract vents and damaged corrugated sheet rooflights. The former boiler house to the rear yard has blocked and missing gutters which are causing spalled bricks, efflorescence and vegetation to the elevations. There is a concrete tile roof to the main slopes, with the eaves in poor condition.

Damaged terracotta blocks to the boundary wall

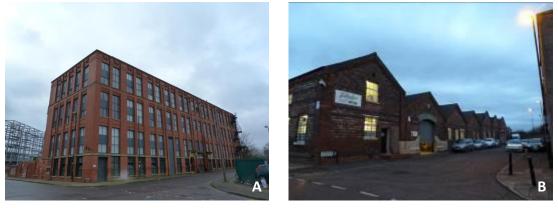
A. Empress Mill

B. Warehouses on the west side of Hadfield Street

- 7.1.6 Victorian warehouse buildings on the west side of Hadfield Street demonstrate the industrial history of the area. Many are constructed of good quality red brick. Some incorporate interesting architectural details and give more effort to adding decoration with bands of blue brick, stone dressings and arched doors/windows. There has been a lot of incremental changes with windows, shutters, air-con units, etc. which negatively impact on the overall character.
