Goose Green Conservation Area – Supplementary Planning Document SPD5.2

TRAFFORD
COUNCIL

Conservation Area Appraisal – October 2014

Goose Green Conservation Area Altrincham Conservation Area Appraisal October 2014

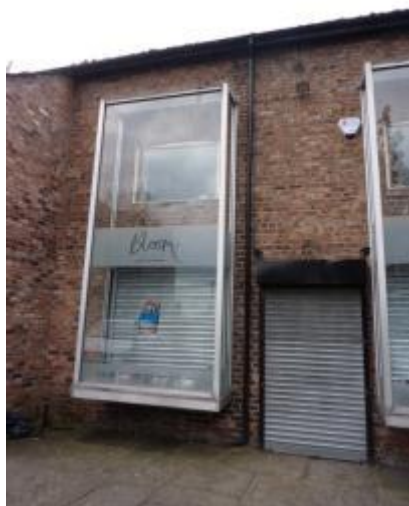
Photograph 5: 20th century windows

- 4.3.5. Roofs are clad with blue slate and the majority of windows are timber framed. There are examples of modern metal framed two storey bays to number 7 Goose Green (Photographs 5,6), late 20th century/early 21st century roof lights to numbers 11-13 Goose Green and a late 20th century dormer extension to numbers 7-9 Goose Green. A number of these alterations diminish the special interest of these heritage assets.

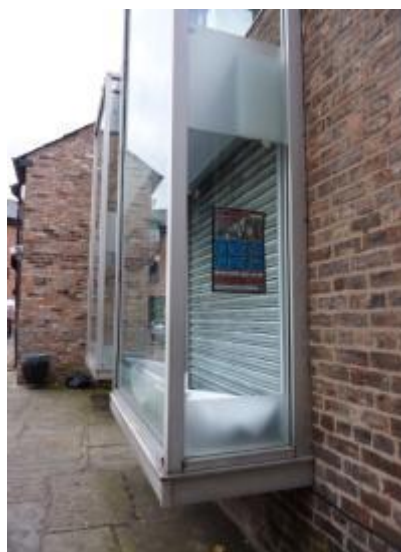
Photograph 6: 20th century windows with internal metal shutters

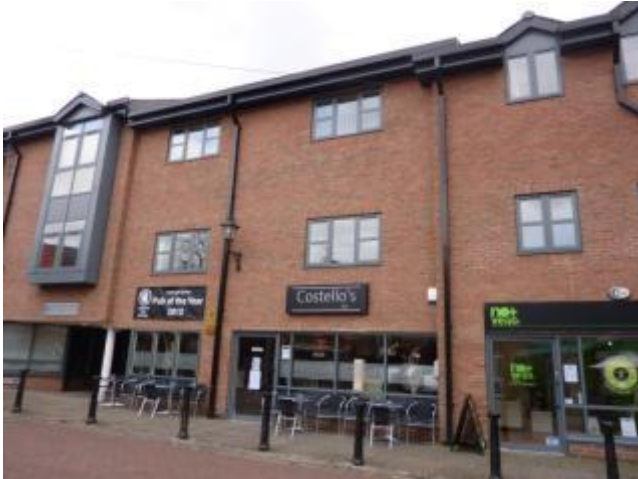
Photograph 7: Late 20th century development, numbers 15-20 Goose Green

the roof line. Nevertheless the massing, large areas of glazing at ground floor and palate of materials do not sufficiently enhance the traditional construction of adjacent historic buildings.

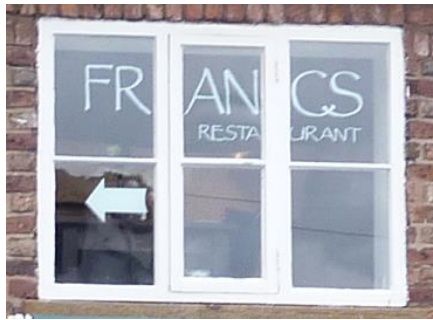
Photograph 10: Casement window

- 4.3.13. Although many of the timber windows are of an appropriate style, material and painted finish, it is likely a number are 20th century replacements. Examples of appropriate windows are the sliding sashes to numbers 9-13 Goose Green and first floor casement windows to numbers 3 and 4 Goose Green. There are examples of inappropriate roof lights to numbers 11-13 Goose Green, which detract from the positive contribution of the roofscape. Windows to the first floor and entrance doors to numbers 5 and 6 Goose Green appear to be constructed from upvc and whilst an attempt has been made to replicate the original design, the thicker profile to glazing bars and glare of glazing detracts from the character of the heritage asset.

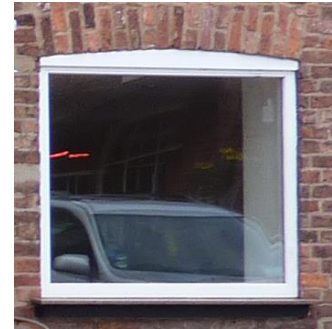
Photograph 11:
Large single pane light

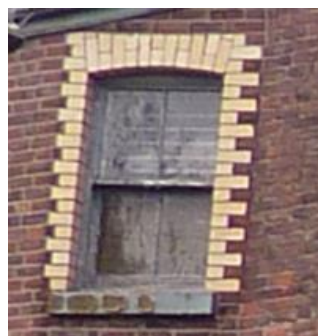
Photograph 13:
2 over 2 vertical sliding sash with decorative brickwork

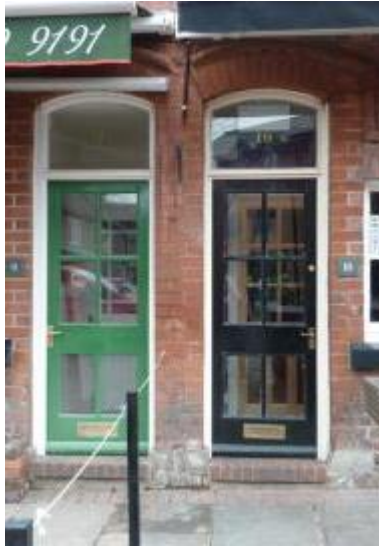
Photograph 15:
Doorways to 9/10

- 4.3.15. Numbers 9-11 Goose Green have openings which are decorated with contrasting red brick used in a pattern of headers and stretchers, with a soldier arch and terracotta hood moulds. Doors consist of timber with timber surrounds and some contain the pattern of glazing consisting of four over two panes of glass. They also all have segmental arched glass fanlights. The door design may not all be original, but they have all adhered to this style which gives these numbers 9-11 a more uniform character. Nevertheless it is noted that number 13 Goose Green incorporates a moulded solid panelled door which compliments the architectural style of the property.

- 4.3.24. The predominant use of brick is repeated throughout Goose Green Conservation Area and is a recognisable element of local character. Specifically the use of contrasting brick to highlight window and door openings is a detail that is repeated throughout the Conservation Area and Altrincham (Photograph 30).
- 4.3.25. Although the windows vary in style, the majority of examples such as casement and sliding sash are appropriate to the heritage assets. Although the detailing of the windows to more recent development at (numbers 15-19) is not traditional, the windows reflect the scale and form of nearby historic examples.
- 4.3.26. Classical details such as the segmental cambered arches over windows and doors are repeated throughout the Conservation Area. Excellent moulded examples remain at, 11 - 13 and 9 - 10 Goose Green (Photograph 15-17).

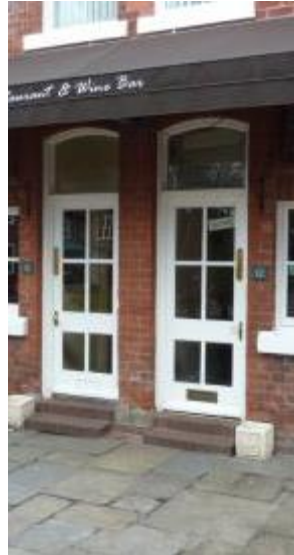
Photograph 16:
Doorways 11/12

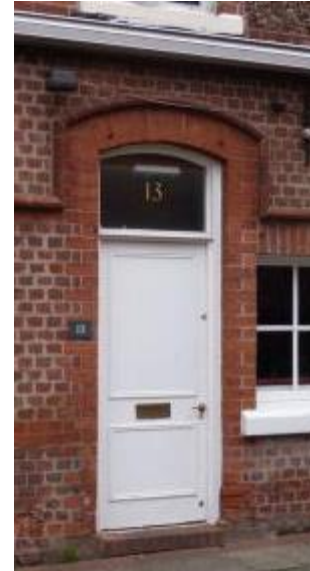
Photograph 17:
Doorway to 13

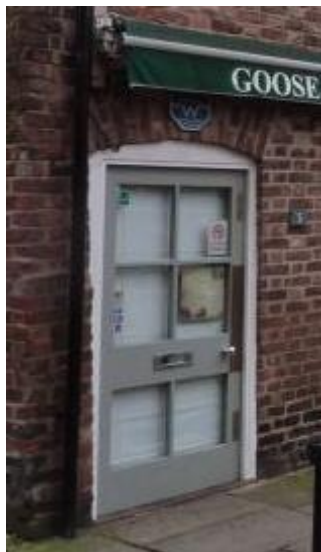
Photograph 18:
Door with soldier arch

- 4.3.16. Other doors within the Conservation Area are less decorative, but still display a brick soldier cambered arch. A number are constructed from timber and those to numbers 3-4

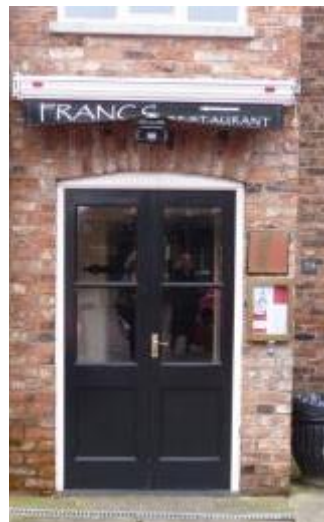
Photograph 19:
**Modern extension to Francs-
with soldier arch**

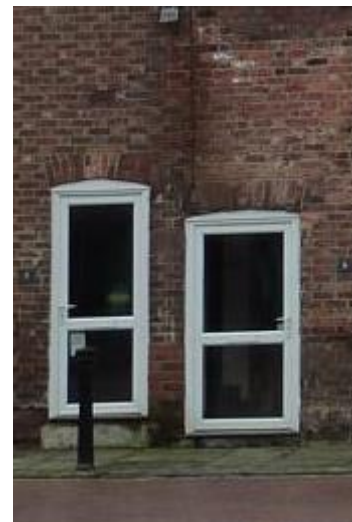
Photograph 20:
Incongruous uPVC Doors to 5/6

Goose Green are of a wider dimension than those to the north east. Doors to numbers 5 and 6 have been replaced with upvc doors, but the openings retain soldier arches. Within the proposed extension, the garage building adjacent to number 22 Back Grafton Street incorporates a large dilapidated metal sliding door.

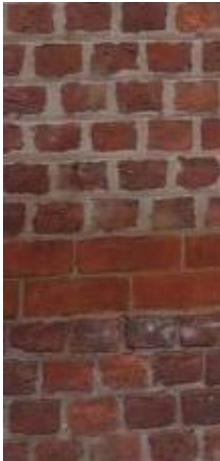
Photograph 21: Header bond with decorative stretcher courses.

- 4.3.17. The bonds of the brickwork also add decorative detail to some of the facades. Number 13 and 11 are of a header bond with decorative courses of red brick stretchers, and decorative brick quoins round the windows and doors. Other buildings are of constructed from Flemish bond or English garden bond.

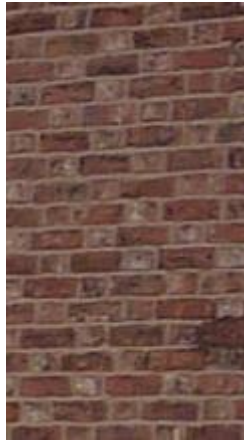
Photograph 22: Flemish

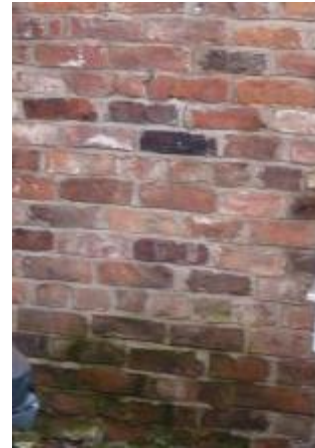
Photograph 23: English garden wall bond

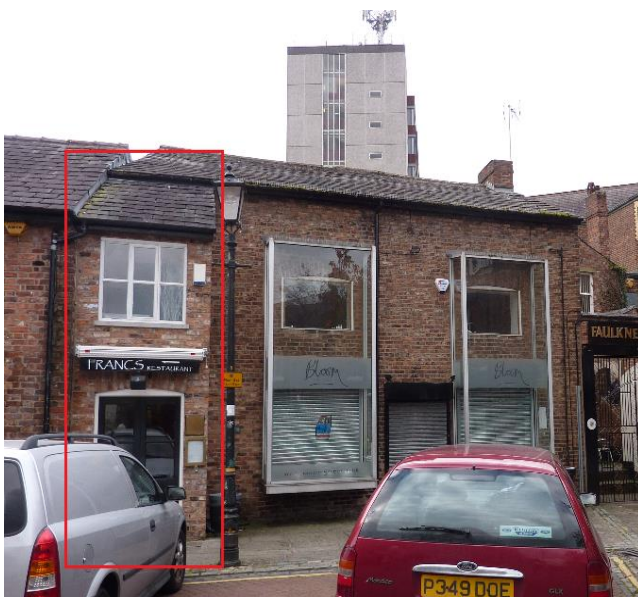
Photograph 24: Example 20th century alteration to frontage

- 4.3.18. There are some examples of minor extensions and alterations to properties in the Conservation Area. These are namely the dormer extension to number 10 and the small new entranceway to number 8 Goose Green. The new entrance way to number 8 although obviously rebuilt has attempted to replicate the variation of adjacent historic brickwork and it is anticipated will weather to the same degree. The dormer extension to number 10 has increased the scale of the structure and this clearly results in an adverse impact on the roofscape and massing of the heritage asset. (Photograph 25).

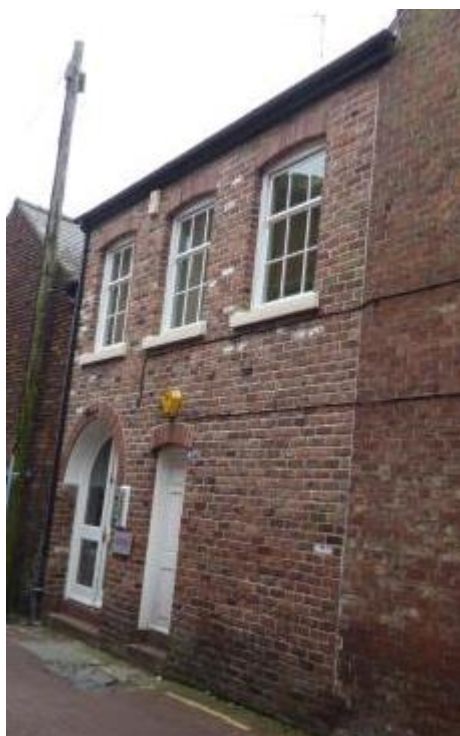
Photograph 26: 11a Goose Green

- 4.3.19. Further new developments to the north of the Conservation Area sited along Back Grafton Street are less intrusive and it is considered do not result in an adverse impact on the character and appearance of Goose Green. Numbers 10a and 11a Goose Green utilise traditional materials, form and detailing such as sash windows and soldier courses over arched openings (see Photographs 26 & 27).

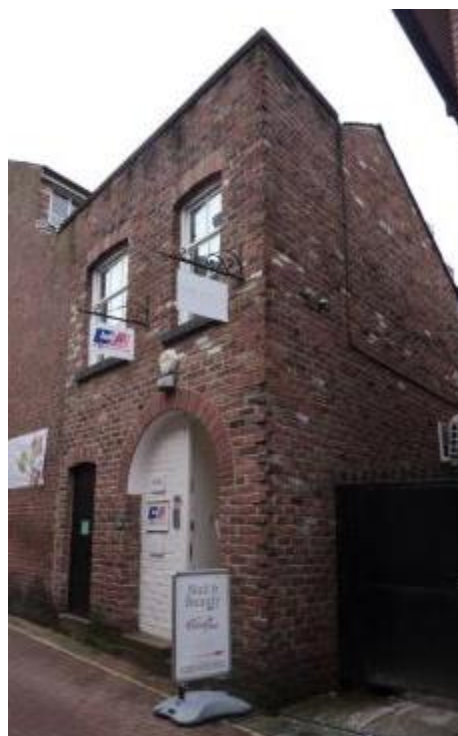
Photograph 27: 10a Goose Green

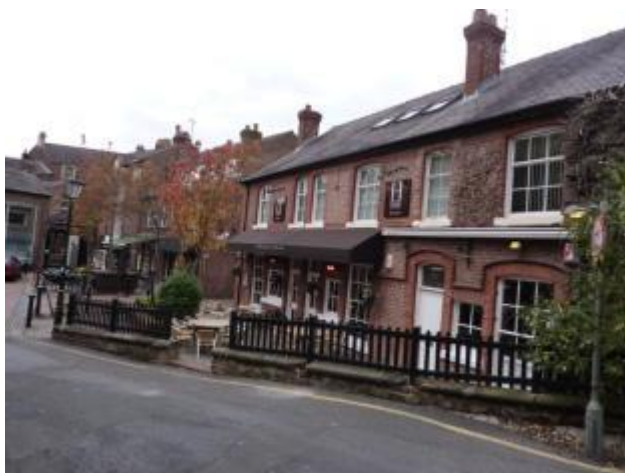
Photograph 30: Brick wall with stone coping

- 4.3.27. Where boundary walls are present within the Conservation Area they are low and constructed from brick with a stone coping (Photograph 30). The use of the black and white timber framing to form the two storey bay window to number 9 reflects the examples of this revival detail, a prevalent feature to Arts and Crafts architecture and found throughout Altrincham. The Arts and Crafts movement took its inspiration from vernacular details such as black and white timber framing commonly found in Cheshire and known as the Cheshire Vernacular style.

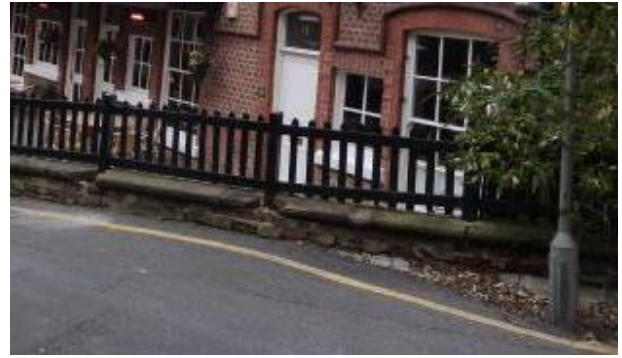
Photograph 43: Wall outside No. 13

- 6.2.5. Some sections of the road surface and road markings within Goose Green, Back Grafton Street and the approach from Denmark Street are in poor state of disrepair.
- 6.2.6. There are some areas of spalled brickwork to the lower level of the boundary wall and bridge parapet on Denmark Street. There are some areas of missing stone copings and damaged brickwork on the boundary wall outside no 13 Goose Green.

- To repair spalling brickwork to boundary walls on the former railway bridge. This issue gives one of the main entrance routes to the Conservation Area a dilapidated appearance.

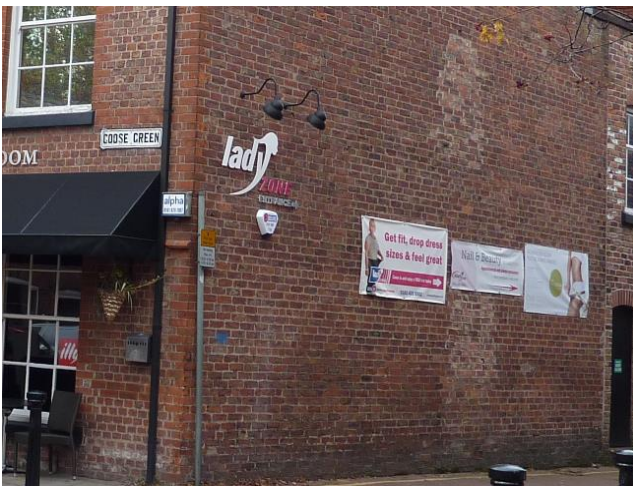
Photograph 46: Inappropriate signage

6.2.3. On the side elevation of number 11a Back Grafton Street there is some temporary signage which is too large and not of an appropriate design or material for the Conservation Area. The signage to 8a Goose Green is also obscuring architectural features of the building and deemed inappropriate.

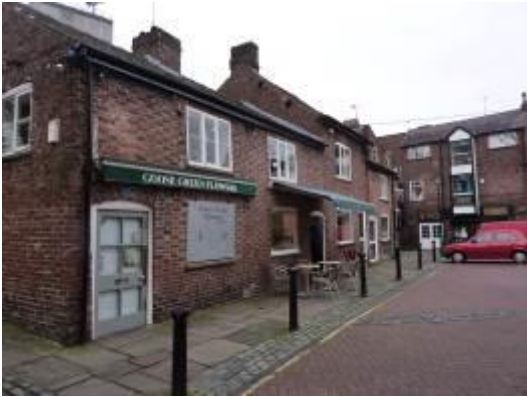
Address: 3-6 Goose Green

Built: Pre 1835, **Condition:** *Good*

Description: These buildings reflect a substantial number of other elements in the Conservation Area in age, style, materials and form. These terraced buildings are 2 storeys in height and are built from handmade Cheshire brick which is laid in a Flemish brick bond. The roof is pitched, clad with blue slate and features external brick chimneys. The windows of these building are rectangular in shape and have stone sills and brick headers; in addition the windows are within a timber casement. The doorways at all the properties are part timbered, part glazed. Other architectural detailing includes elements of modest traditional shop fronts at properties number 3 and 4, whereas properties numbers 5-6 have modern signage. Another feature includes property number 5 which is a taller in height. As a group they illustrate the development of the settlement in which they stand.

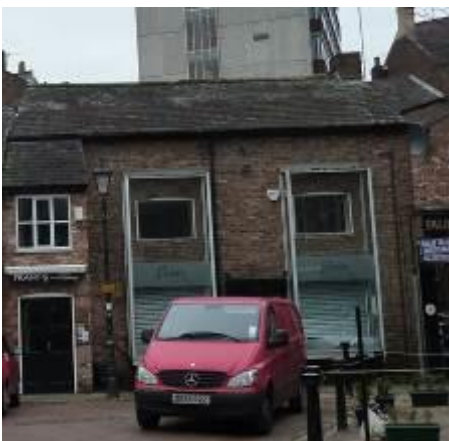
Address: 7-8 Goose Green

Built: 1835-1852, **Condition:** *Good*

Description: These buildings reflect a substantial number of other elements in the Conservation Area in age, style, materials and form. These terraced buildings are 2 storeys in height and are built from handmade Cheshire bricks which are laid in an English garden wall brick bond. The roof is pitched clad with blue slate and features external brick chimneys. The windows of these building at first floor level are rectangular

in shape and feature cambered brick headers and bricks sills. The doorway at property number 7 is part timbered and part glazed, whereas the entrance at property 8 is aluminium and features security measures at first floor windows. Building has been altered to incorporate 2 story aluminium bay windows. As a group they illustrate the development of the settlement in which they stand.

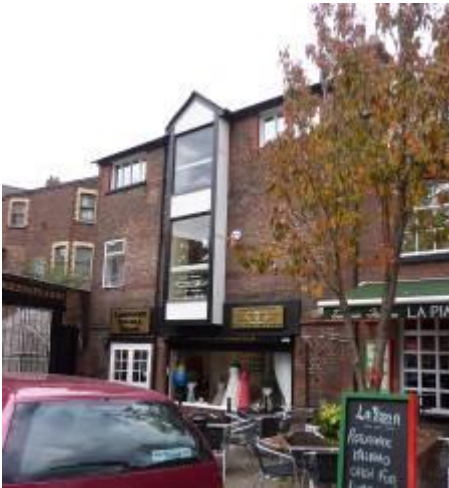
Address: 8a Goose Green

Built: 1876-1897, **Condition:** *Good*

Description: This building reflects a substantial number of other elements in the Conservation Area in age, style and materials. This terraced building is 3 storeys in and is built from handmade Cheshire brick which is laid in a header brick bond. The roof is pitched cladded with blue slate and features external brick chimneys. The windows of these building are rectangular in shape and are within a timber casement. The doorway is part timbered, part glazed painted in white. Other architecture features include stone sills and brick headers to the windows at first floor level, a modern shop frontage with a wide ground floor level window, modern shop signage with security shutters and a 2 story oriel window. It illustrates the development of the settlement in which it stands.

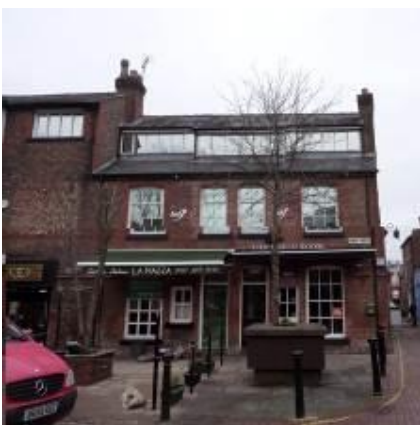
Built: 1876-1897, **Condition:** *Fair*

Description: These buildings reflect a substantial number of other elements in the Conservation Area in age, style and materials. These terraced buildings are 2 storeys in height with additional accommodation in the roof and are built from handmade Cheshire brick which is laid in a header brick bond. The roof is pitched cladded with blue slate and features external brick chimneys. The windows of these buildings are tall and squared in shape and have stone sills and brick headers; in addition the timber vertical sliding sash windows are painted white. The doorways are part timbered part glazed and feature a fanlight above them. Other architectural features include red stock brick detailing. As a group they illustrate the development of the settlement in which they stand. The use of number 9 contributes to the character of the area.

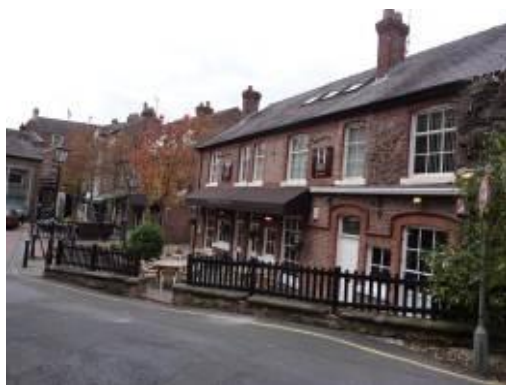
Address: 11-13 Goose Green

Built: 1876-1897, **Condition:** *Good*

Description: These buildings reflect a substantial number of other elements in the Conservation Area in age, style, materials and form. These terraced buildings are 2 storeys in height and are built from handmade Cheshire brick which is laid in a header brick bond. The roof is pitched cladded with blue slate tiles and features external brick chimneys. The windows of these buildings are tall and squared in shape and have stone sills and brick headers; in addition the timber vertical sliding sash windows are painted white. The doorways are part timbered part glazed and feature a fanlight above them. Other architectural features include red stock brick detailing and a part-brick boundary wall composing of 3 courses with a flat stone coping. As a group they illustrate the development of the settlement in which they stand. The use contributes to the character of the area.

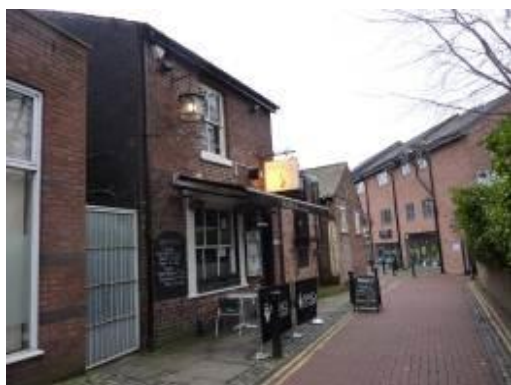
Proposed Extension, Address: 2 Goose Green

Built: 1852-1876, **Condition:** *Good*

Description: This building reflects a substantial number of other elements in the Conservation Area in age, style and materials. This terraced building is 2 storeys in height and is built from handmade Cheshire brick which is laid in a stretcher brick bond. The roof is pitched, cladded with blue slate tiles and features external brick chimneys. The windows of these building are tall and squared in shape and have stone sills and brick headers; in addition the timber vertical sliding sash windows are painted white. The doorway to this building is part timbered; part glazed and features a fanlight above it. Other architectural features include elements of traditional shop frontages such as a traditional signage and a hanging sign. It illustrates the development of the settlement in which it stands.

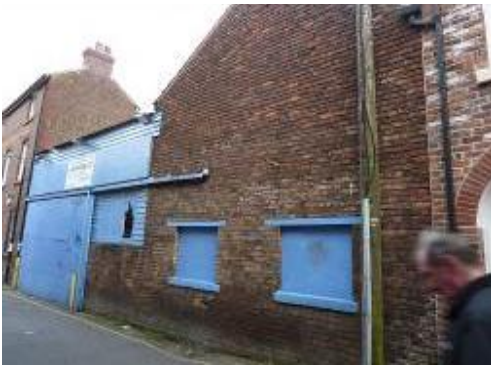
Built: 1897-1908, **Condition:** *Poor*

Description: This building illustrates the development of the settlement in which it stands. The warehouse built from handmade Cheshire brick laid in a stretcher brick bond. The building features a metal wooden sliding doorway and a roof which is pitched and cladded with blue slate. It reflects the traditional former uses in the area.
