Old Market Place Conservation Area – Supplementary Planning Document SPD5.3

TRAFFORD
COUNCIL

Conservation Area Appraisal – October 2014

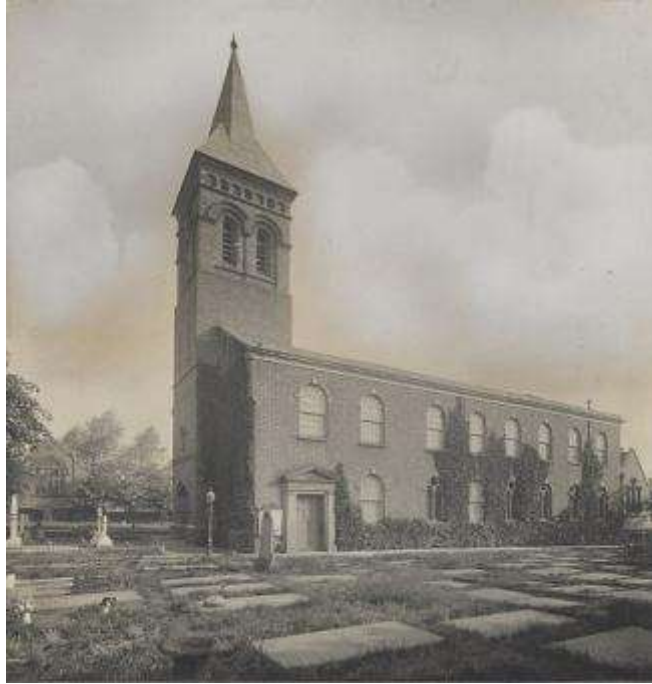
**Photograph 1: St. George's Church,
no date (Trafford Lifetimes, TL8687)**

- 4.2.39. There was much rebuilding in the 18th century, and timber framed medieval properties in this area were demolished and replaced or refaced in the Georgian Style. Properties standing today that date to this period are 9-15 Old Market Place and the properties on the opposite side of the road, numbers 8-16 Old Market Place and 26-36 Church Street. More residential housing was also erected along Victoria Street in the 18th century (see Map 7). The Old Market Place continued to be the centre of the town consisting of a combination of commercial and residential properties, being known as Higher Town, the property in this area was in high demand. This was the Civic core, with the market, professional businesses, public houses and where the first Church of England church was built in Altrincham, St. George's Church in 1799 (Photograph 1).

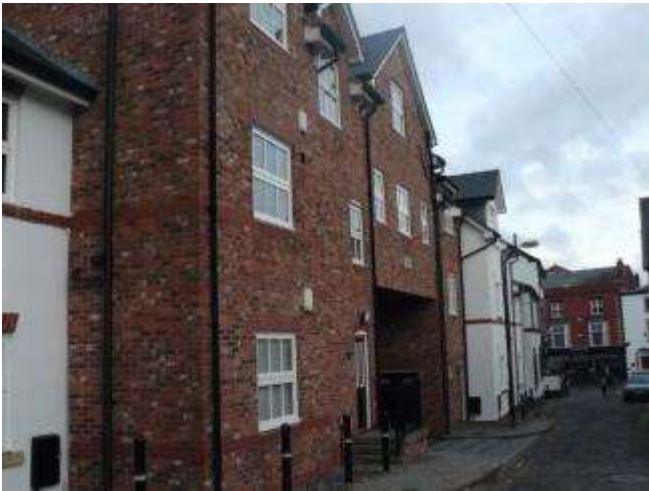
Photograph 7: Late 20th- 21st century development

4.3.37. The area of more recent residential development situated at Albert Place and Church Walk consists of terraced town houses and apartments ranging from two to three storeys (photographs 7-8). Architectural detailing is modest and to some degree reflects the style of properties at the Old Market Place. Nevertheless the use of elements such as gablets and presentation of gable ends to the street is uncommon in the character zone and the use of more recent materials such as upvc does not reflect the quality of adjacent historic buildings. This development attempts to reflect the surrounding area through small details, but the scale and massing of a number of properties is imposing and inappropriate.

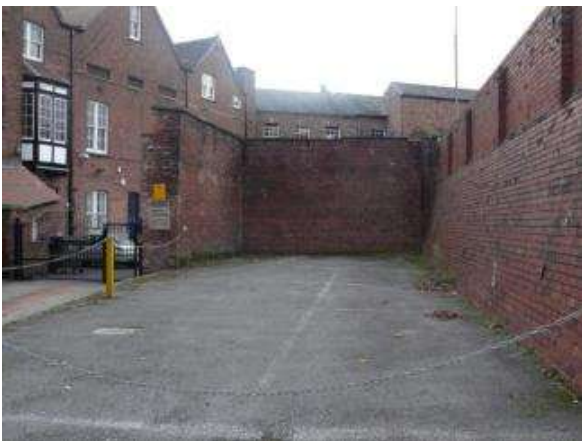
Photograph 11: Small car park on Albert Place

4.3.45. There are two bowling greens sited to the north and south of Albert Place. The bowling green located to the north adjacent to Church Walk is currently in a state of disrepair and is screened from the public by a concrete wall (Photograph 12). A small area hard standing situated on the south side of Albert Place (Photograph 11) is currently utilised as a car park.

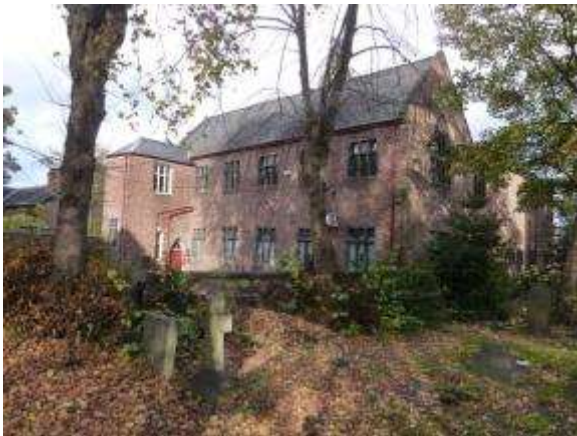
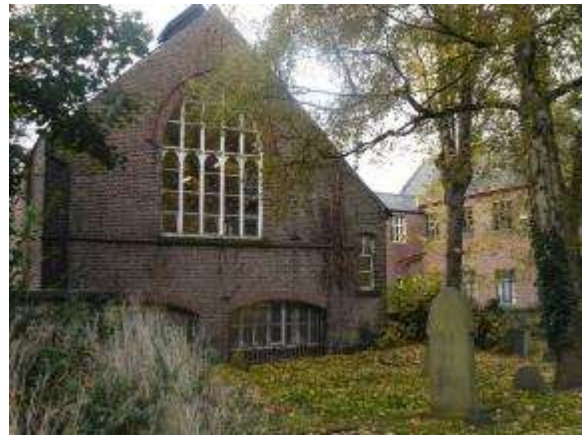
Undertakers is the former school building which is now the scout hut. This too has architectural details that are Gothic in style, such as the large arched multi light window (Photographs 17-18).

Photograph 17: Undertakers to be included in boundary extension

Photograph 18: Former school, now scout hut

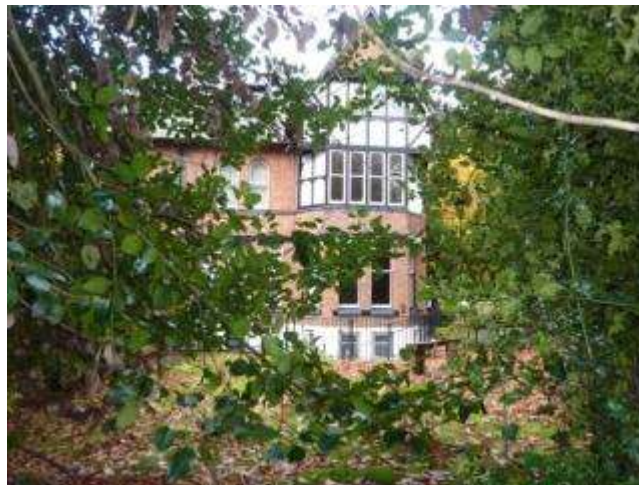
4.3.55. To the northwest of the church yard along Church Walk is a large red brick semi-detached mid Victorian property, part of which is named Beech Hurst, both sides of which have been converted into flats. The property is set in spacious grounds and has elements of the Tudor Revival style such as areas of decorative black and white timber detailing (Photograph 19). The rear of elevation of the property displays numerous phases of extensions and alterations. This was incorporated into the 2014 extension.

Photograph 19: Black and white half timbered detailing to Victorian semi-detached residence

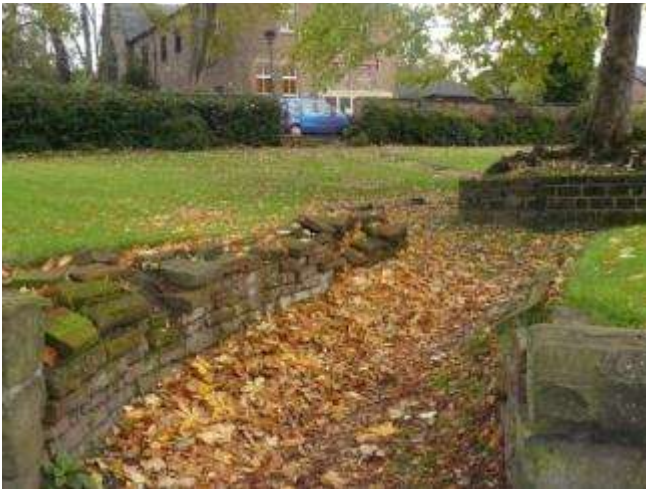
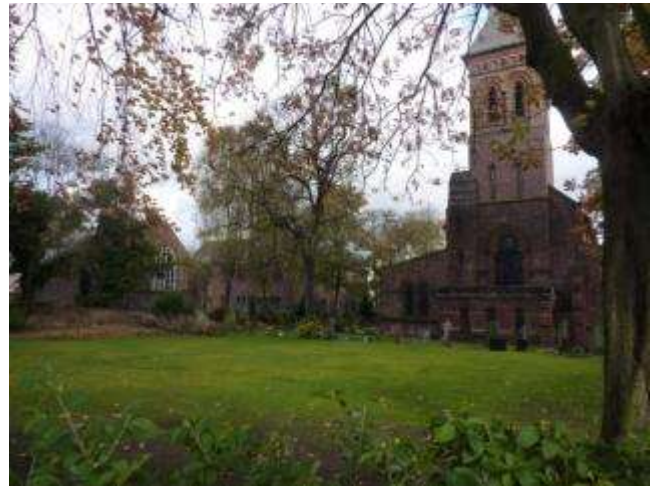
- 4.3.62. There are areas of open green space surrounding St George's particularly to the southwest and along Church Street to the northeast. To the west of the Church lies the graveyard (Photographs 20-21).
- 4.3.63. The spatial character of this character zone is one of large individual buildings surrounded by green space or open space. There are mature trees to the west and east of the Church, and these continue along Church Street, which provides an important landscape contribution to the street scene and wider character zone. Whilst the character zone includes part of Church Street, the general atmosphere is one of quietude combined with a spacious quality assisted by the mature landscaping.

Photograph 20: Green space adjacent to St George's Church

Photograph 21: Churchyard to the rear of St George's Church

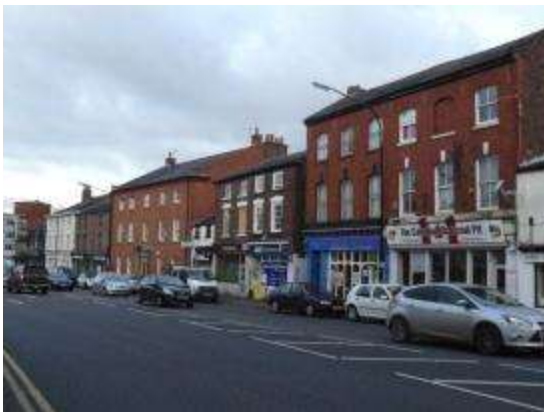
Photograph 26: Commercial properties on Church Street

4.3.70. There is a combination of architectural styles throughout this character zone. Along the east side of Church Street and the Old Market Place between Kingsway and Woodlands Road, a number of buildings are designed in a classical style (Photograph 26). Architectural detailing includes decorative brackets, pediments, pilasters and fanlights to doorways, decorative moulded cornices, stone sills and lintels (some with decorative key stones). The majority of properties also adhere to the classical proportions, although not all rise to three storeys.

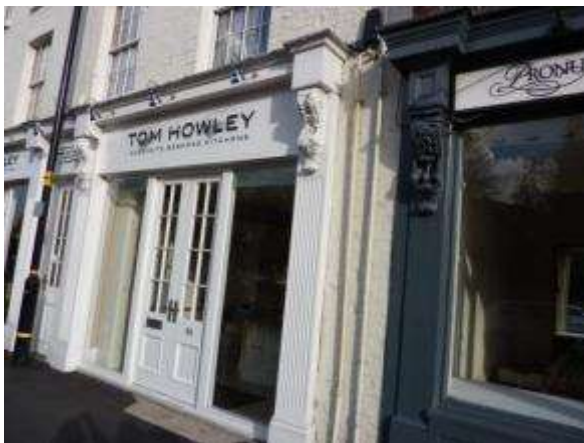
4.3.72. Due to the varying uses of the buildings, the facades differ in style. The shop fronts to the north along Church Street are traditional in design, retaining historic detailing and positively contributing to the character and appearance of the street scene. These include: painted timber shop fronts vertically subdivided to form small windows, centrally placed doors, decorative plinths, fluted/ plain pilasters, panelled stall raiser, decorative consoles, fascia and cornices constructed from painted timber. The signage is constructed from either painted timber boards or individual applied lettering (Photograph 28-29).

Photograph 28: Traditional painted timber shop fronts with decorative pilasters, consoles, minimal fascias and signage with external spot lighting

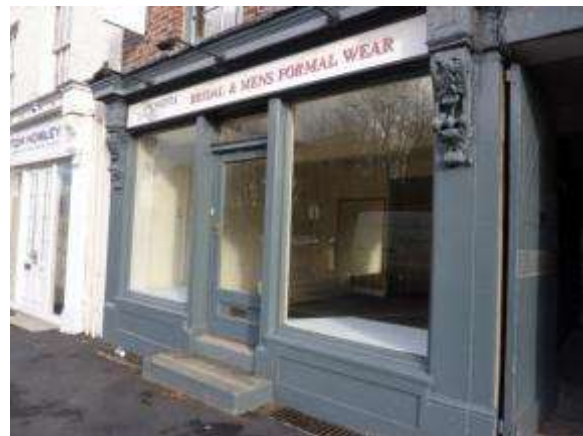
Photograph 29: Good example of a traditional painted timber shop front with vertically subdivided windows and centrally placed door mirroring symmetry on upper floors.

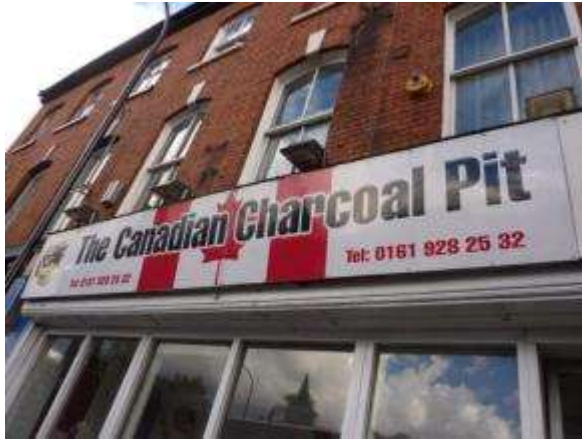
4.3.73. To the southern end of Church Street there are examples of 20th century shop fronts which are less successful. Whilst some of these have been replaced with painted timber surrounds, the design often fails to respect the symmetry of the upper floors timber fascias and signage are often disproportional and constructed of inappropriate materials and at 18 Church Street an incongruous external roller shutter has been installed. Examples of this can be seen at the Canadian Charcoal Pit, Prontaprint and the newsagents (Photographs 30-31).

Photograph 30: Disproportionate fascia and vinyl signage

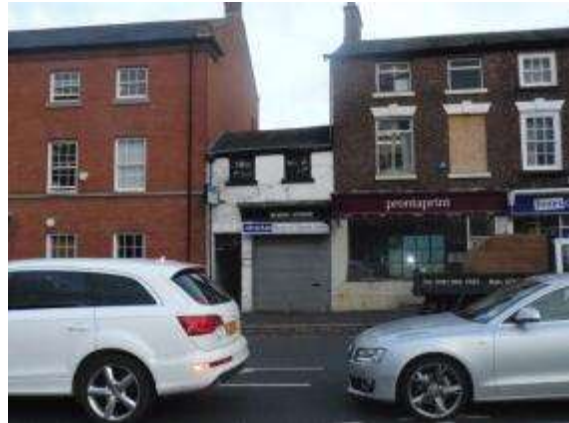
Photograph 31: 18 Church Street displaying external roller shutter and inappropriate signage at Prontoprint

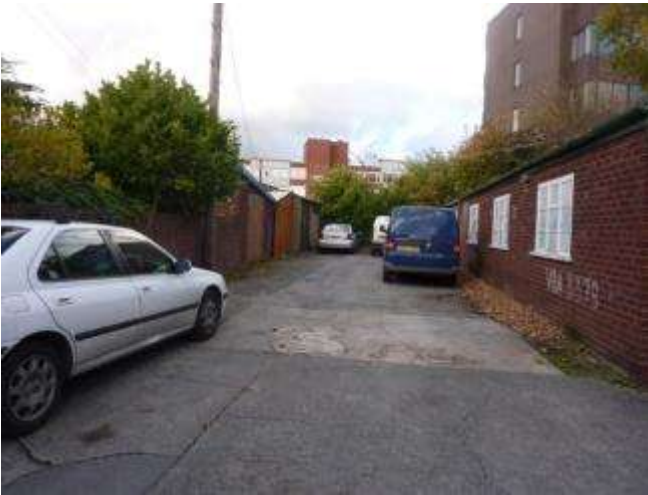
Photograph 32: Open space to the rear of Church Street

- 4.3.78. There are no significant green spaces within the character zone, although there is a small area to the east of the Malt Shovels on Victoria Street. There are some open spaces to the rear of the properties along Church Street and Garden Lane (Photographs 32-33). These areas can be accessed via a passage leading from Woodlands Road and also from Victoria Street. A number of extensions and alterations of varying quality and design have been undertaken in these areas since the mid-20th century.

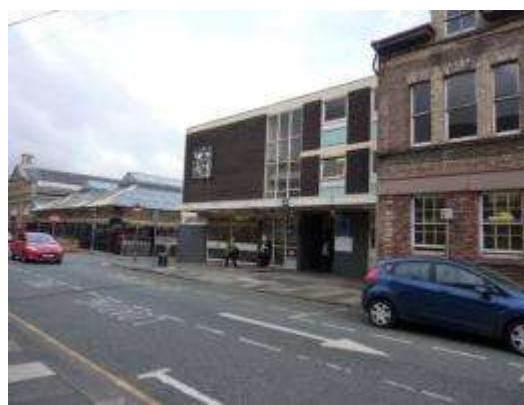
Photograph 35: Mid 20th-21st century extension to Altrincham General Hospital

4.3.86. Altrincham Hospital is a building that varies in date and style (Photograph 34, 35, 39). The original building is in the Queen Anne style, constructed from red brick with ashlar quoins to the corners and string course designed by Russian architect Peter Pons. The Conservative

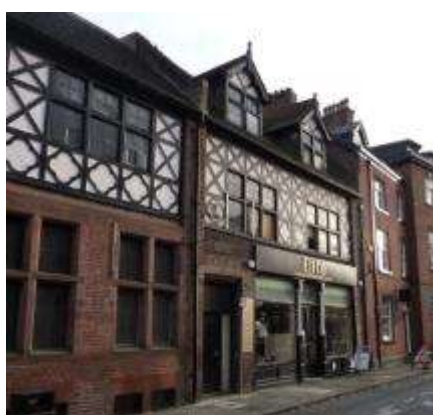
Photograph 36: 1-3 Market Street

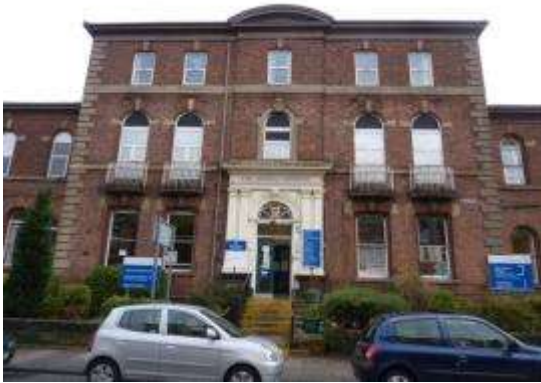
Photograph 39: Main entrance of Altrincham General Hospital accessed from Market Street

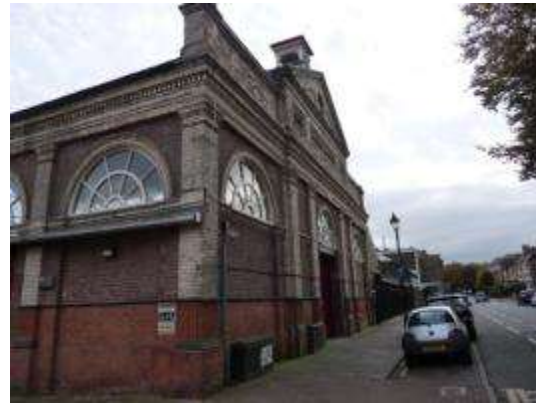
Photograph 40: The Market House fronting Market Street

Club sited on Market Street and the Market House are of a Classical revival style. The Market House is constructed from a pink brick utilising Cheshire commons for elevations, a red stock brick for the plinth and classical detailing picked out in a cream variety. The roof is clad with blue slate and a dentilled cornice extends around the building with a parapet over bays 1 to 3 and a pediment with central clock over bay 2. There are large semi-circular lights in each bay (Photograph 40).

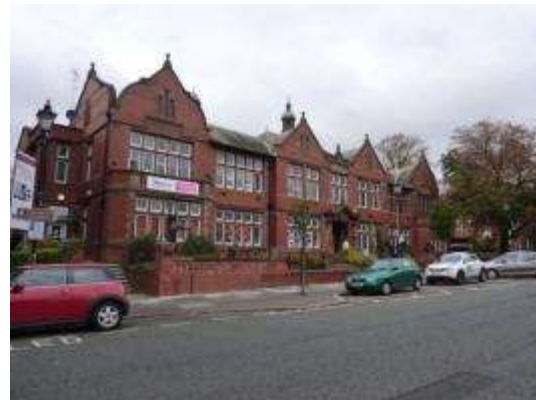
Photograph 42: Altrincham Town Hall, Market Street

4.3.87. Also located on Market Street, is Altrincham Town Hall, the principal elevation clearly visible from Shaws Road. The building is an example of polite late Victorian architecture in the Jacobean revival style designed by architect Charles H. Hindle, extended in 1930. The Town Hall is constructed from red stock property brick with red sandstone dressings detailing, ogee shaped gables with decorative terracotta finials and red sandstone stone mullion and transom windows (Photograph 42).

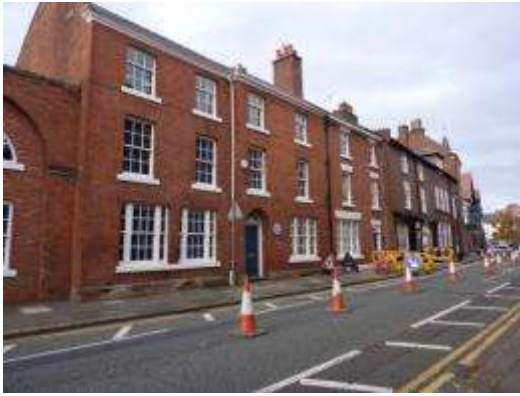
Photograph 43: Georgian properties on Market Street

style. Numbers 10-18 and 5-7 Market Street are examples of Georgian classicism (Photographs 43-44). They have retained architectural details such as decorative brackets and fanlights to doorways and stone sills and lintels. The properties also adhere to the classical proportions of construction. Numbers 1A-3 and 11 Market Street are Victorian buildings undertaken in the style of Tudor revival (Photograph 36-37). There are also examples of domestic "High Victorian" architecture, where properties incorporate elements of Gothic, Romanesque and Italianate features into buildings. Examples in this character zone retain polychromatic brick work; semi-circular arched openings and pitched dormer windows with decorative barge boards. There is an important group of buildings located on the corner of Old Market Place and Market Street which date to 1890's of a Tudor Revival style with elements of black and white timber framing and stained glass windows. They were built for Sir William Cunliffe Brooks probably by George Truefitt and reflect the architectural style of other Cunliffe Brooks buildings 1-3 Market Street and Bank House (former Brooks Bank). Numbers 2,-8 Kingsway are shops and offices erected in 1870 on Kingsway.

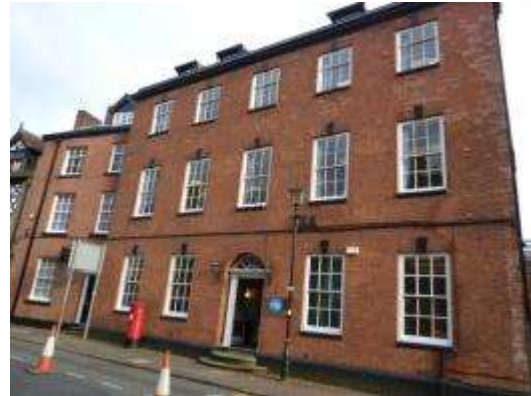
Photograph 44: Double fronted Georgian property on Market Street

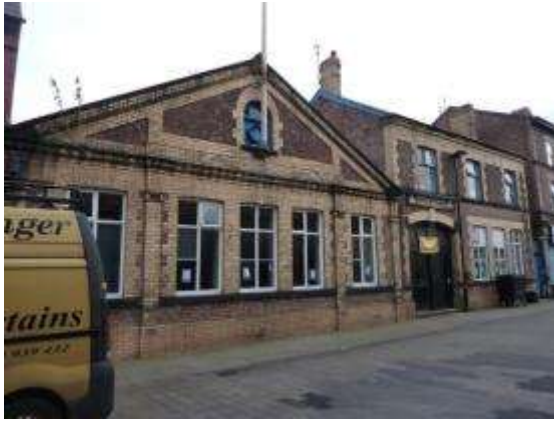
Photograph 47: Conservative Working Men's Club

4.3.89. An exception on the east side of Greenwood Street is the Conservative Men's Working Club, which is of an Italianate, classical style (Photograph 47). It is constructed from Cheshire common brick with architectural detailing highlighted in a cream brick with timber framed sash and casement windows.

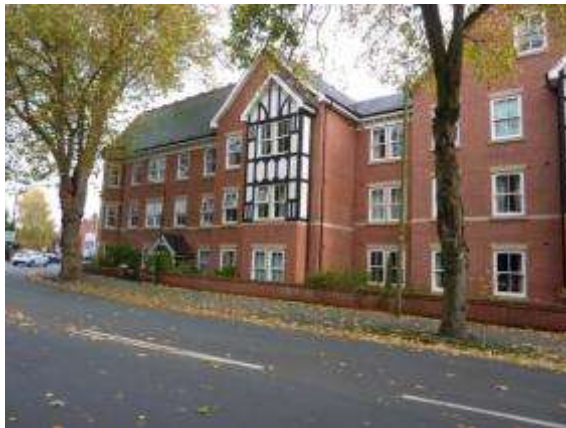
Photograph 49: 20th century development on Groby Road

4.3.90. A block of apartments occupies the corner of Groby Road High Street constructed in the late 20th/early 21st century. It is designed to incorporate elements of the Tudor revival comprising of red brick with substantial gables relieved with areas of black and white timbered detailing (Photograph 49).

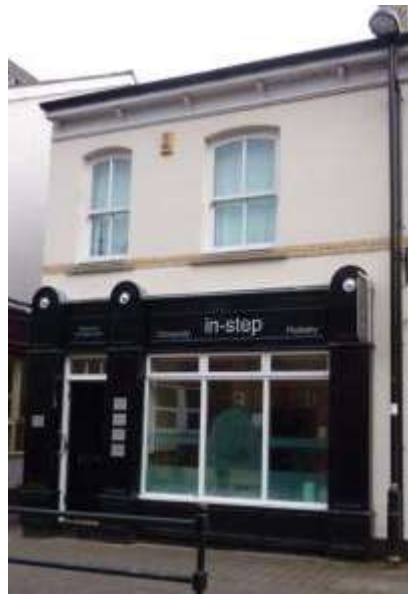
Photograph 54: Three Light Display Window

4.3.91. Due to the variety of historic uses of buildings in the character zone, there is no consistent approach to the style of facades at ground level. There are a number of shop fronts in the character zone which have retained historic characteristics. Many retain elements such as timber plinths and pilasters with timber fascias (Photograph 53-54). Where they have been altered or replaced there are some recent examples which have been designed in an appropriate traditional style, constructed from painted timber in a complimentary colour and proportional to the dimensions of the facade property. A theme that is repeated along Greenwood Street is tri- partite windows of three mullion and transom lights as the main display window. There are also numerous examples of traditional hanging shop signs along Greenwood Street, located at ground floor level.

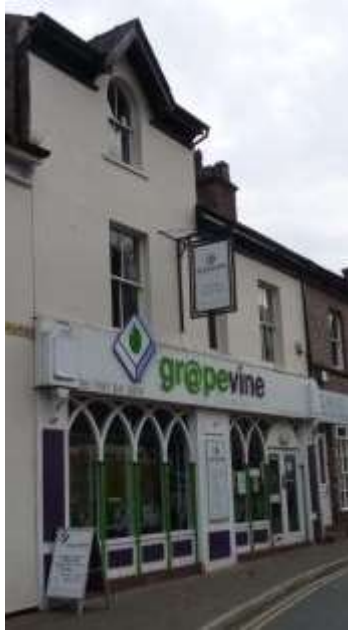
4.3.92. The Grapevine towards the southern end of Greenwood Street may be considered to be inappropriate signage, in terms of scale, design and material as does that of the Taste of India Indian restaurant. The lettering of the Grapevine in particular is of an incongruously large scale for the fascia and the use of materials for the Taste of India is signage is uncomplimentary, the fascia appears to have been replaced with a vinyl insert (Photographs 55-56) and an external roller shutter has been installed.

Photograph 55: Greenwood Street

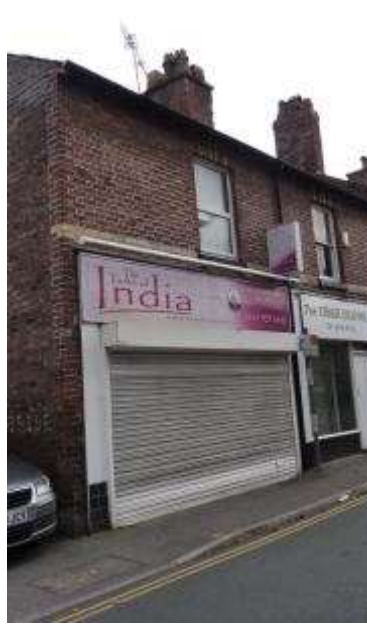
Photograph 56: Greenwood Street

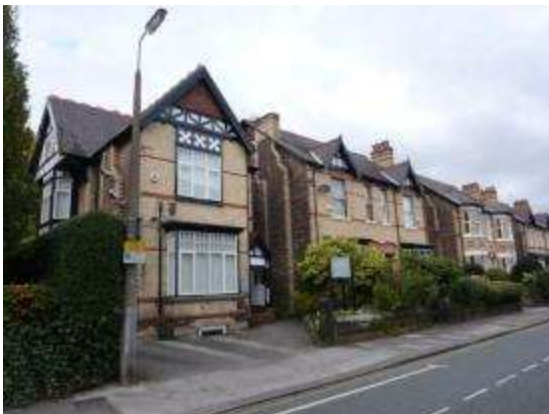
Photograph 62: Residential Properties on Market Street

4.3.105. The dominant architectural styles in this character zone are a combination of Victorian revival styles. Along Market Street there are Victorian Gothic semi-detached and detached residential properties of polychromatic brickwork, some with bay windows (Photograph 62). Some have also gabled fronts with black and white timber detailing, decorative timber barge boards and finials.

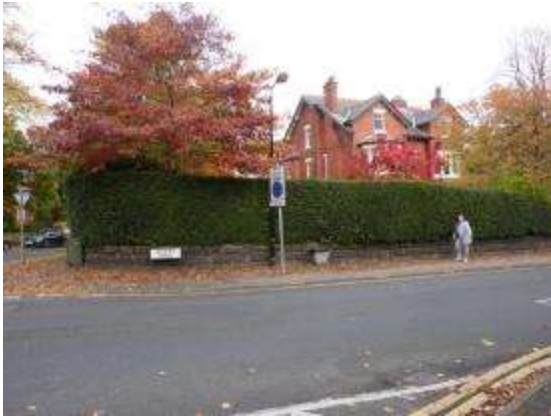
Photograph 64: Crammond House, Victorian property on corner of Groby Road & Regent Road

4.3.106. The character zone also contains more substantial detached and semi-detached Victorian and Edwardian properties. These include the residential properties on Sylvan Grove, Groby Road, Groby Place and Regent Road. Those on Groby Road provide examples of the Romanesque revival style, with architectural details such as arched recessed openings. Houses included within the Conservation Area on Sylvan Grove are Edwardian, in an Arts and Crafts style. Properties on Dunham Road are a combination of the Victorian Revival styles (Photographs 64-65). There are a number of white brick 1840's houses located on Groby Place.

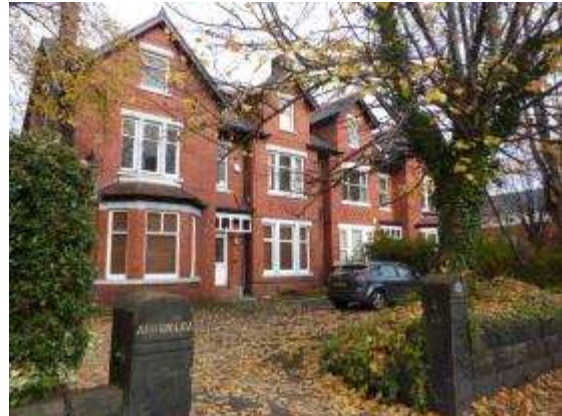
Photograph 65: Examples of Victorian properties at 40-42 Regent Road

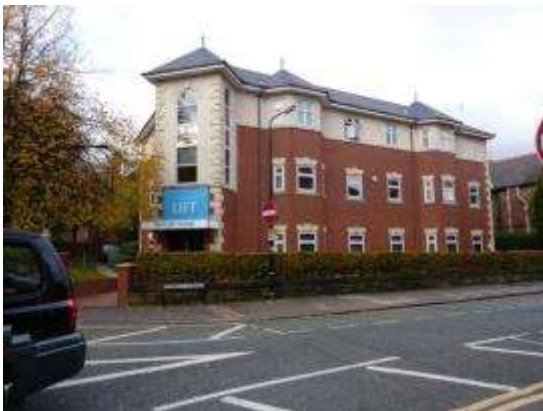
Photograph 66: 20th-21st century development on Market Street

4.3.107. There are examples of mid-20th - 21st century developments within the character zone which have in part adhered to revival styles. It is noted that whilst some elements of these designs are successful, the articulation of these buildings is often diminished by the fenestration, palette of materials and overall massing (Photographs 66-67). Regent Court sited on Groby Road is substantial in size, nevertheless it does present pitched gable ends to the street. The apartment building on the corner of Market Street and Regent Road again significant in its massing, exhibits two projecting bays with gabled fronts with quoin detailing.

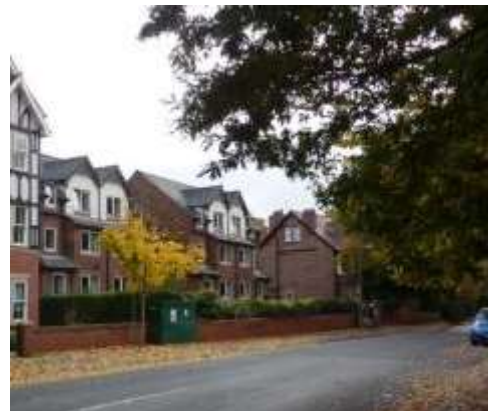
Photograph 67: Mid 20th-21st century development on Groby Road

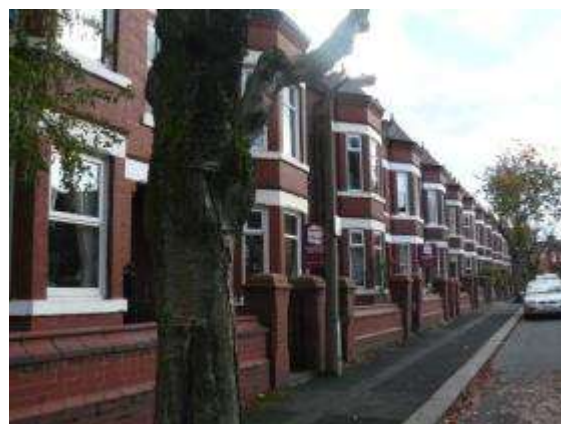
Photograph 73: Richmond Road

- 4.3.122. The dominant architectural styles in this area date to the Victorian and Edwardian periods. Along The Mount are some examples of substantial early Victorian villas in the Romanesque revival style as well as a number of properties at the western end of The Mount designed in a Georgian Classical style (Photograph 72).
- 4.3.123. Richmond Road and Townfield Road comprise of terraced and semi-detached Victorian and Edwardian residential properties with canted bay windows, gabled fronts and some with black and white timber detailing (Photograph 73).

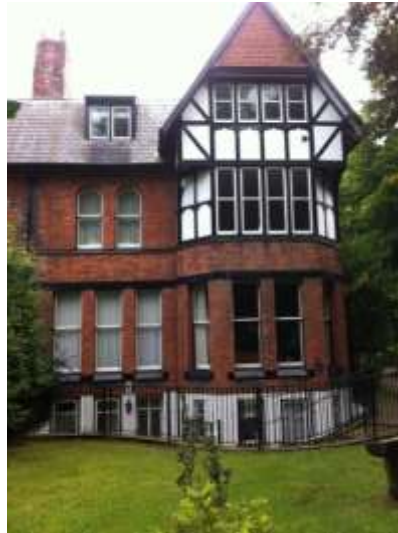
Photograph 80: Beech Hurst, now flats

- 6.2.2. Beech Hurst, a semi-detached Victorian property on Townfield Road, now converted to flats, is also in need of some repair. In particular there are areas of spalling brick work and water damage. A number of decorative ridge tiles are also damaged or missing. The bowling green pavilion, accessed from Church Walk, is currently in a state of dereliction and the site is overgrown with vegetation.

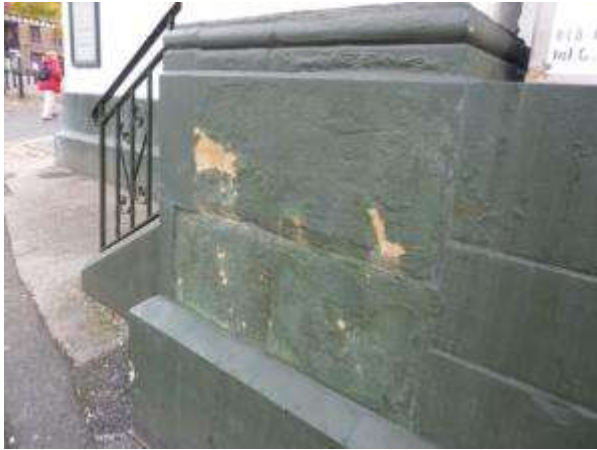
Photograph 81: The Old Market Place Tavern

- 6.2.1. There are a number of properties within the Conservation Area which are displaying signs of deterioration. Among these include the Old Market Tavern; grade 2 listed which is displaying signs of water ingress and decay. There is evidence of foliage growing out of gutters and downpipes and the decorative coat of arms has been removed from above the first floor middle window on the southern elevation. As this is a landmark property of architectural and historic interest, the condition of this property is having a noticeable negative impact on the character and appearance of the Conservation Area. Numbers 1 & 3A Market Street, grade 2 listed, are also vacant and no.3A in particular is in a poor condition. A number of urgent works are currently being undertaken to this property to safeguard its condition.

- There are examples of areas of decay and dereliction to individual properties, such as the Old Market Tavern and numbers 1-3A Market Street. The rear elevations of some of the properties along Church Street display signs of neglect, such as water damage, inadequately maintained joinery and render. There are also examples of inappropriate alterations such as poorly sited air conditioning units, ducting and wiring at the side of No 2 Church Street. The causes of these sources of decay need to be investigated and addressed. It is advised that the Council consider undertaking a Heritage at Risk Strategy for the Conservation Area.

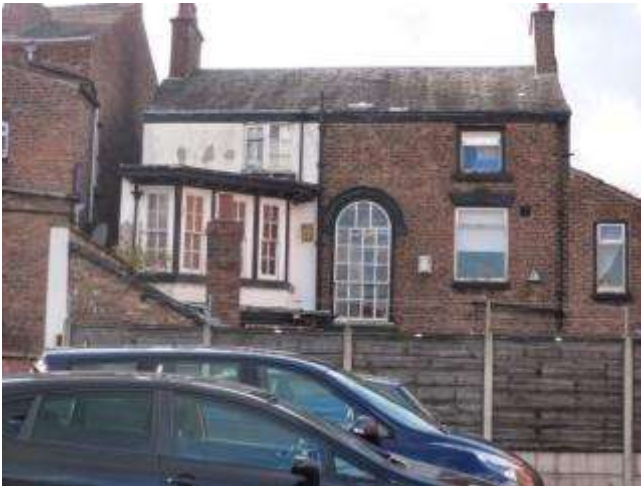
Photograph 85: Rear of properties on Church Street

6.2.4. The rear elevations of some properties along Church Street are also displaying signs of neglect, such as water damage, poorly maintained joinery and plasterwork. There are also a number of examples of inappropriate alterations including incongruously sited air conditioning units, ducting and wiring at the side of No 2 Church Street. These are prominent additions when viewed from Church Street and Victoria Street, resulting in an adverse impact on the character and appearance of the Conservation Area.

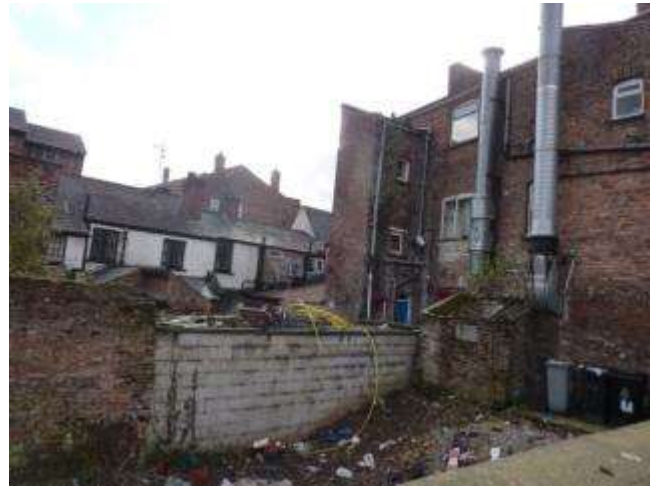
Photograph 86: Inappropriate siting of ventilation system

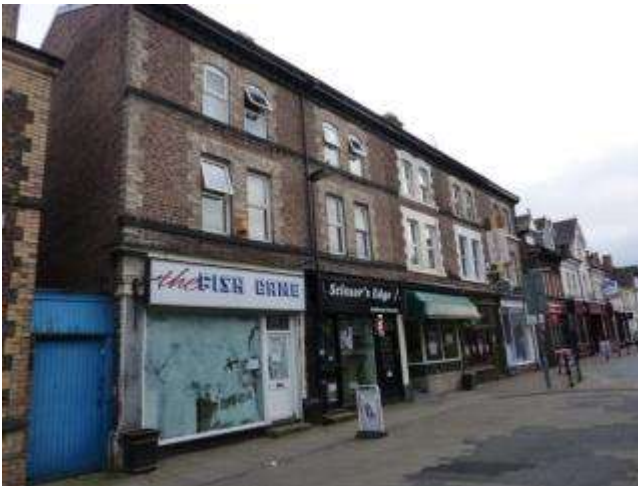
6.2.7. A number of shop fronts within the Conservation Area have been replaced with frontages constructed from anodised or plastic coated metals. These shop fronts often incorporate large areas of unrelieved glass, excessively deep fascias disproportionate and poorly designed signage internally illuminated. . There are also examples of external solid metal roller shutters within the Conservation Area, which have a detrimental effect on the character and appearance of the street scene. There are also examples of banners and posters placed on a semi-permanent basis which detract from historic elevations.

Photograph 88: Vacant Shop premises with intrusive signage

- Inappropriate shop fronts have a negative effect on the street scene and often fail to respect the significance of individual heritage assets. There are examples of replacement shop fronts within the Conservation Area consisting of homogenous frontages with poorly designed signage, illumination and security. Semi-permanent banners and advertising is also resulting in an adverse impact on historic elevations.

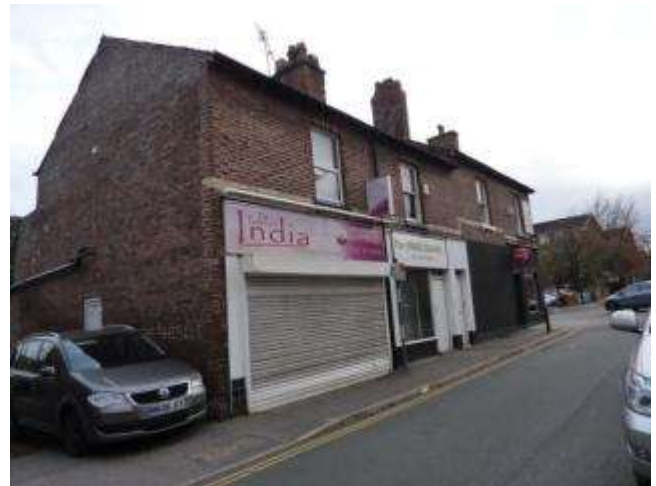
Photograph 89: Intrusive signage and roller shutters

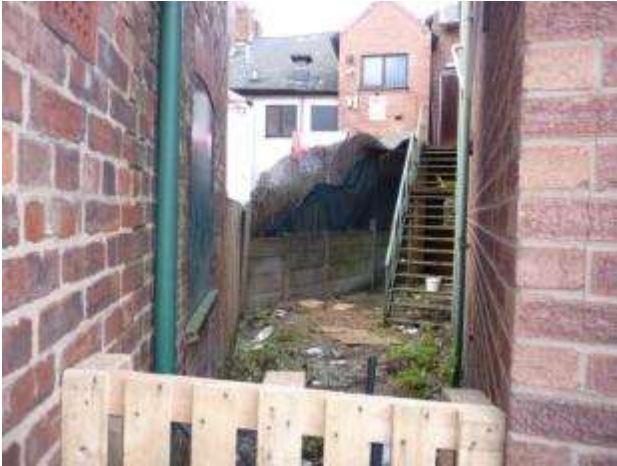
Photograph 90: Rear of property on Church Street

6.2.10. Some of the properties along Church Street have open spaces to the rear which are unkempt and where rubbish has been dumped. In particular numbers 6 & 8 Church Street

- Some of the properties along Church Street have open spaces to the rear that are in a state of disrepair and where rubbish has been discarded. The former bowling green and its pavilion, accessed from Church Walk, also require improvement. The site and building are in a poor condition and are currently overgrown and unusable.

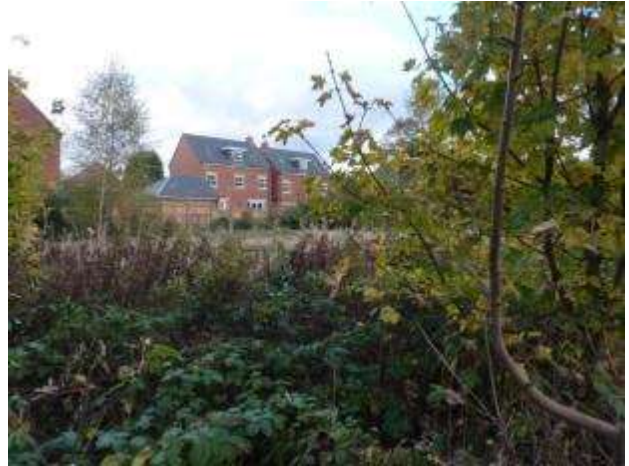
Photograph 91: The Bowling Green, adjacent to Albert Place

and also open space to the west of 34 Victoria Street. The former bowling green and its pavilion, accessed from Church Walk, is in very poor condition, it is currently overgrown and unusable.

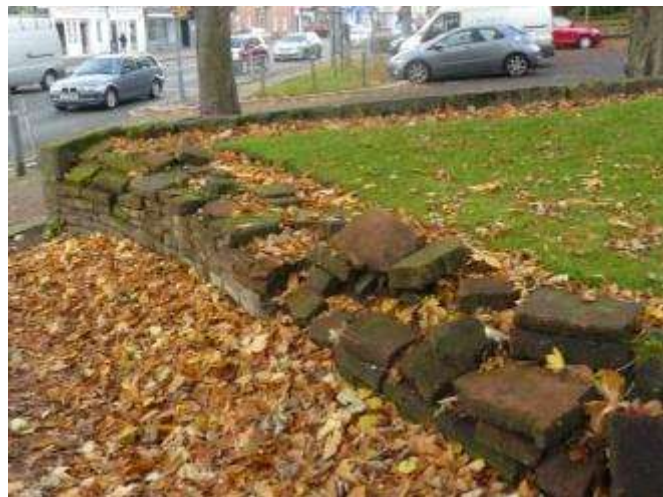
Photograph 92: Deteriorating stone wall adjacent to St George's Church

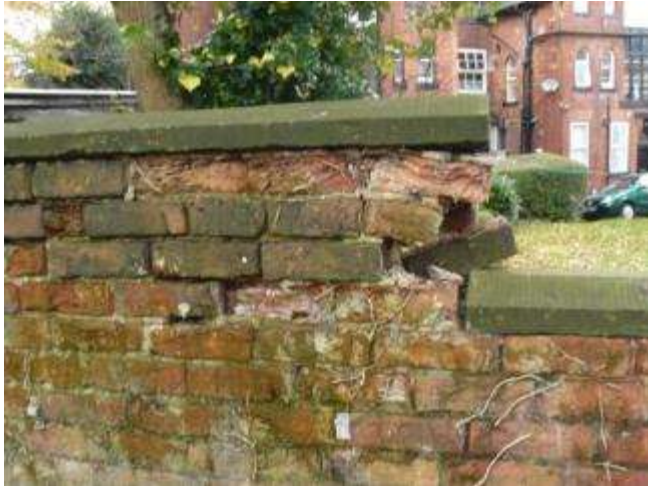
Photograph 93: Spalled brick boundary wall to Churchyard

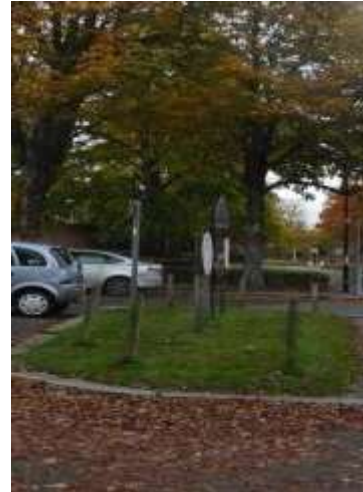
Photograph 94: Proliferation of wooden posts outside St George's Church

6.2.17. There are a variety of bollards, guard rails and street furniture located throughout the Conservation Area. These vary in quality and style and consideration should be given to a street clutter audit, when resources permit, to contemplate the removal and consolidation of these structures where possible; for example there is a proliferation of wooden posts in the grassed area in front of the Church of St George. A-boards can also detract from the historic street scene and impede pedestrian movement.

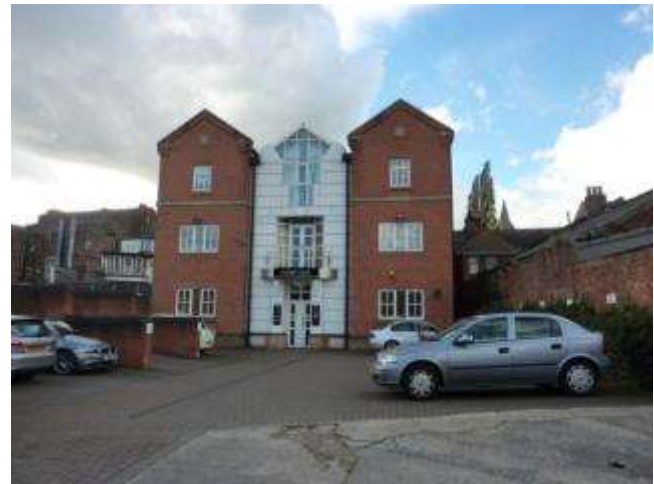
Photograph 96: Large area of deteriorating hard standing & tarmac to rear of properties on Church Street

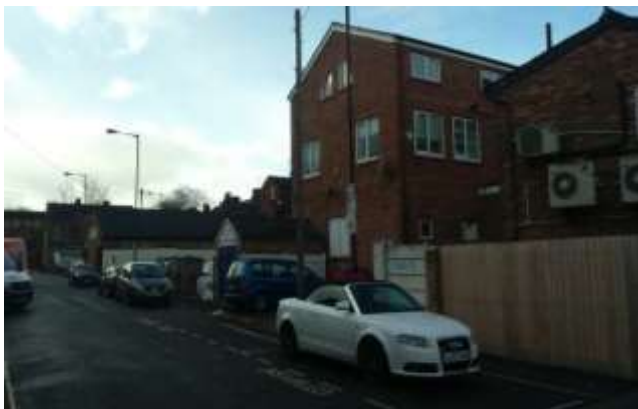
Photograph 97: Poor quality public realm at southern end of Central Way

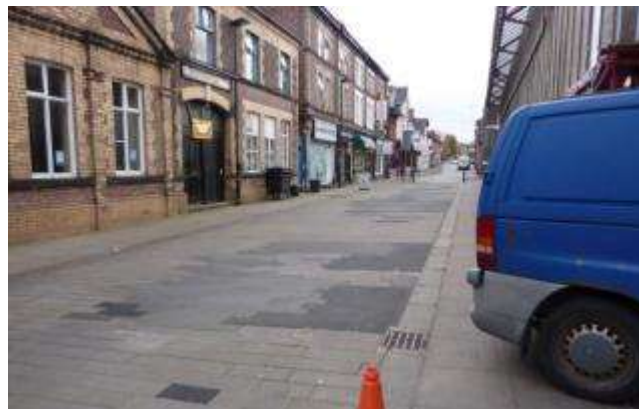
Photograph 98: Poorly repaired public realm on Greenwood Street

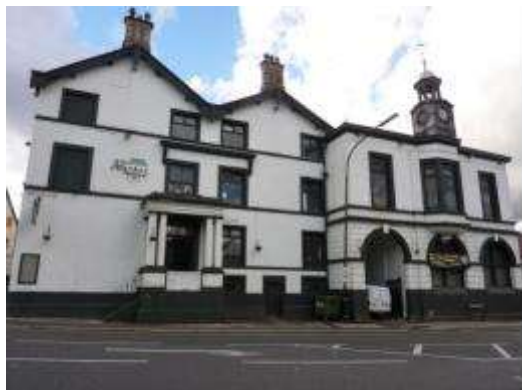
Address: Old Market Tavern, Grade II

Built: Early C19, **Condition:** *Fair, some evidence of damp and water ingress. Foliage growing from gutters and chimney*

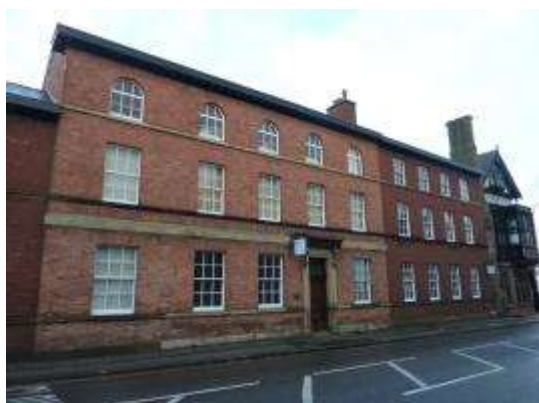
Reference	OMP/14		
Site Name	8, Dunham Road, Altrincham		
Grade	II		
Address	8 Dunham Road		
Postcode	WA14 4 NX	Location	SJ 7672 8803
SMR Reference	3749.1.0	Listed Building No.	1067952
Listing Description	<p>Offices. Early C19. Brick with stone dressings and slate roof. 3 storeys, 5 bays, double-depth, formerly with a carriage entry in bay 1 and with the door in bay 4. Stone plinth, sill bands, first floor band, modillion eaves and pitched roof. The C20 door has a moulded stone surround with enriched console brackets and cornice. The 4 ground floor and 5 first floor windows have cambered brick arches, stone sill bands and C20 replacement sashes. The second floor windows have semi-circular heads and C20 glazing.</p>

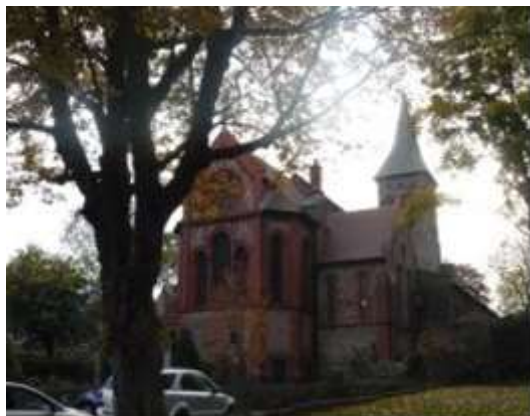
Reference	OMP/05		
Site Name	Church of Saint George		
Grade	II		
Address	Church of Saint George, Church Street, Altrincham		
Postcode	WA14 4DB	Location	SJ 7674 8820
SMR Reference	3743.1.0	Listed Building No.	1067949
Listing Description	<p>Church. Base of tower possibly 1799, tower and spire 1874, chancel 1886 and considerable re-building completed about 1897. Nave by Paley and Austin. Red brick, terracotta enrichments, slate spire and clay tile roofs. Nave, aisles, west tower and porch; polygonal chancel with vestry and side-chapel. 6-bay clerestory and aisles with stone bands, flat buttresses and coupled semi-circular headed windows with hoodmoulds (except for north which re-uses the stained glass, semi-circular headed windows and stone tracery of the former church). 3-stage tower with spire, recessed arched openings to belfry, blind arcade above and corbelled brick eaves. Chancel has tall semi-circular headed lights with terracotta enrichments, a 3-light east window with a rose window below a decorated gable. Interior: moulded brick semi-circular arched nave arcade on circular columns with moulded capitals and bases. The aisles continue to either side of the tower which is carried on massive brick piers. King and queen-post roof trusses with diagonally braced purlins. Stained glass.</p>

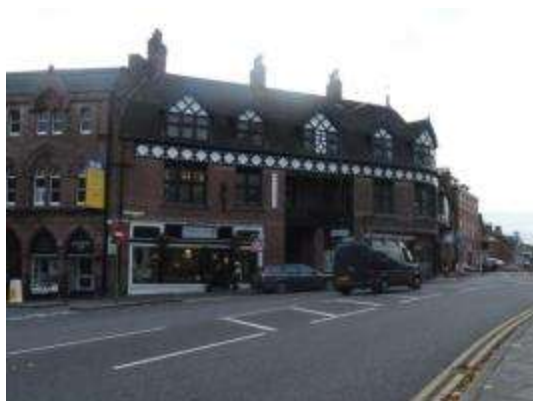
Reference	OMP/07		
Site Name	2, 2a, 4a, 4 Old Market Place		
Grade	II		
Address	2, 2a, 4a, 4 Old Market Place		
Postcode	WA14 4NP	Location	SJ 7677 8803
SMR Reference	3752.1.0	Listed Building No.	1120933
Listing Description	Commercial premises, now restaurants and offices. 1890's for Sir William Cunliffe Brooks probably by George Truefitt. Header bond brick, decorative timber framing and clay tile roof. 5 bays with 2 storeys (plus attic) and 2 bays on Post Office Street. Romantic in manner and yet almost symmetrically composed. Stone plinth, stone bands, decorative timber- framed eaves band, mansard roof with 3 chimneys. Entrance to 2A and 4A in a central recess with balcony above. On either side are large shop fronts (little altered) with 2 and 3- light mullion and transom windows above, 5 windows with decorative bargeboards, finials and timber-framed gables. (All windows have leaded lights except for ground floor). The facade sweeps gracefully into Post Office Street, a weather-vane on the roof recording the initials of the patron. The building complements Cunliffe Brooks's other buildings, Lloyds Bank (q.v.) and Nos. 1 and 3 Market Street (q.v.).

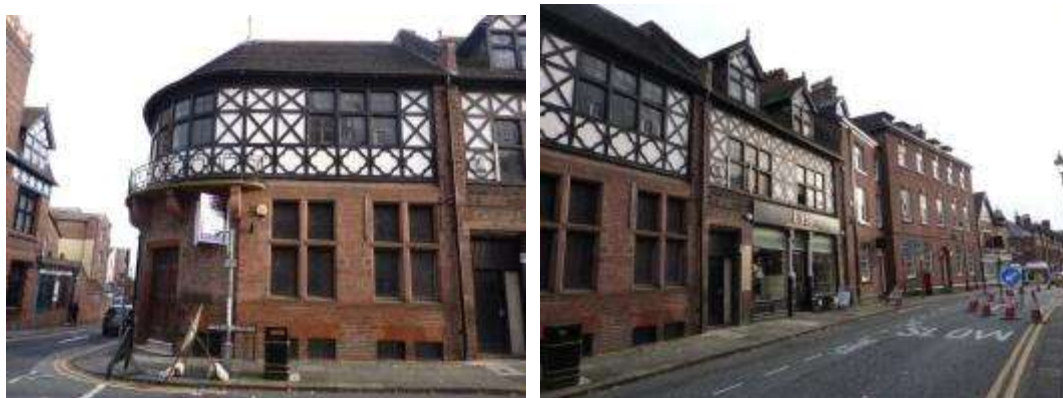
Address: 1, 1a and 3 Market Street , Grade II

Built: 1890, **Condition:** *Poor*

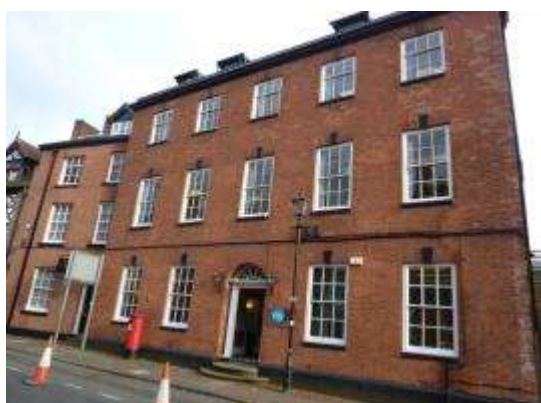
Reference	OMP/03		
Site Name	7, Market Street		
Grade	II		
Address	7, Market Street, Altrincham		
Postcode	WA14 1QE	Location	SJ 7675 8799
SMR Reference	3740.1.0	Listed Building No.	1356478
Listing Description	House, now offices. Early C19. Brick with slate roof. 5 bays; 3 storey, double-depth central-staircase plan with small wings to rear. Stone plinth, eaves cornice and parapet. Central 4-panel door with segmental overlight, fluted 3/4 columns and segmental step approach. Windows are sashes with flat brick arches, stone sills, keystones and original glazing bars. Gable Stacks.

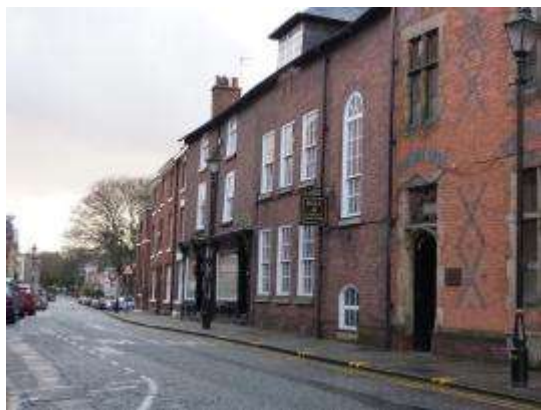
Reference	OMP/12		
Site Name	10 & 12, Market Street		
Grade	II		
Address	10 & 12, Market Street, Altrincham		
Postcode	WA14 1QB	Location	SJ 7673 8800
SMR Reference	7343.1.0	Listed Building No.	1067958
Listing Description	<p>2 Houses, now with shop fronts. Early C19. Flemish bond brick with slate roof. Each house has a shop front on the ground floor with door to the right and 3 storeys. The long plots have worker's cottages in the rear yard which were inserted later. C19 shop fronts, that to No. 12 having a cornice and enriched consoles. The 4 first and second floor window openings have flat brick arches, stone sills and various 9, 12 and 16-pane sash windows. Horizontally sliding sashes to rear. Included for group value.</p>

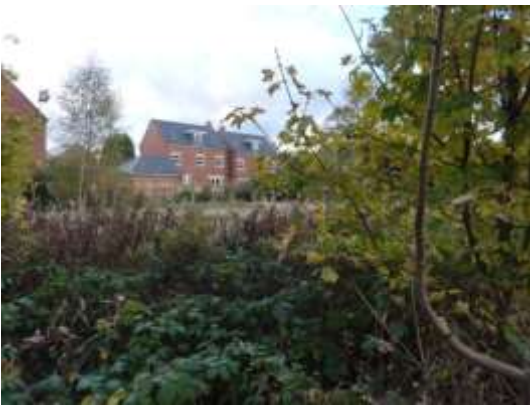
Address: The Bowling Green and Pavilion

Built: 1835-1852, Pavilion erected 1875 – 1910, **Condition:** Poor

Description: These elements illustrate the development of the settlement in which they stand. This open space of land features a boundary wall and a pavilion. The boundary wall is 6 courses high and is built from red sandstone whereas the small single brick pavilion is constructed from brick and features a hipped roof clad with blue slate and decorative ridge tiles. Much of the site is overgrown. They reflect a traditional former use of the area.

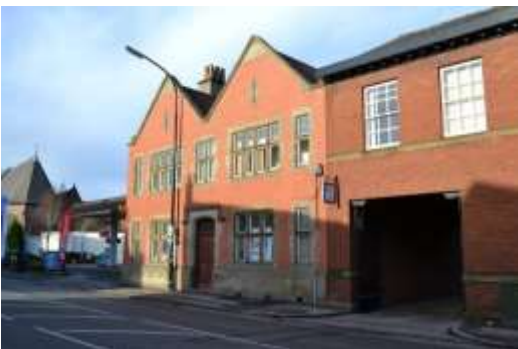
Address: 12 Dunham Road

Built: 1908 - 1937, **Condition:** Good

Description: This building reflects a substantial number of other elements in the Conservation Area in age, style and materials. This 2 storey terraced is built from red stock brick and laid in Flemish

wall bond. The roof is pitched cladded with rosemary clay tiles and features external chimneys and stone finals. The windows of this building are mullioned and tall in shape and have stone surrounds to them; in addition the windows are within a timber casement. The entrance doorway has revival details to it and features a fanlight which has stained glass within it. Other architectural elements include a double gable and stone detailing. This terraced building has a regular form and a symmetrical composition. It illustrates the development of the settlement in which it stands.

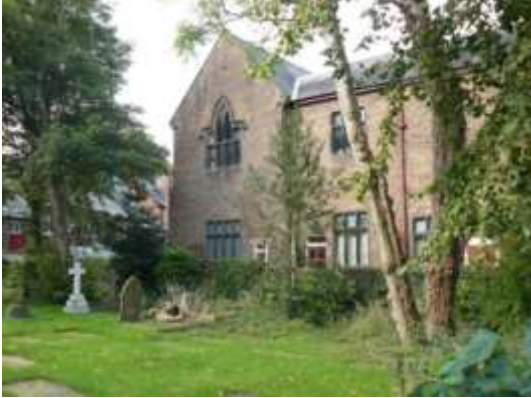
Address: Ashton Brookes (Funeral Directors), Churchside

Built: 1852-1876, **Condition:** Fair

Description: This building reflects a substantial number of other elements in the Conservation Area in age, style and materials. The building was constructed from handmade Cheshire brick and features stone surrounds to windows which have glazing set into them and gothic arches to the entrance and first floor window. Other features include a prominent gable and a pitched roof cladded with blue slate. The building has an irregular plan form and is two storeys in height. It also reflects the traditional uses and functional character of the area. It illustrates the development of the settlement in which it stands. It contributes positively to the setting of an adjacent designated heritage asset.

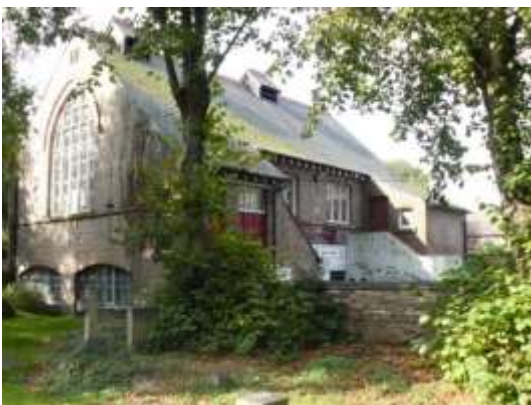
Address: The Scout Hut/Former School Building Churchside, Church Street

Built: 1852-1876, **Condition:** Fair

Description: This building reflects a substantial number of other elements in the Conservation Area in age, style and materials. Elements in this building include handmade Cheshire brick, laid in a variation of 'English Garden brick bond', a pitched roof cladded with blue slate, decorative terracotta ridge tiles and a large prominent arched window. The building features a simple plan form and is two storeys in height. It also reflects the traditional uses and functional character of

the area. It illustrates the development of the settlement in which it stands. It contributes positively to the setting of an adjacent designated heritage asset. It is largely complete, retains many historic features and is of historic interest as it demonstrates the civic nature of the area and it also has a social significance. In terms of style it also forms part of a group with the current Undertakers, which brings a unified architectural value to the area.
