Old Market Place Conservation Area – Supplementary Planning Document SPD5.3

TRAFFORD
COUNCIL

Conservation Area Appraisal – October 2014

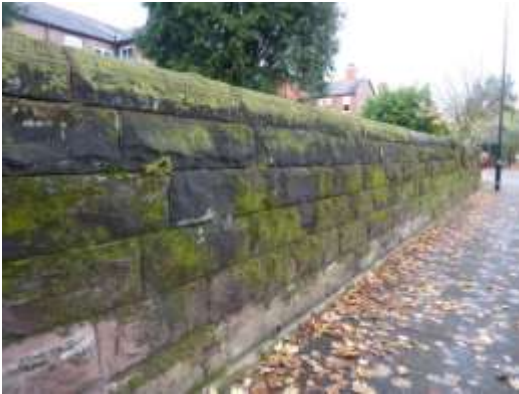
Address: Sandstone Boundary Wall, Churchside, Church Street

Built: 1876 – 1897, **Condition:** Fair

Description: This element reflects a substantial number of other elements in the Conservation Area in age, style and materials: the wall is between six to seven courses high and is constructed from red sandstone; it features shaped coping stones and a pitched face. It contributes positively to the setting of an adjacent designated heritage asset.

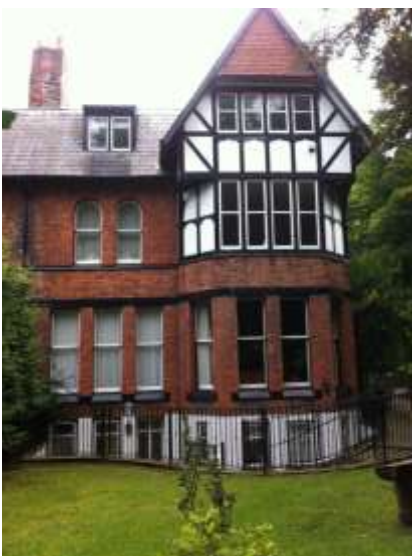
Address: Beech Hurst and Groombridge House, Townfield Road

Built: 1873-1887, **Condition:** Fair

Description: These buildings reflect a substantial number of other elements in the Conservation Area in age, style, materials and form. This Edwardian semi-detached building is three storeys high

with additional accommodation in the basement; it is built from red stock brick, which is laid in a Flemish brick bond. The windows are timber vertical sliding sash windows painted, in black and white and include brick headers and stone sills. The roof is pitched, cladded with blue slate and features external chimneys and decorative roof tiles. Other architectural features of this building include prominent gables with half-timber detailing and domestic revival side entrances. The building has an irregular plan form and has a symmetrical composition. The properties have spacious gardens to the front, which has a 3-4 red sandstone boundary wall, although original substantial gate piers only remain at Beech Hurst. They illustrate the development of the settlement in which they stand. They also reflect the traditional uses and functional character of the area.

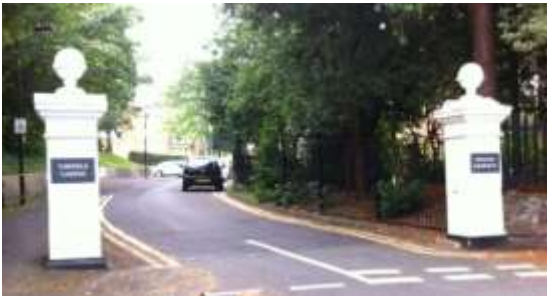
Address: Townfield Gardens stone gate piers, Townfield Street

Built: 1835-1852, **Condition:** Fair

Description: This element reflects a substantial number of other elements in the Conservation Area in age, style and materials. The stone gate piers once provided access to the now demolished Townfield House; they are built from stone and painted in white with a black coloured base. They reflect the traditional uses and functional character of the area.

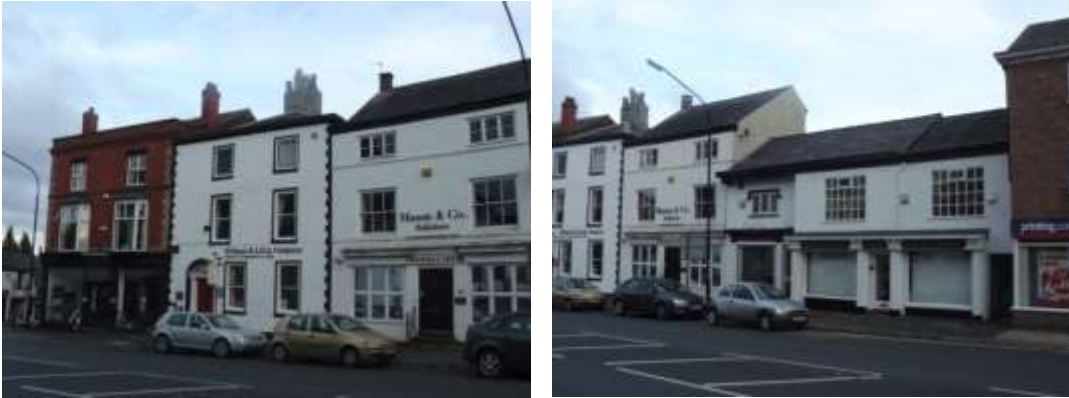
Address: 8-18 Old Market Place

Built: Pre 1835 and 1876-1897, **Condition:** Fair

Description: These buildings reflect a substantial number of other elements in the Conservation Area in age, style, materials and form. Properties 8 to 16 are white rendered, whereas number 18 is constructed from red stock brick with stone detailing. These buildings feature both hipped and gabled roofs, both of which are clad with blue slate and feature chimneys. Although vertical sliding sash windows remain present in properties 14 and 16, the rest of the buildings glazing have been replaced with UPVC/PVC. In addition these terraced properties feature traditional shop fronts, have a simple form and their height varies between two and three storeys. As a group they illustrate the development of the settlement in which they stand. They have a significant association with medieval burgage plot boundaries. They also reflect the traditional uses and functional character of the area.

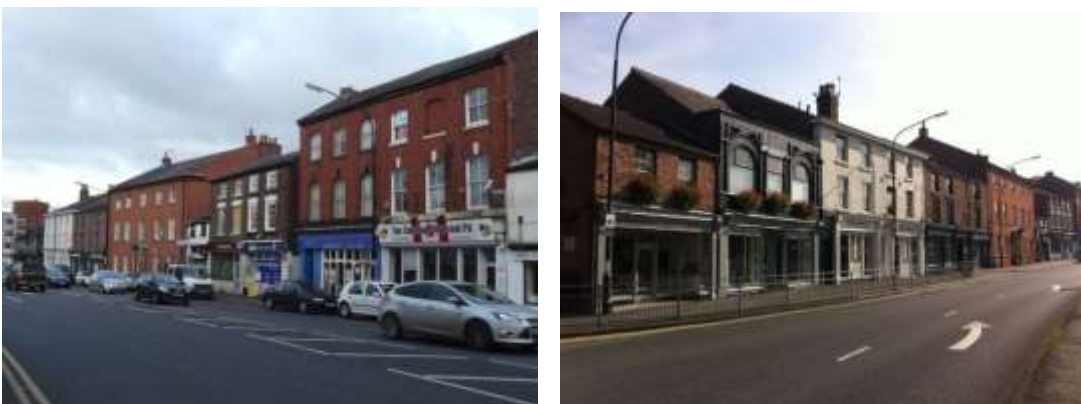
Address: 2-36 Church Street

Built: Pre 1835, 1835-1852 and 1852-1876, **Condition:** Fair

Description: These buildings reflect a substantial number of other elements in the Conservation Area in age, style, materials and form. A number of these properties are in a Flemish brick bond constructed from handmade Cheshire brick. They feature a Georgian symmetrical window line,

pitched roofs clad with blue slate, external chimneys, vertical sliding sash window and traditional styled shop fronts. Building 20-24 also features a neo-classical styled entrance. The buildings have a simple form and their height varies in storeys. As a group they illustrate the development of the settlement in which they stand. They have a significant association with medieval burgage plot boundaries. They also reflect the traditional uses and functional character of the area. 16 Church Street and 18 Church Street are at risk.

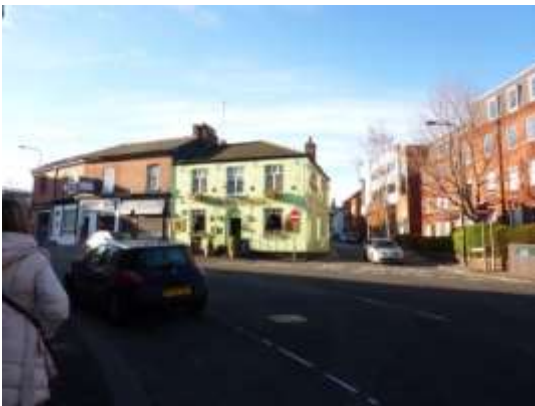
Address: The Victoria Public House, 29 Stamford Street

Built: 1852-1876, **Condition:** Good

Description: This building reflects a substantial number of other elements in the Conservation Area in age, style, materials and form. This terraced public house is two storeys high and has a regular form and a symmetrical composition. The brickwork of the property is painted and the roof is hipped and clad with blue slate and features external chimneys. The windows of the property are elongated/tall in shape; they have stone sills and are in a timber-casement. Other features of this building include a semi-circular arched doorway and a painted plinth. It reflects the traditional uses of the area. It illustrates the development of the settlement in which it stands.

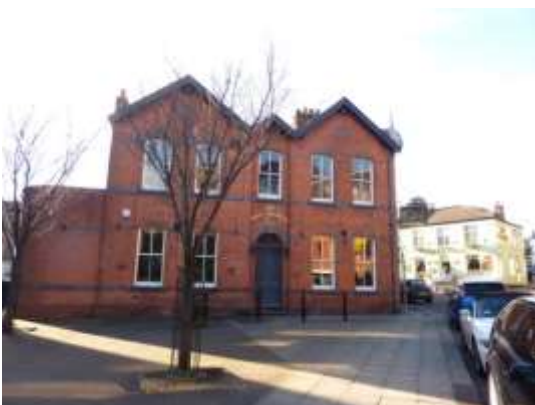
Address: The Malt Shovels Public House, 39 Stamford Street

Built: 1852-1876, **Condition:** Good

Description: This building reflects a substantial number of other elements in the Conservation Area in age, style, materials and form. This terraced building is two storeys high with additional accommodation in the roof, is built from red stock brick, which is laid in a Flemish brick bond. The public house also has blue brick dressings to the south and west elevation and a painted render to the west elevation. The windows are mullioned, elongated and tall and in shape with vertical sliding sash window glazing. Stone sills surround the windows on the west and north elevation. The roof is pitched to west elevation, gabled to the north elevation, both of which are cladded with blue slate. The building features external chimneys and finals and gablets to the west elevation. The building has a solid panelled semi-circular arched door with a fanlight to the north elevation and a solid panelled revival detailed doorway to the west elevation. Other architectural elements of this building include a string course to the north and west elevations, a small front garden to the north, blue brick decorative cambered headers and key detail to windows and over door. The building has an irregular plan form and a symmetrical composition. Although some elements of symmetry can be found at the north and west elevations. It reflects the traditional uses of the area. It illustrates the development of the settlement in which it stands.

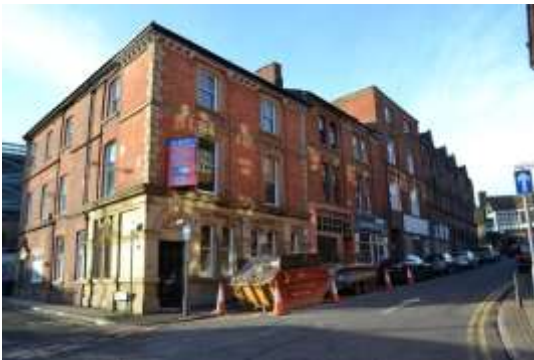
Address: 10-16 Kingsway

Built: 1852-1876, **Condition:** Fair

Description: These building reflect a substantial number of other elements in the Conservation Area in age, style, materials and form. The majority of these building are built from red stock brick in a Flemish brick bond and vary in height from three to four storeys. Other walling that remains present in these buildings is stone; this is featured on the first floor of property number 16. Properties 10 and 16 have hipped roofs, whereas properties 12 and 14 have pitched roofs; all the roofs are cladded with blue slate and feature chimneys and eaves brackets. The windows of the buildings are timber vertical sliding sash windows and vary in shape from squared to tall, properties 10 and 16 have stone sills and stone headers where was 12 and 14 have stone sills and brick headers. Other features of these buildings are revival details on the doorways and number 16 has corbels. They have a regular plan form and symmetrical composition. As a group they illustrate the development of the settlement in which they stand. They also reflect the traditional uses and functional character of the area.

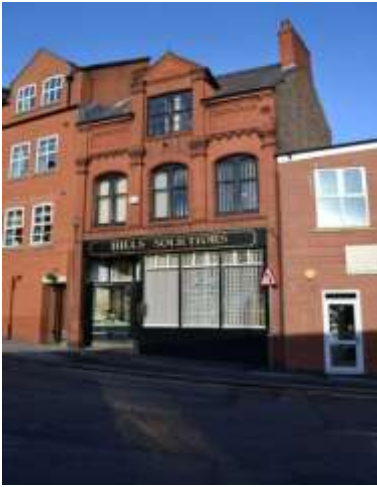
Address: 19-21 Kingsway (Hills Solicitors)

Built: 1876-1897, **Condition:** Good

Description: 19-21 Kingsway is a 2 story terraced building with additional accommodation in the roof; it is built from red stock brick which is laid a stretcher brick bond. The roof is pitched, cladded with blue slate and features chimneys and a gablette. The windows are vertical sliding sash glazed and have brick sills and headers. Other architectural elements include gauged brickwork with classical detailing to the upper floors, timber and brick shop front in a traditional style, a part glazed, part timber door with a fanlight, and a recessed porch. The building has a regular plan form and an asymmetrical composition. Although some elements of symmetry can be found on the upper floors.

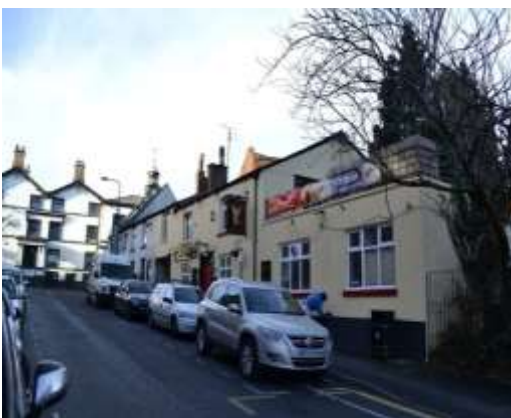
Address: Old Roebuck, Victoria Street

Built: Pre 1835, **Condition:** Fair

Description: This building reflects a substantial number of other elements in the Conservation Area in age, style, materials and form. This terrace is two storeys high and has a regular form and has a symmetrical composition. The wall of the building is rendered in a cream colour. The roof is pitched and cladded with blue slate and features chimneys. The windows of the property are squared in

shape which have stone sills and are in a leaded light casement. Other features of this building include a heavy wooded framed door with a leadlight fanlight. The building has extensions to both the ground and first floor. It reflects the traditional uses of the area. It illustrates the development of the settlement in which it stands.

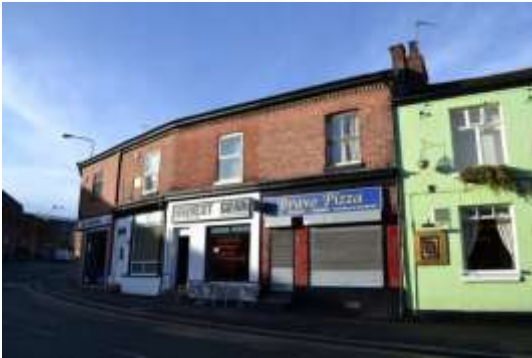
Address: 23, 25 and 27 Stamford Street

Built: Pre 1835, **Condition:** Fair

Description: These building reflect a substantial number of other elements in the Conservation Area in age, style, materials and form. These two story terraces are built from red stock brick in a Flemish wall bond, the roof is pitched, cladded with blue slate and feature chimneys. The windows of these buildings are square and tall in shape and have been replaced by UPVC; the windows have stone sills and brick headers. The doors have also been replaced by UPVC and security measures. These terrace buildings have a regular form. As a group they illustrate the development of the settlement in which they stand. They also reflect the traditional uses and functional character of the area.

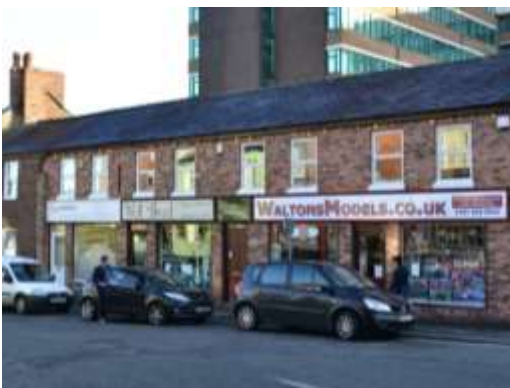
Address: 30-38 Stamford Street

Built: Pre 1835 and Post 1865, **Condition:** Fair

Description: This building reflects a substantial number of other elements in the Conservation Area in age, style, materials and form. These two storey terraces are constructed from handmade Cheshire brick in a stretcher wall bond. The properties features windows such as top hung opening

windows and large shop frontage windows, the windows on the first floor feature stone sills and brick headers. The roof of these building is pitched, cladded with blue slate, and features chimneys. The building has a regular plan form, a symmetrical composition. It is noted that properties 30-36 incorporate replacement brick and no boundary treatment remains. As a group they illustrate the development of the settlement in which they stand. They also reflect the traditional uses and functional character of the area.

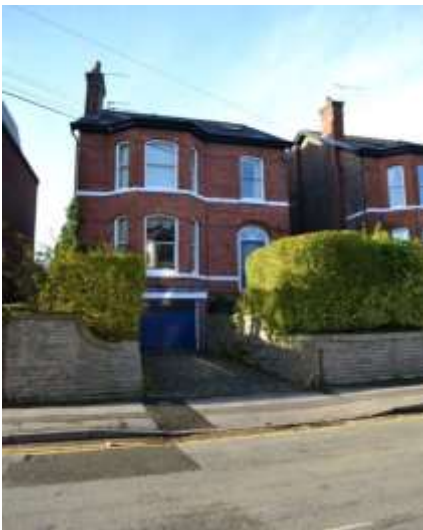
Address: 1 Springfield Road

Built: 1876-1897, Condition: Good

Descriptions: This building reflects a substantial number of other elements in the Conservation Area in age, style, materials and form. This detached building on Springfield Road is two storeys plus basement and is constructed from red stock brick and is in Flemish wall bond. The roof is pitched, cladded in blue slate and features chimneys. The windows of the property are tall vertical sliding sash windows and have stone sills and brick headers. The doorway to the house is a semi-circular arch which includes a fanlight. The property has a small front garden, with some original boundary treatment. The boundary wall is 10 courses high and features existing stone gate piers. It reflects the traditional uses of the area. It illustrates the development of the settlement in which it stands.

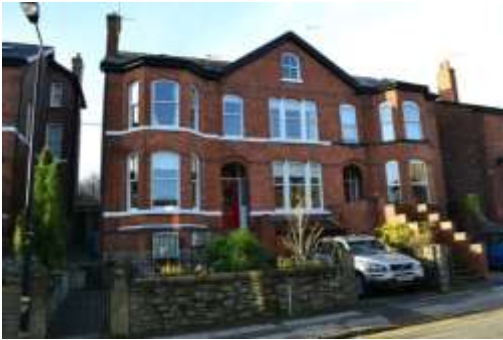
Address: 3 and 5 Springfield Road

Built: 1876-1897, **Condition:** Good

Description: This building reflects a substantial number of other elements in the Conservation Area in age, style, materials and form. This two storey plus basement, semi-detached building is constructed from red stock brick and is laid in a Flemish brick bond. The windows of this building are vertical sliding sash windows within a timber casement which feature stone sills and brick headers; in-addition the building includes a mullioned barley-sugar designed window. The roof is pitched, cladded with blue slate and features external chimneys. Other architectural element of this building include a two story canted bay, a recessed porch and a part glazed, part timbered, semi-circular arched door. The site also features a small garden to the front of the property although some has been removed for parking, the original boundary wall has been replaced and an original solid stone pedestrian gate remains at property number 3. This semi-detached building features additionally accommodation in the basement and roof and is of an irregular plan form and has a symmetrical composition. It reflects the traditional uses of the area. It illustrates the development of the settlement in which it stands.

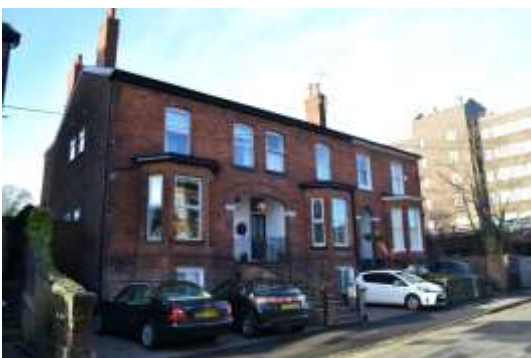
Address: 7-11 Springfield Road

Built: 1852-1876, **Condition:** Good

Description: This building reflects a substantial number of other elements in the Conservation Area in age, style, materials and form. This two storey, terrace building on Springfield Road is constructed from red stock brick and is in Flemish wall bond. There is also accommodation within the basement. The roof is pitched, cladded in blue slate and features chimneys. The windows of the

property are tall vertical sliding sash windows which have stone sills and brick headers. The doorway to the house is a solid panelled door that features an ogee, fanlight, slide panels of glazing and a recessed porch. Other architectural features include a one-story canted bay and a blue bricked string course at the basement level of the building. The property has a small front garden, with some original boundary treatment. The boundary wall is five courses high and features stone coping. The building has an irregular plan form and properties 7-9 have symmetrical composition while property number 11 has an asymmetrical composition. It reflects the traditional uses of the area. It illustrates the development of the settlement in which it stands.

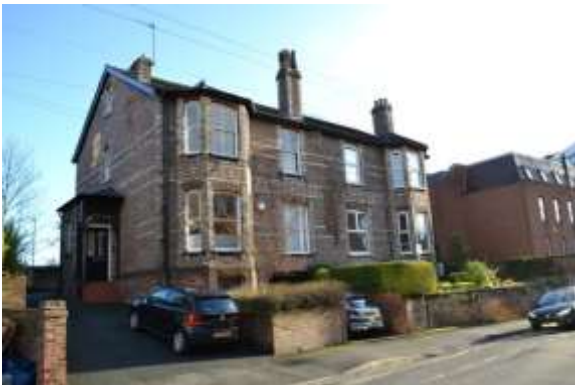
Address: 2-8 Springfield Road

Built: 1876-1897, **Condition:** Fair

Description: These building reflect a substantial number of other elements in the Conservation Area in age, style, materials and form. These two story buildings which have additional accommodation in the basement and roof are constructed from red stock brick, handmade Cheshire brick and cream brick; these bricks are laid in a variation of wall bonds. The windows are elongated in a shape and are vertical sliding sash windows which have stone sills and brick headers. The roof the buildings is pitched, cladded with blue slate tiles; all properties have chimneys and some decorative ridge tiles. Other features of 2-8 Springfield Road include a part glazed, part timbered doorways with fanlight and side porch and two story canted bays plus basement. Original boundary features and treatment have been removed except from property number 2; which has a small garden to the front, approximately the boundary wall is of 16 courses and is made from handmade Cheshire brick. Additionally the property has a stone coping to boundary wall and original solid stone gate piers. The buildings are in a regular plan form and are of a symmetrical composition. They illustrate the development of the settlement in which they stand. They also reflect the traditional uses and functional character of the area.

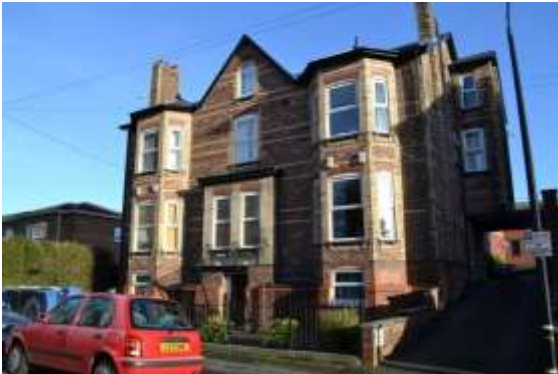
Address: 10-12 Springfield Road

Built: 1876-1897, **Condition:** Good

Description: This building reflects a substantial number of other elements in the Conservation Area in age, style, materials and form. This two story buildings which has additional accommodation in the basement and roof are constructed from red stock brick, handmade Cheshire brick and cream brick; these bricks are laid using an English garden brick bond. The windows are elongated in a shape and have been replaced with upvc; the windows have stone sills and brick headers. The buildings have pitched roofs which are cladded in blue slate tiles; all properties have chimneys and finals. Other features of this property include a part glazed, part timbered doorway, a blue bricked string course, modern canopy over entrance and a two story canted bays plus basement. Original boundary features and treatment have been removed and the front garden has been converted for parking. The buildings are in a regular plan form and are of a symmetrical composition. It reflects the traditional uses of the area. It illustrates the development of the settlement in which it stands.

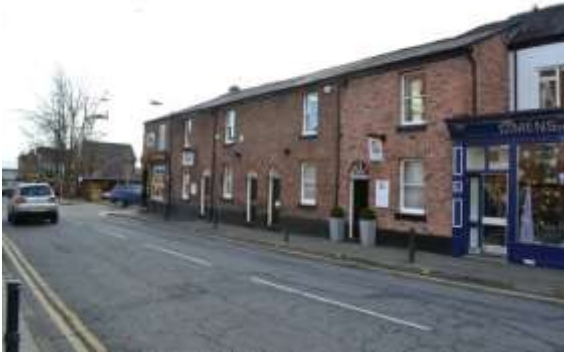
Address: 25-33 Regent Road

Built: Pre 1835 and 1876-1897, **Condition:** Good

Description: These buildings reflect a substantial number of other elements in the Conservation Area in age, style, materials and form. These 2 storey terraced buildings are built from handmade Cheshire brick and laid in a Flemish bond. The roof is pitched, clad with blue slate and has an external chimney on property number 25. Properties 27-33 have tall shaped vertical sliding sash windows, painted in white. Whereas the windows on 25 have been replaced with UPVC/PVC and a large shop frontage window appears to be present. The doors to the properties are solid panelled doors with a semi-circular fanlight. Other architectural features include traditional shop signage, stone sills and brick headers. The terraces have a regular form and an asymmetrical composition. They also reflect the traditional uses of the area. As a group they illustrate the development of the settlement in which they stand.

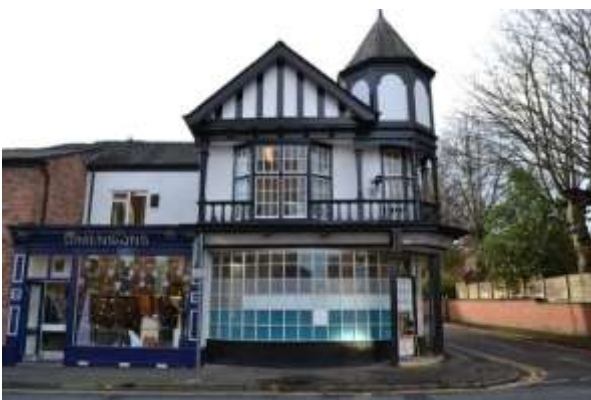
Address: 33a, 35 & 35a Regent Road

Built: Pre 1835 and 1876-1897, **Condition:** Good

Description: These buildings reflect a substantial number of other elements in the Conservation Area in age, style, materials and form. These 2 storey terraced buildings have a painted brick facade. The roof is pitched, clad with blue slate and features external brick chimneys, decorative ridge

tiles and finals. Properties 33a and 35 have part glazed, part timbered door, whereas 35a has a solid panelled door. The buildings have various window shapes, from a bay window at property number 35 to squared windows at 35a. The windows at 35 and 35a are glazed in multi-paned timber casement. Other architectural features include traditional shop fronts, stone sills at 35a and brick headers to 33a and 35a, gables, a tower, canted bays at first floor level and a balcony. The group of buildings have an irregular form and have an asymmetrical composition. They also reflect the traditional uses of the area. 33a Regent Road incorporates the lower section of an 18th century cotton mill and 35a, which is set back fronting Normans Place, is the mill owners house. As a group they illustrate the development of the settlement in which they stand. Number 35 has landmark quality. **Address: The Conservative Club, Market Street**

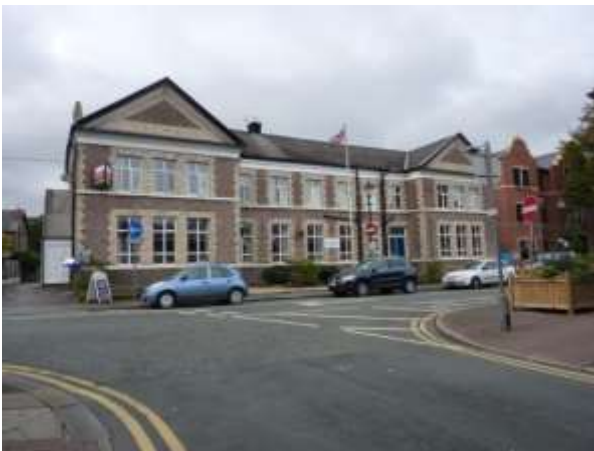
Built: 1876-1897, **Condition:** Good

Description: This building reflects a substantial number of other elements in the Conservation Area in age, style, materials and form. Altrincham Conservative Club is a two story building built from Cheshire common and cream brick which is laid in a header brick bond. The windows of the building are tall and elongated in shape and feature stone sills and brick headers, the glazing of windows comprises of UPVC/PVC. The Conservative Club has a pitched roof which is cladded in blue slate. Other architectural features of the building include gables, string courses, and a part glazed, part timbered door with a fan light. The building has a regular plan form, is of symmetrical composition and has a small garden to the front of the building. It reflects the traditional uses of the area. It illustrates the development of the settlement in which it stands. This building has landmark quality.

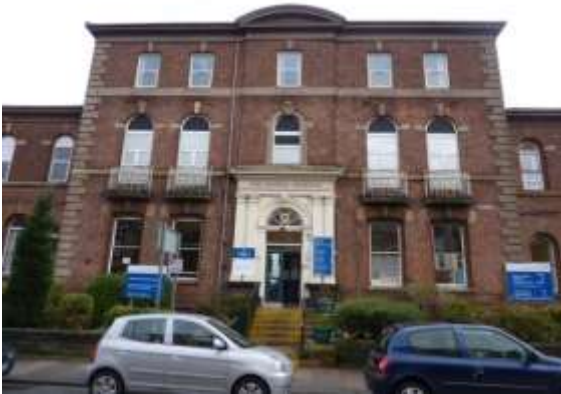
Address: Altrincham General Hospital

Built: 1852-1876, 1876-1897 and 1908-1937, **Condition:** Fair

Description: This building reflects a substantial number of other elements in the Conservation Area in age, style, materials and form. This building has a variations of levels; three storeys. The original Victorian building is constructed from handmade Cheshire brick whereas Edwardian extensions have been built from a dark coloured red stock brick. The bricks are laid in a Flemish brick bond. The roof of the building is pitched and cladded with blue slate. The windows of the building are elongated and have been replaced with UPVC/PVC and they feature stone stills and brick headers. The entrance doorway has revival details, part timbered; part glazed and has a fan light. The building has no site features and has had various later extensions. A number of these historic extensions are also of architectural interest such as those on Market Street and the 1914 addition on Regent Road and chart the growth and importance of the Hospital. The original building was symmetrical with a balanced composition, nevertheless the later additions results in an irregular plan form adding to the interest of the site. It reflects the traditional uses and functional character of the area. It illustrates the development of the settlement in which it stands. This building, extensions and site has landmark quality.

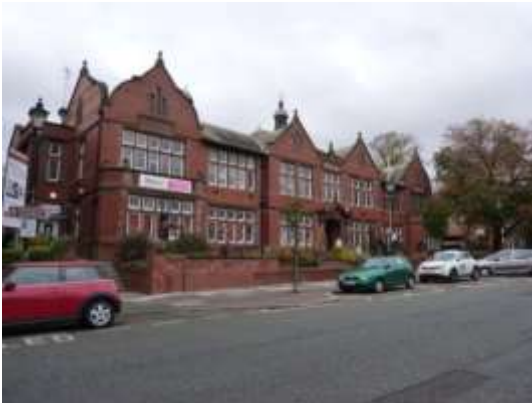
Address: Altrincham Town Hall, Market Street

Built: 1900 but further extensions added between 1909-1965, **Condition:** Good

Description: This building illustrates the development of the settlement in which it stands. It reflects the traditional functional character in the area. Its use contributes to the character and appearance of the area. Work of a particular architect. It has landmark quality. It reflects a substantial number of other elements in the conservation area in age, style, materials, form or other characteristics. Altrincham Town Hall is two storeys high and is built from red stock brick which is laid in a Flemish bond. The roof is pitched, clad with Westmorland tiles and features finials and traditional vents. The windows of the town hall are transomed in shape and are within timber casements with stained glass. The main entrance to the building is a revival detailed, incorporating stained glazing & part-timbered door. Other architectural features include gables, a recessed porch, a string course, stone detailing to windows and a stone plaque. This detached building has an irregular form and a symmetrical composition, it was extended in the 1930s. It relates to adjacent designated heritage assets in age, use and materials.

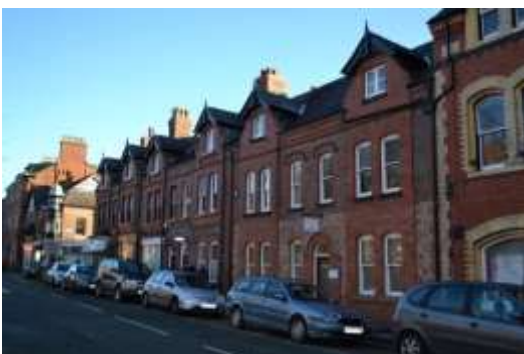
Address: 13-23 Market Street

Built: 1876-1897, **Condition:** Good

Description: These buildings reflect a substantial number of other elements in the Conservation Area in age, style, materials and form. These two story buildings are constructed from red stock brick and handmade Cheshire brick; these bricks are laid using a combination of Flemish and a header brick bound. The windows are elongated in a shape and are vertical sliding sash windows

which have stone sills and brick headers. The building's roof is pitched roofs cladded blue slate tiles; all properties have chimneys, finals and gablets. Other features of these properties include a part glazed, part timbered semi-circular doorway with a fanlight, a traditional shop front, a string-course and additionally accommodation in the roof. The buildings are in a regular plan form and are of an asymmetrical composition. As a group they illustrate the development of the settlement in which they stand. They also reflect the traditional uses and functional character of the area.

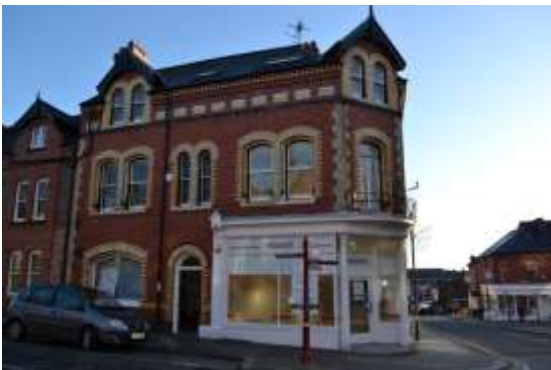
Address: 25 Market Street

Built: 1876-1897, **Condition:** Good

Description: This building reflects a substantial number of other elements in the Conservation Area in age, style, materials and form. 25 Market Street is built from red stock brick laid in a Flemish wall bond. The windows are elongated vertical sliding sash windows which have some stained glass within a timber casement. The roof of this building is hipped, cladded with blue slat and has other roof features such as finals, gablet, weather-cock and an external chimneys. The building has a regular plan form, is of symmetrical composition and is two storeys high with accommodation within the roof. The building illustrates the development of the settlement in which they stand. They also reflect the traditional uses and functional character of the area.

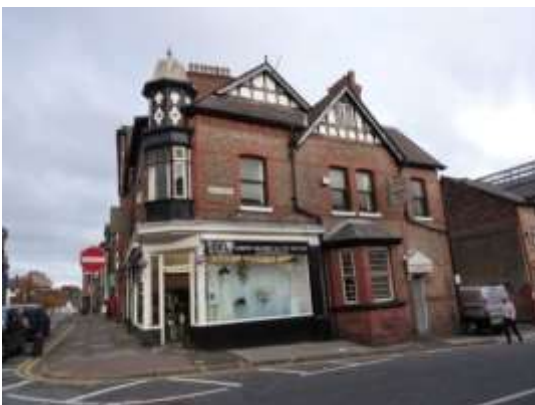
Address: 11 Market Street

Built: 1876-1897, **Condition:** Good

Description: This building reflects a substantial number of other elements in the Conservation Area in age, style, materials and form. Eleven Market Street is constructed from handmade Cheshire brick and is two storeys high with accommodation in the roof. The roof is pitched and cladded with blue slate, it has a series of gables with half-timbered detailing and external chimneys. The building has large shop frontage windows on the ground floor are squared, tall shaped vertical sliding sash windows on the first floor and roof, these windows feature stone sills and brick headers. Other features of the building include finials, dormers, a single story canted bay and a tower feature on floors one and two. It reflects the traditional uses and functional character of the area. It illustrates the development of the settlement in which it stands.

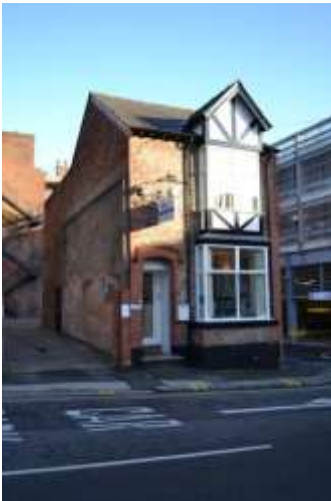
Address: 28 High Street

Built: 1876-1897, Condition: Good

Description: This building reflects a substantial number of other elements in the Conservation Area in age, style, materials and form. This building has been constructed from handmade Cheshire brick in a variation of different wall bonds. The original tall windows have been replaced by PVC. The roof of the building dual pitched and is cladded with blue slate. Other features of the building include two story canted bay which features half-timbered detailing, stone sills and headers, semi-circular doorway and a porch. This detached building (which was once part of terraced housing) has a regular building form and is 2 storeys in height. It reflects the traditional uses and functional character of the area. It illustrates the development of the settlement in which it stands.

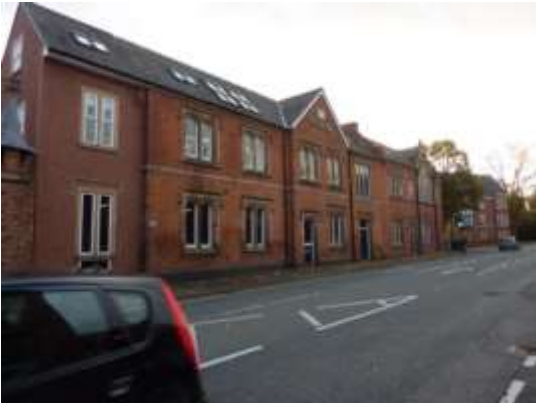
Address: The Warrant House, Dunham Road

Built: 1852-1876, **Condition:** Good

Description: This building reflects a substantial number of other elements in the Conservation Area in age, style, materials and form. Warrant is 2 story's high are built from red stock brick which is laid in a variation of brick bonds. The roof is pitched and cladded with blue slate tiles. The windows of this building are transomed in shape and have stone surrounds to them; in addition the windows are within a timber casement. The entrance doorway has revival details to it and features a fanlight which has glazing within it. Other architectural features include gables, a string course, stone detailing and small garden to the north-west elevation. This detached building has an irregular form and has a symmetrical composition. It reflects the traditional uses and functional character of the area. It illustrates the development of the settlement in which it stands.

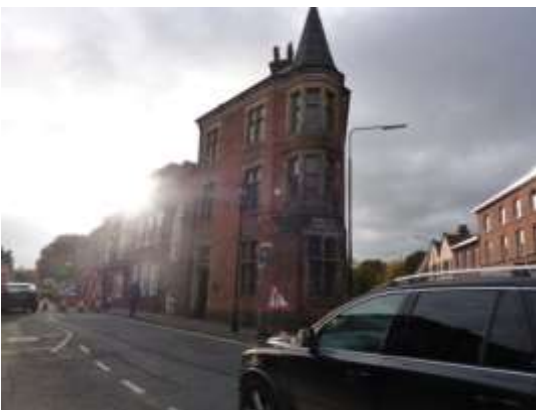
Address: 4-8 Market Street

Built: 1876-1897, **Condition:** Good

Description: This building reflects a substantial number of other elements in the Conservation Area in age, style, materials and form. Four Market Street is constructed from red stock brick in a Flemish wall bond; the building is three storeys high and has an irregular form and an asymmetrical composition. Other walling which remains present in the building is stone. The roof of the building is hipped and cladded with blue slate, the roof features chimneys, eaves brackets and a tower. The

windows are tall shaped, vertical sliding sash windows which have stone sills and stone headers. The doorway has a solid panelled door with a fanlight. It reflects the traditional uses and functional character of the area. It illustrates the development of the settlement in which it stands. It contributes positively to the setting of an adjacent designated heritage asset. This building has landmark quality.

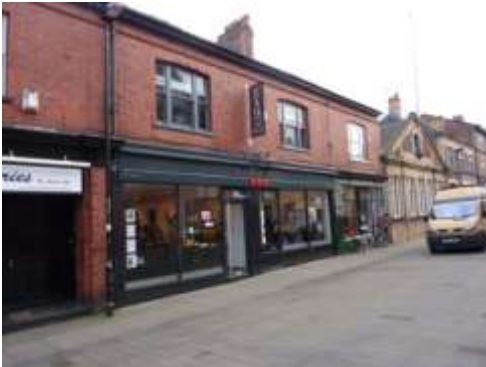
Address: 50-56 Greenwood Street

Built: 1876-1897, **Condition:** Good

Description: These buildings reflect a substantial number of other elements in the Conservation Area in age, style, materials and form. They also reflect the traditional uses and functional character of the area. These 2 story terraced buildings are built from red stock brick and laid in a Flemish bond. The roof is pitched, cladded with blue slate and features external brick chimneys. Properties 56-50 have tall shaped wooden vertical sliding sash windows, painted in either grey or white. These buildings also have large shop frontage windows. Properties 56 and 50 have a recessed porch with a solid wooded door with some glazing, whereas property 54 has a modern clear glazed door. Other architectural features include traditional shop signage at 50, stone sills and brick headers to windows. The terraces have a regular form and a symmetrical composition. As a group they illustrate the development of the settlement in which they stand. They also reflect the traditional uses and functional character of the area.

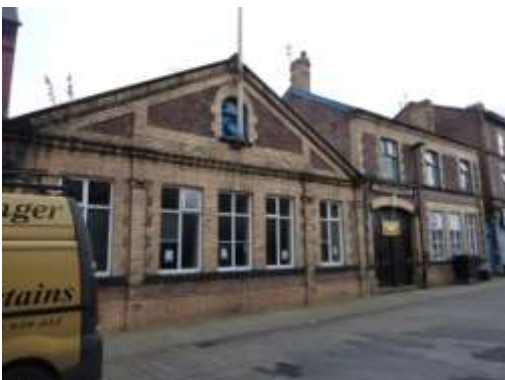
Address: Conservative Working Men’s Club, 48 Greenwood Street

Built: 1876-1897, **Condition:** Good

Description: This building reflects a substantial number of other elements in the Conservation Area in age, style, materials and form. It reflects the traditional uses of the area. The Working Men's Club is built from handmade Cheshire brick and cream brick which are laid in a header brick bond. The roofs are pitched and cladded with blue slate, the roof features external chimneys. The windows of the Working Man's Club are tall shaped, top hung windows within a timber casement. Other architectural features include a large wooded panelled door with a frosted glazed fanlight and an elevated flag pole. The building has a regular form and an asymmetrical composition. It illustrates the development of the settlement in which it stands. It contributes positively to the setting of an adjacent designated heritage asset.

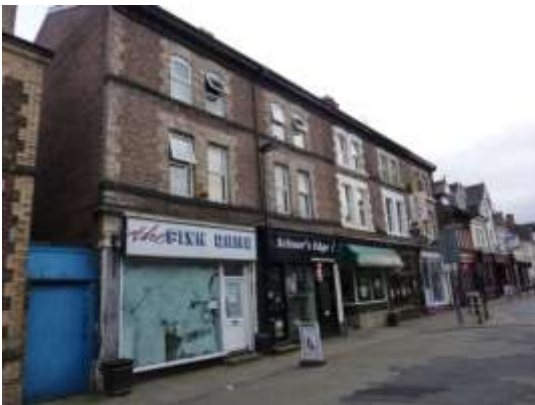
Address: 38-46 Greenwood Street

Built: 1876-1897, **Condition:** Some vacancy to the ground floor. Generally good condition.

Description: These buildings reflect a substantial number of other elements in the Conservation Area in age, style, materials and form. These 3 story terraced buildings are built from handmade Cheshire brick with cream brick dressing and are laid in a header brick bond. The roof is pitched, cladded with blue slate and features external brick chimneys. Properties 42-38 have tall shaped wooden vertical sliding sash windows, painted in white. Whereas 46 and 44 have been replaced with UPVC. In-addition these buildings also have large shop frontage windows which range in modern and traditional shop frontages. Other architectural features include stone sills and brick headers to windows, wooden panelled doors with some glazing and painted brickwork around the first and second floors at properties 40 and 42. The terraces have a regular form and a symmetrical composition. They also reflect the traditional uses and functional character of the area. As a group they illustrate the development of the settlement in which they stand.

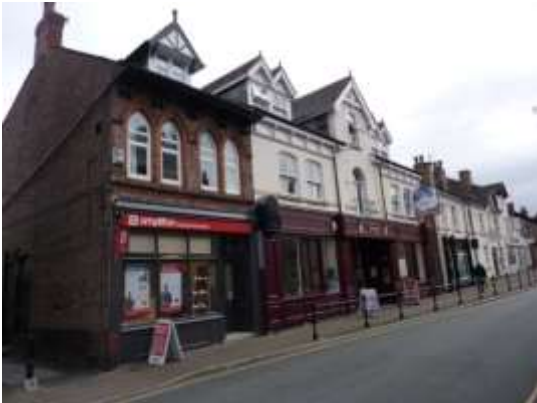
Address: 28-34 Greenwood Street

Built: 1876-1897, **Condition:** Good

These buildings reflect a substantial number of other elements in the Conservation Area in age, style, materials and form. These 2-3 story terraced buildings are built from handmade Cheshire brick at property number 34, and have a rendered façade at properties 28 to 32. The roof is pitched, clad with blue slate and features external brick chimneys, eaves brackets, dormers and finials. These buildings on Greenwood Street on the first floor have tall arched shaped vertical sliding sash windows, painted in white, whereas on the ground floor these buildings have a large traditional shop window. Other architectural features include part glazed, part timbered doors, traditional and modern styled shop fronts, stone sills and brick headers at properties 28-32, bricks sills and brick headers and sills at number 34 and a cream brick string course at properties 28-32. These terraces have an irregular form and an asymmetrical composition. As a group they illustrate the development of the settlement in which they stand. They also reflect the traditional uses and functional character of the area.

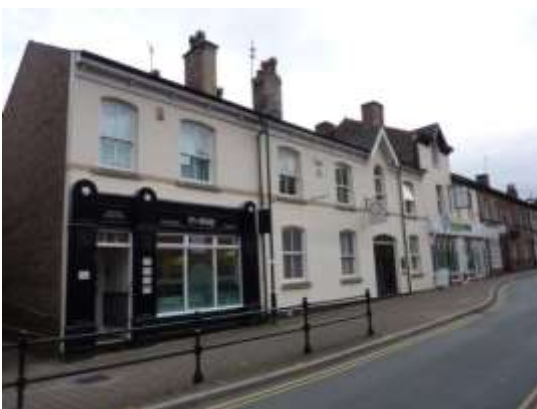
Address: 20-26 Greenwood Street

Built: 1876-1897, **Condition:** Good

Description: These buildings reflect a substantial number of other elements in the Conservation Area in age, style, materials and form. These terraced buildings vary between two to three storeys

in height and have a rendered facade. The roof is pitched, cladded with blue slate and features external brick chimneys. Properties 20-26 have tall arched shaped wooden vertical sliding sash windows, painted in white; additionally properties 20 and 26 have large shop front windows. Properties 22-26 have a solid wooded door with a fanlight which has glazing within it, whereas number 20 has a modern glazed door. Other architectural features include a gable, a cream brick string course at properties 22-26, traditional shop signage and front at 26. The terraces have an irregular form and an asymmetrical composition. As a group they illustrate the development of the settlement in which they stand.

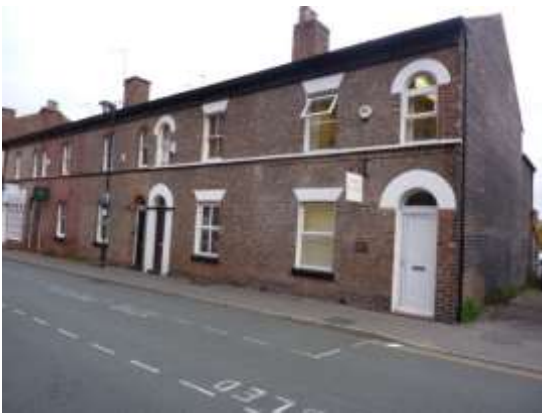
Address: 10-18 Greenwood Street

Built: 1876-1897, **Condition:** Good

Description: These buildings reflect a substantial number of other elements in the Conservation Area in age, style, materials and form. These 2 story terraced buildings are built from handmade Cheshire brick and laid in a header brick bond. The roof is pitched, cladded with blue slate and has an external chimney on properties. These properties on Greenwood Street have squared shaped vertical sliding sash windows on the ground and first floor level and some arched shaped windows also on the first floor. The doors to the properties are solid panelled doors with a semi-circular clear glazed fanlight. Other architectural features include traditional shop signage at number 8, stone sills and brick semi-circular headers; some of which are painted white. The terraces have a regular form and an asymmetrical composition. As a group they illustrate the development of the settlement in which they stand. They also reflect the traditional uses and functional character of the area.

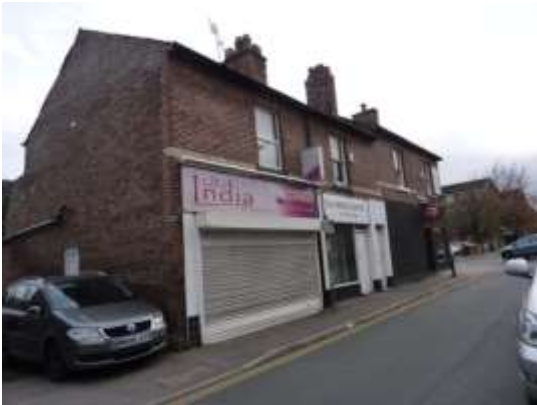
Address: 2-6 Greenwood Street

Built: 1852-1876 (Possibly pre 1836), **Condition:** Fair

Description: These buildings reflect a substantial number of other elements in the Conservation Area in age, style, materials and form. These 2 story terraced buildings are built in a patterned Flemish brick bond, the stretcher bricks consist of handmade Cheshire brick the header bricks consists of blue brick. The roof is pitched, cladded with blue slate and has an external chimney on properties. These properties on Greenwood Street have tall shaped vertical sliding sash windows on the first floor level, painted in white. The ground floor of these buildings has been converted to other usages, which has led to the original frontages being modernised. Other architectural features a cream bricked string course. The terraces have a regular form and an asymmetrical composition. As a group they illustrate the development of the settlement in which they stand.

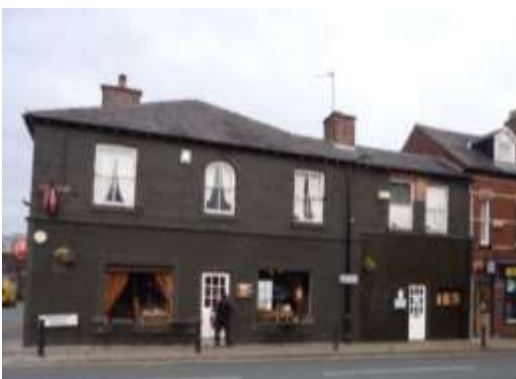
Address: 28-30 Regent Road

Built: 1852-1876, **Condition:** Good

Description: These buildings reflect a substantial number of other elements in the Conservation Area in age, style, materials and form. These terraced buildings have a rendered façade, the roof is hipped, and cladded with blue slate which has an external chimneys. These properties on Regent Street have squared tall and arched vertical sliding sash windows on the first floor whereas the ground floor has a wide shaped window. Other architectural features include part glazed, part timbered doors and stone sills and brick headers. As a group they illustrate the development of the

settlement in which they stand. They also reflect the traditional uses and functional character of the area.

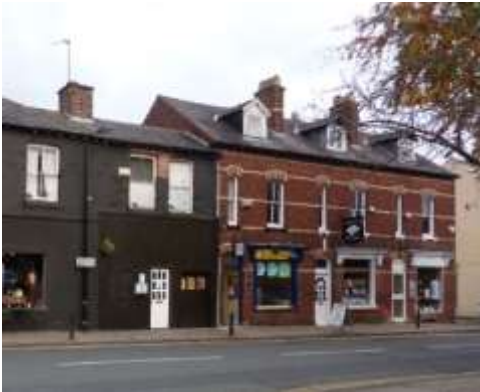
Address: 22-26 Regent Road

Built: 1876-1897, **Condition:** Good

Description: These buildings reflect a substantial number of other elements in the Conservation Area in age, style, materials and form. These 2 story terraced buildings are built from handmade Cheshire brick and cream brick, these bricks are laid in a Flemish brick bond. The roof is pitched, clad with blue slate and have features such as external chimneys and dormers. These buildings on regent road on the first floor have tall arched shaped vertical sliding sash windows, painted in white, whereas on the ground floor these buildings have a large traditional shop window. The doors for these buildings are part glazed, part timbered doors with a fanlight, which have stained glazing within them. Other architectural features include traditional styled shop fronts, stone sills and brick arched headers in red and cream brick. These terraces have an irregular form and an asymmetrical composition. As a group they illustrate the development of the settlement in which they stand. They also reflect the traditional uses and functional character of the area.

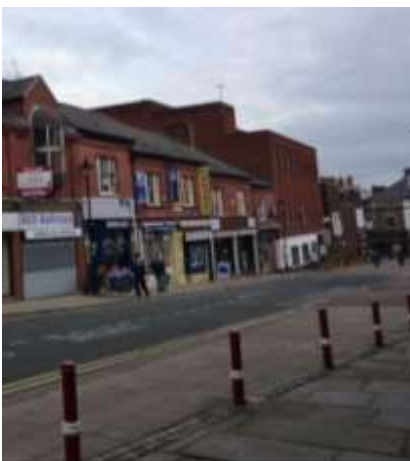
Address: 10-16 Shaw Road

Built: 1876-1897, **Condition:** Good

Description: These buildings reflect a substantial number of other elements in the Conservation Area in age, style, materials and form. These 2 story terraced buildings are built from red stock brick and laid in a Flemish brick bond. The roof is pitched, cladded with blue slate and has an external chimney. These properties on Shaw's Road have squared shaped timbered vertical sliding sash windows on the first floor level. The ground floor of these buildings has been converted to other usages, which has led to the original frontages being modernised and changed for security purposes. Other architectural features include modern glazed doors and stone sills and brick headers to the first floor windows, additionally the terraces have a regular form and a symmetrical composition. As a group they illustrate the development of the settlement in which they stand.

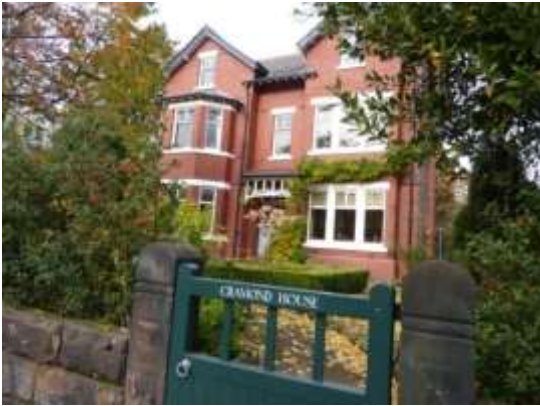
Address: Cramond House, 38 Regent Road

Built: 1876-1897, **Condition:** Good

Description: This building reflects a substantial number of other elements in the Conservation Area in age, style, materials and form. Cramond House is built from red stock brick in a Flemish wall bond. The windows are timber vertical sliding sash windows which feature stained glass within a timber casement. The roof of this building is pitched, cladded with blue slate, decorative ridge tiles and an external chimney. The building has an irregular plan form, is of asymmetrical composition and is two storeys with accommodation within the roof. It illustrates the development of the settlement in which it stands. It also reflects the traditional uses and functional character of the area.

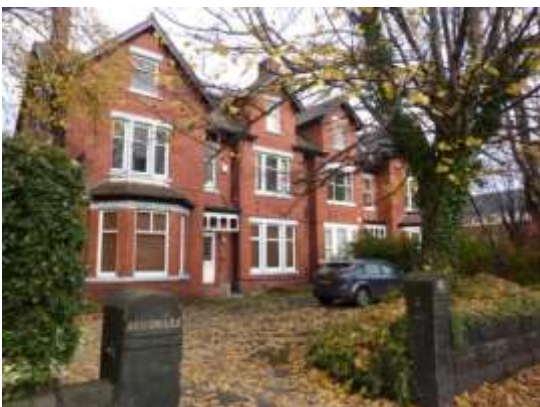
Address: 40-42 Regent Road

Built: 1876-1897, **Condition:** Good

Description: This building reflects a substantial number of other elements in the Conservation Area in age, style, materials and form. These former semi-detached buildings have a regular plan and a symmetrical composition. They are constructed from red stock brick in a Flemish wall bond. They feature a pitched roof which is cladded with blue slate, decorative ridge tiles and chimneys. The windows of the building are timber vertical sliding sash windows (only at Ardenlea). Other features

include a canted bay at floor one, 4 gables, a timbered door with glazing at Ardenlea, a three course boundary wall with gate piers, a spacious plot and is two storeys high with accommodation in the roof. It illustrates the development of the settlement in which it stands. It also reflects the traditional uses and functional character of the area.

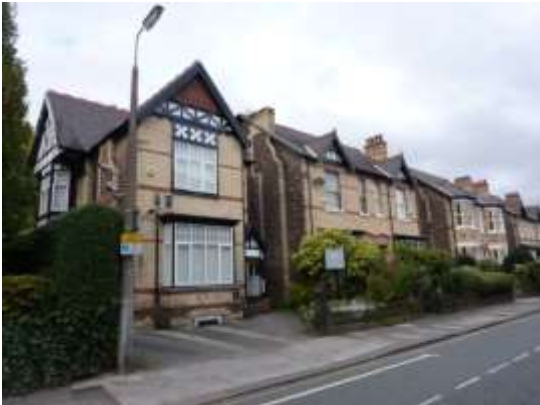
Address: 34-22 Market Street

Built: 1876-1897, **Condition:** Good

Description: These buildings reflect a substantial number of other elements in the Conservation Area in age, style, materials and form. These two story buildings are constructed from cream brick with a red brick dressing; these bricks are laid using a combination of English garden and a stretcher wall bound. The windows are elongated in a shape and are vertical sliding sash windows which feature stone sills and headers. The roof of the buildings is pitched with blue slate tiles; all properties have chimneys, finials and decorative ridge tiles. Other features of these properties include semi-circular doorways with fanlight and porch, 2 story canted bays, half-timber detailing, small front gardens and two course sandstone boundary with coping wall and gate piers, although some of these properties have had original boundary treatment removed. The buildings are in a regular plan form and are of a symmetrical composition. As a group they illustrate the development of the settlement in which they stand. They also reflect the traditional uses and functional character of the area.

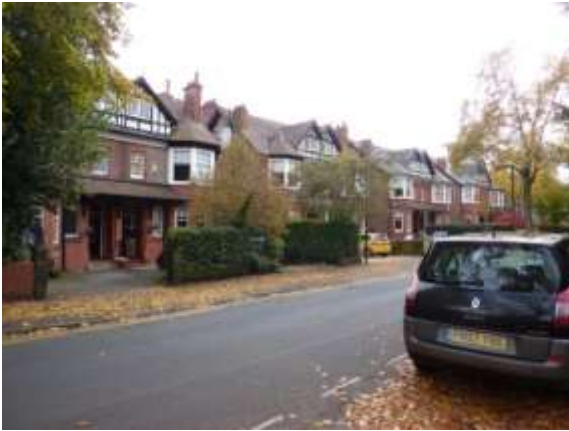
Address: 1-8 Groby Road

Built: 1897-1908, **Condition:** Good

These buildings reflect a substantial number of other elements in the Conservation Area in age, style, materials and form. These buildings are constructed from red slate and handmade Cheshire brick, laid in various wall bonds. The windows are timber vertical sliding sash windows with some stained glass. The roof the buildings have different styles, property numbers 1-4 have pitched roofs with rosemary clay tiles, whereas properties 5-6 have pitched roofs with clay tiles, all properties have chimneys and decorative ridge tiles. Other features of these properties include 2 storeys high with additional roof accommodation, original timbered doors with stained glass, 2 story canted bays, half-timber detailing, spacious plots and three course sandstone boundary wall and gate piers, although some have been removed at a few properties. The buildings are in a regular plan form and are of a symmetrical composition. As a group they illustrate the development of the settlement in which they stand. They also reflect the traditional uses and functional character of the area.

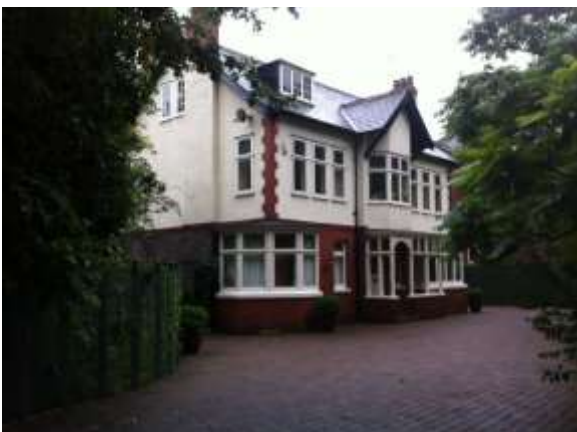
Address: Stoneleigh, Dunham Road

Built: 1897-1908, **Condition:** Good

Description: This building reflects a substantial number of other elements in the Conservation Area in age, style, materials and form. This building is constructed from handmade Cheshire brick, red stock brick and is rendered on the first floor. It features a pitched roof, clad with blue slate, decorative ridge tiles and external chimneys. The windows are in a timber casement, some of which have stained glass in them. Other features include a gable, a spacious plot and a two course sandstone boundary wall and gate piers. The building has a regular plan form. It illustrates the development of the settlement in which it stands. It also reflects the traditional uses and functional character of the area.

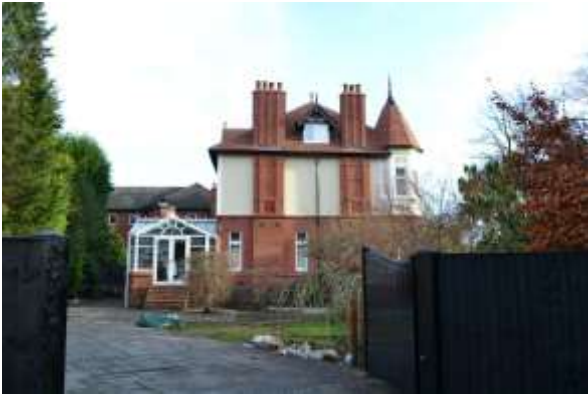
Address: Doonfoot House, Regent Road

Built: 1897-1908, **Condition:** Good

Description: This building reflects a substantial number of other elements in the Conservation Area in age, style, materials and form. This building is built from red stock brick and is rendered on the first floor. The windows are in a timber casing and feature stained glass. The building has a hipped roof and chimneys. Other features of this building include a spacious plot, a corner tower and a four course sandstone wall with stone gate piers and h hedge. The building has an irregular plan form, is of asymmetrical composition and is two storeys with accommodation within the roof. It illustrates the development of the settlement in which it stands. It also reflects the traditional uses and functional character of the area.
