Old Market Place Conservation Area – Supplementary Planning Document SPD5.3

TRAFFORD
COUNCIL

Conservation Area Appraisal – October 2014

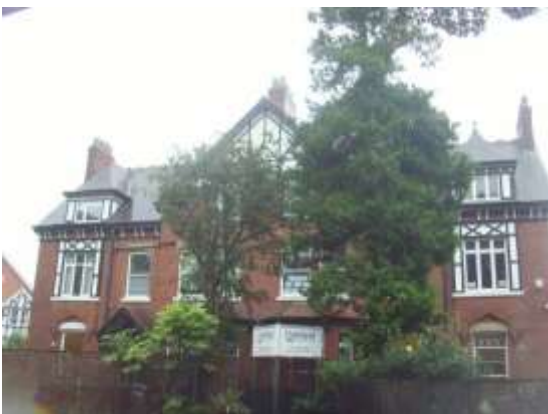
Address: Oakfield & Haslefield (Oakfield Nursery School), Dunham Road

Built: 1897-1908, **Condition:** Good

Description: This building reflects a substantial number of other elements in the Conservation Area in age, style, materials and form. These former semi-detached buildings have a regular plan and a symmetrical composition. The building is constructed from red stock brick in an English garden wall bond. The windows are either timber vertical sliding sash windows or windows in a timber casement with stained glass. It illustrates the development of the settlement in which it stands. It also reflects the traditional uses and functional character of the area.

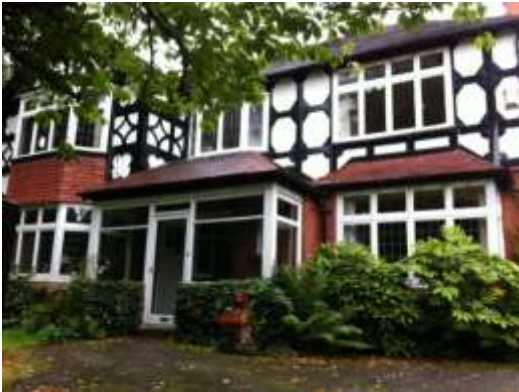
Address: Lindsey House, Groby Road

Built: 1908-1937, **Condition:** Good

Description: This building reflects a substantial number of other elements in the Conservation Area in age, style, materials and form. This building has been constructed from red stock brick with half-timbered detailing at first floor level; the bricks are in a stretched wall bond. The windows are in a timber casement with leaded lights. The roof of the building hipped and cladded with rosemary tiles and features external chimneys. Other features of the building include two story canted bay, a three course boundary wall made from sandstone and original gate piers. The building has an irregular plan form and is storeys high. It illustrates the development of the settlement in which it stands. It also reflects the traditional uses and functional character of the area.

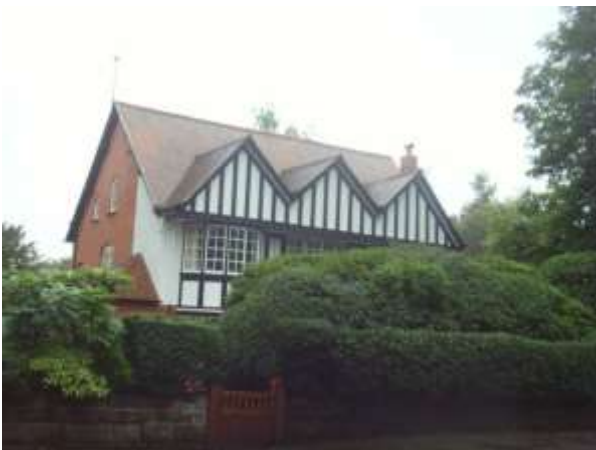
Address: The Knowles, Dunham Road

Built: 1897-1908, **Condition:** Good

Description: This building reflects a substantial number of other elements in the Conservation Area in age, style, materials and form. This building is built from red stock brick in an English garden wall bond and has a rough cast render at the first level. The roof is pitched and cladded with rosemary clay tiles, chimneys and features three gablettes. The windows are in a timber casement, some of which have stained glass in them. Other features of the building include half-timbered detailing and a spacious plot which has a three course boundary wall with hedging. The building has a regular

plan form and is two storeys high with roof accommodation. It illustrates the development of the settlement in which it stands. It also reflects the traditional uses and functional character of the area.

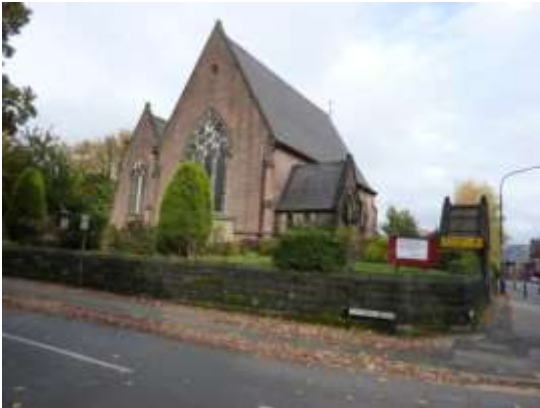
Address: The Unitarian Chapel, Sylvan Grove

Built: 1852-1876, **Condition:** Good

Description: This building reflects a substantial number of other elements in the Conservation Area in age and materials. The building has an irregular plan form with porch and a lych-gate. The building is constructed from handmade Cheshire brick laid in a header brick bond. The windows are pointed arched with leaded lights, surrounded by stone mullions. The building's roof is clad with blue slate and has decorative ridge tiles. Other features of the building include a four course red sandstone wall with coping and the building is elevated from the surrounding landscape. Note that this building shares the plot ninth the small school rooms. It illustrates the development of the settlement in which it stands. It also reflects the traditional uses and functional character of the area. This building has landmark quality.

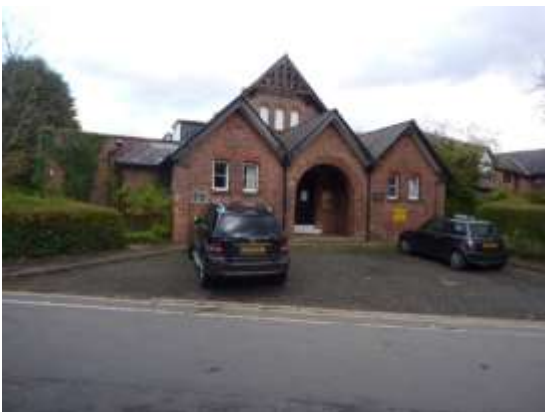
Address: Unitarian Former Sunday School & Church Hall, Sylvan Grove

Built: 1876- 1897, **Condition:** Fair

Description: These buildings reflect a substantial number of other elements in the Conservation Area in age, style, materials and form. This building is constructed from handmade Cheshire brick,

in a stretcher and English garden wall bond. It features windows in a timber casement with black and white detailing and a pitched roof cladded in blue slate. Other features include a prominent half-timber gable, 3 small gables to the south-west elevation, and a large arched entrance. This building has a simple plan form and has a symmetrical composition. They illustrate the development of the settlement in which they stand. They also reflect the traditional uses of the area.

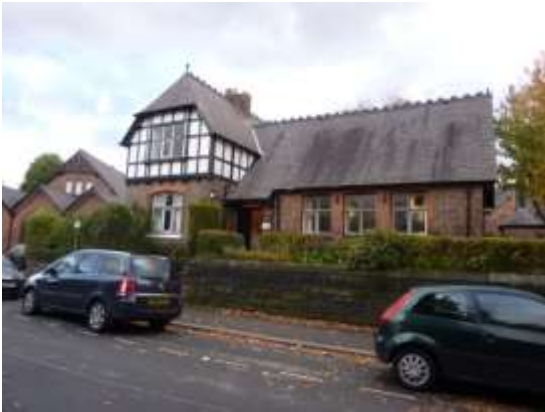
Address: Church Hall, Sylvan Grove

Built: 1876-1897, **Condition:** Good

Description: These buildings reflect a substantial number of other elements in the Conservation Area in age, style, materials and form. This building is constructed from handmade Cheshire brick in a header bond with red brick dressings. It features windows in a timber casement with black and white detailing, and a pitched roof cladded in blue slate, the roof also has decorative ridge tiles and a ball finial. Other features include a prominent half-timbered gable, a four course red sandstone wall with coping and the building is elevated from the surrounding landscape. This building has a regular plan form and has an asymmetrical composition. They illustrate the development of the settlement in which they stand. They also reflect the traditional uses of the area.

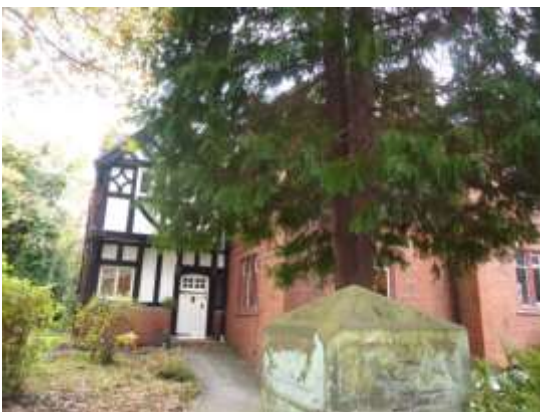
Address: The Parsonage, Sylvan Grove

Built: 1897-1908, **Condition:** Good

Description: This building reflects a substantial number of other elements in the Conservation Area in age, style, materials and form. The detached 2 story building has an irregular plan form and was built from red stock brick laid in an English garden wall bond. The building features a mixture of window shapes that are in a timber casement with leaded lights and timber casements with stain glass and terracotta surrounds. The roof is pitched with rosemary clay tiles and terracotta ridge tiles. Other features include a number of prominent gables with half-timbered detailing and flint detailing at floor one, a spacious and well landscaped garden and a four course boundary wall with stone gate piers. It illustrates the development of the settlement in which it stands. It also reflects the traditional uses and functional character of the area.

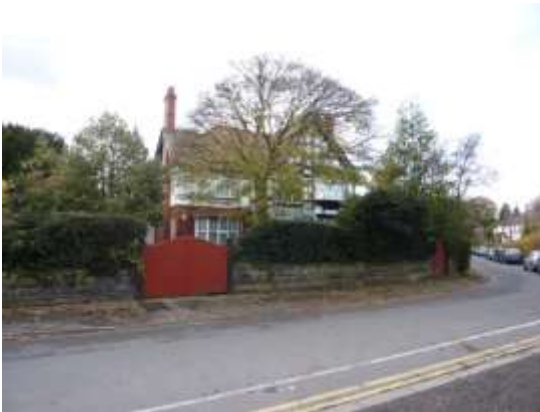
Address: Glen Mona, Sylvan Grove

Built: 1897-1908, **Condition:** Good

Description: This building reflects a substantial number of other elements in the Conservation Area in age, style, materials and form. This detached two-story property has an irregular plan form and an asymmetrical composition, half the property is rendered while the other is formed from red stock brick of a Flemish variation. The roof of the property is pitched and cladded with rosemary clay tiles and features an external chimney. Other features include UPVC windows, a half-timbered prominent gable, four coarse sandstone boundary walls with holly and a spacious garden which surrounds the property. It illustrates the development of the settlement in which it stands. It also reflects the traditional uses and functional character of the area.

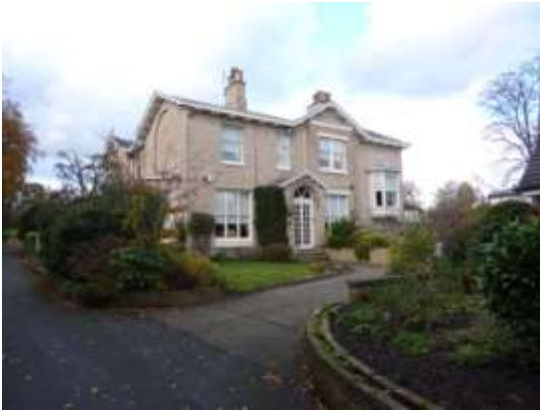
Address: 3-4 Groby Place

Built: 1835-1852, **Condition:** Good

Description: This building reflects a substantial number of other elements in the Conservation Area in age, style, materials and form. These 2 story semi-detached buildings have a regular plan form and a symmetrical composition. They are built from cream brick and are in a Flemish bond. The windows of this building are vertical sliding sash windows. The roof is pitched, cladded with blue slate and feature chimneys. Other features of this building include brick headers and stone sills, external covered porch at entrances with round arch details and a spacious plot. The building has no historic boundary treatment. It illustrates the development of the settlement in which it stands. It also reflects the traditional uses and functional character of the area.

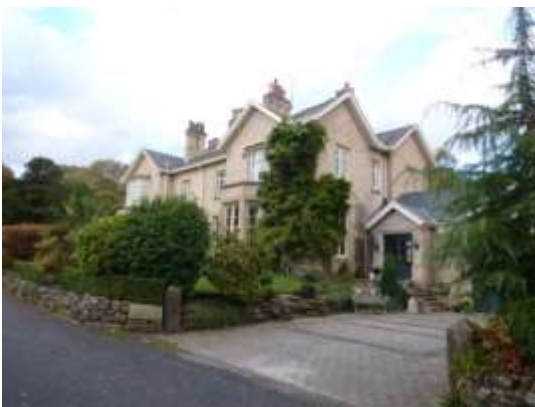
Address: 6a-7 Groby Place

Built: 1835-1852, **Condition:** Good

Description: These buildings reflect a substantial number of other elements in the Conservation Area in age, style, materials and form. This two story semi-detached building has a regular plan form and a symmetrical composition. They are built from cream brick and are in a Flemish bond. The windows of this building are vertical sliding sash windows with a timber casement. The roof is pitched, cladded with blue slate and feature chimneys. Other features of this building include stone headers and sills, a counted bay at ground floor level, external covered porch at entrances with

round arch details and a spacious plot. The building is slightly elevated and has a random low coped boundary wall. They illustrate the development of the settlement in which they stand. It also reflects the traditional uses and functional character of the area.

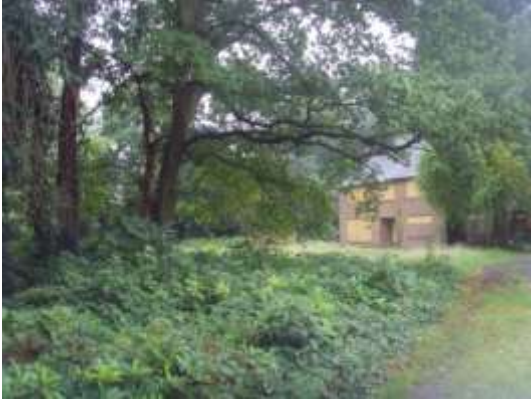
Address: 8 Groby Place

Built: 1908 - 1937, **Condition:** Fair

Spacious plot with landscape value which forms significant backdrop to Groby Place and the character zone. Property currently vacant.

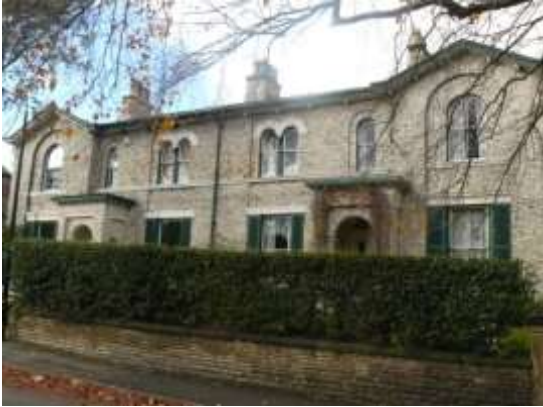
Address: 2-4 The Mount

Built: 1852-1876, **Condition:** Good

Description: These buildings reflect a substantial number of other elements in the Conservation Area in age, style, materials and form. This building has a symmetrical south elevation, a regular plan form, a pitched roof with blue cladded slate, chimneys and corbel detailing. The building has been constructed with cream bricks in a Flemish bond; the windows on the first floor are round arched windows and feature timber vertical sliding sash windows. Low stone bound treatment remains in part with stone coping and one solitary gate post, the south elevation of the building has a small front garden, whereas the north elevation features a large spacious garden. They illustrate the development of the settlement in which they stand. They also reflect the traditional uses and functional character of the area.

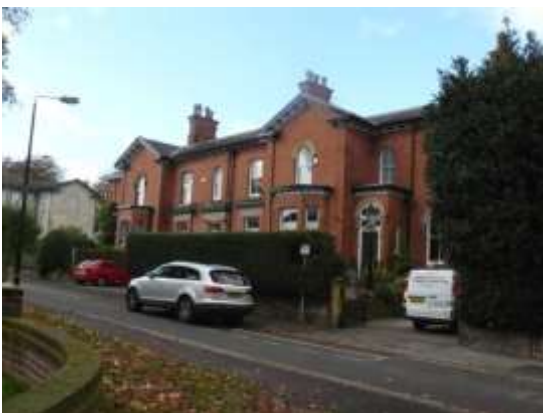
Address: 6-10 The Mount

Built: 1852-1876, **Condition:** Good

Description: These buildings reflect a substantial number of other elements in the Conservation Area in age, style, materials and form. This terrace building has a regular plan form and a symmetrical composition, it features a two advanced gables with canted bays at ground floor level.

The building is constructed from red stock brick, laid in a Flemish bond, the roof is pitched cladded with blue slate. The windows are timbered vertical sash windows, some of which are painted in black and white; in property numbers 6 and 10 stain glass is present above the windows. Other features include round headers with sills and other stone dressings and chimneys with corbel detailing. The property has small front gardens to its south elevation, the garden features historical boundary treatment with stone coping, boundary treatment has been lost at property number 8 and the stone gate piers have been relocated. They illustrate the development of the settlement in which they stand. They also reflect the traditional uses and functional character of the area.

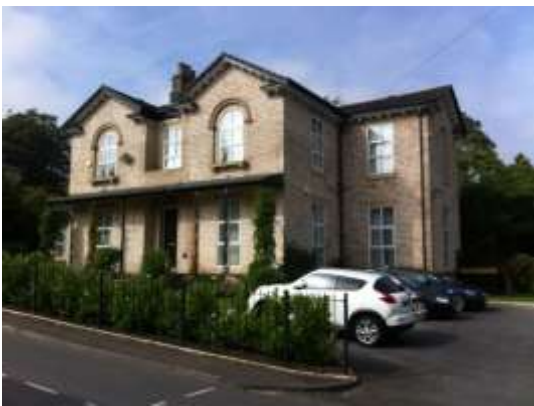
Address: 12 The Mount

Built: 1852-1876, **Condition:** Good

Description: These buildings reflect a substantial number of other elements in the Conservation Area in age, style, materials and form. This building has a symmetrical south elevation with two predominate gables and features a cast iron veranda. It's constructed from cream brick laded in a stretcher course, additional it has a pitched roof with a chimneys and concrete tiles. The building features a regular plan form, the existing windows have been replaced with PVC, and the traditional boundary treatment has been replaced with 20th century railings and hard landscaping. They illustrate the development of the settlement in which they stand. They also reflect the traditional uses and functional character of the area.

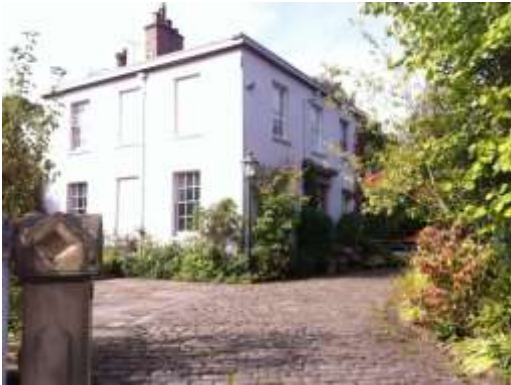
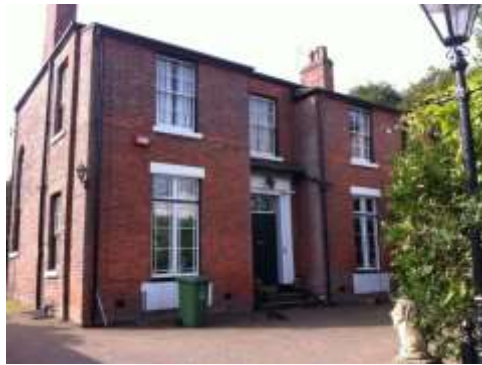
Address: 14 and 16 The Mount

Built: Pre 1835, **Condition:** Good

Description: These buildings reflect a substantial number of other elements in the Conservation Area in age, style, materials and form. Both these buildings have a simple plan form, spacious plots, original stone gate piers, 12 pane vertical sash windows, hipped roofs clad with slate, sills and headers and are classically symmetrical. Building number 16 has been built from handmade Cheshire brick in a Flemish bond, whereas property 14 has been rendered. They illustrate the development of the settlement in which they stand. They also reflect the traditional uses and functional character of the area.

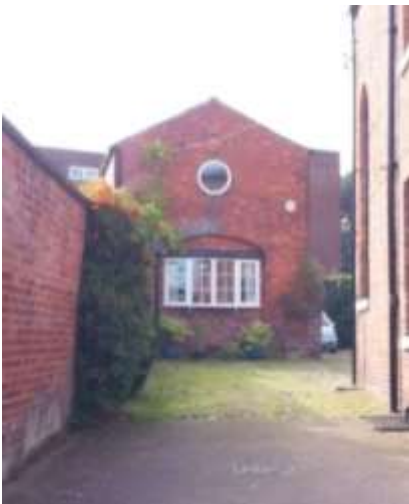
Address: 18 The Mount

Built: Pre 1835, **Condition:** Good

Description: These buildings reflect a substantial number of other elements in the Conservation Area in age, style, materials and form. This outbuilding is constructed from brick and is two storeys high; it has a simple form and has pitched roof clad with slate. The building features a pitching eye window at the first floor and cobblestones remain present outside the building. They illustrate the development of the settlement in which they stand. They also reflect the traditional uses and functional character of the area.

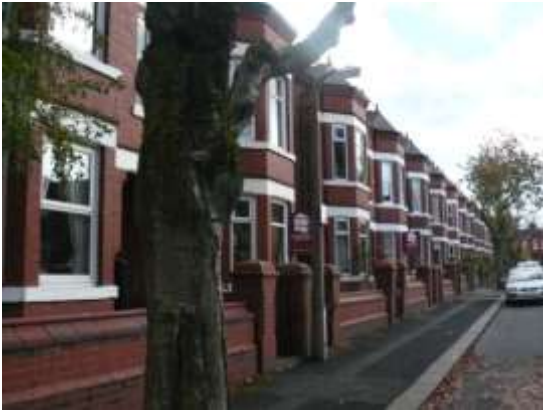
Address: 2-32 Richmond Road

Built: 1897–1908, **Condition:** Good

Description: These buildings reflect a substantial number of other elements in the Conservation Area in age, style, materials and form. This rhythm of properties are built from Cheshire common brick and is laid in an English garden brick bond, the west elevation of the semi-detached properties also have red stock brick. The roof is pitched, cladded in blue slate and features chimneys and decorative terracotta ridge styles. Some properties have tall vertical sliding sash windows, although some have replaced with UPVC. The windows have stone sills and headers. Many of the doorways to homes on Richmond Road have a recessed porch, which within has a part timbered, part glazed door with fanlight. Other architectural elements include 2 story canted bays with terracotta finals and white painted stone sills and lintels. The property has a small front garden, with higher levelled garden to the rear. The boundary wall is 10 courses high and features brick coping and existing brick gate piers. The buildings have an irregular plan form and a symmetrical composition. They illustrate the development of the settlement in which they stand. They also reflect the traditional uses and functional character of the area.

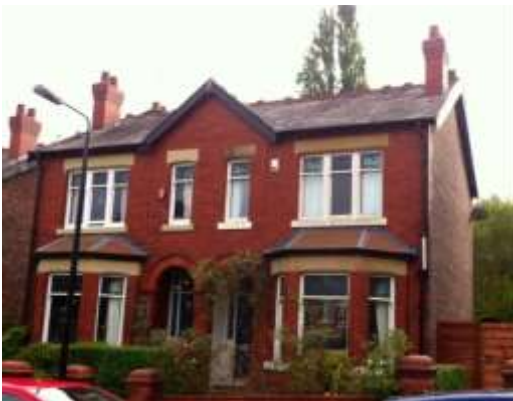
Address: 1-11 Townfield Road

Built: 1897-1910, **Condition:** Good

Description: These buildings reflect a substantial number of other elements in the Conservation Area in age, style, materials and form. These five pairs of semi-detached buildings on Townfield Road are built from red stock brick which are laid in an English garden wall bond. These 5 pairs of semi-detached buildings on Townfield Road are built from red stock brick which are laid in an English garden brick bond. The roof is pitched and clad with blue tiles and features external chimneys and decorative ridge tiles. The windows of these buildings are tall in shape and are timber vertical sliding sash windows which feature some stained glass. The doorway to the property is part glazed, part timbered and has a fanlight with stained glazing. Other architectural elements include a gablet, one story canted bay, a small garden to the front and a recessed porch. The boundary wall is 9 courses high and features brick coping and existing brick gate piers. The buildings have an irregular plan form and a symmetrical composition. They illustrate the development of the settlement in which they stand. They also reflect the traditional uses and functional character of the area.
