Conservation Area Appraisal – A UFW' &\$%\*

# Barton-upon-Irwell Conservation Area

## Conservation Area Appraisal

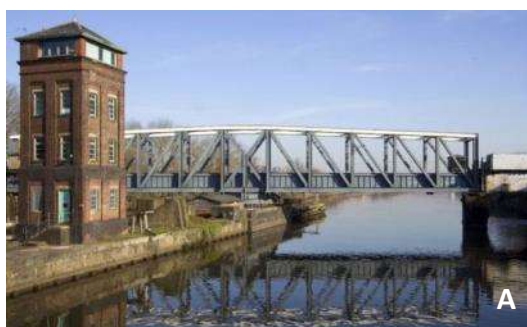
A Barton Aqueduct (Wikimedia Commons)

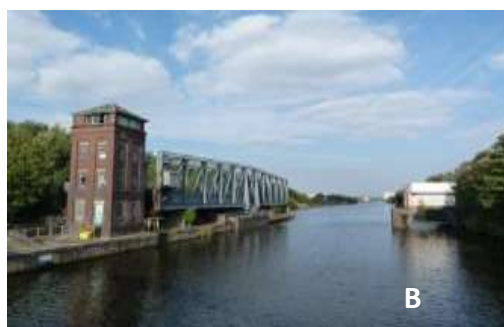
B Aqueduct in the open position

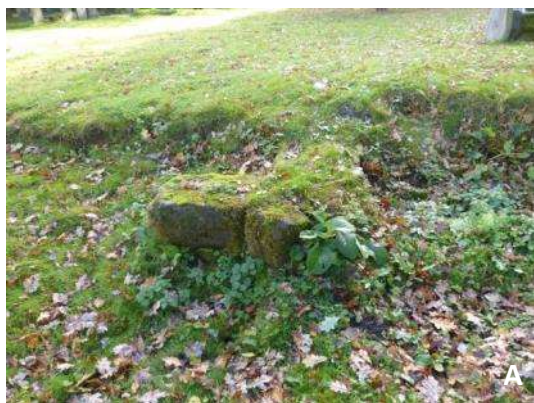
4.7.3 Remains that are easily visible include the foundations of St Catherine's Church within the centre of the graveyard. The footprint of the church is obvious and some stones are visible above ground.

A Remains of St Catherine's Church

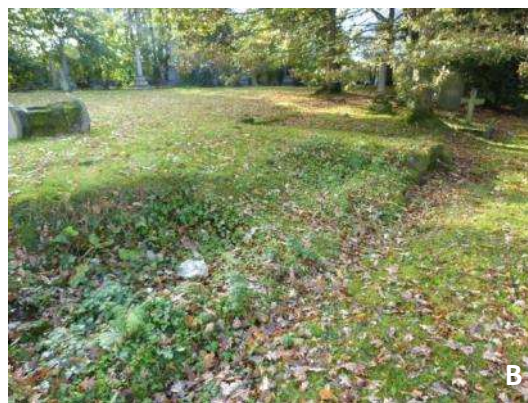
B Remains of St Catherine's Church

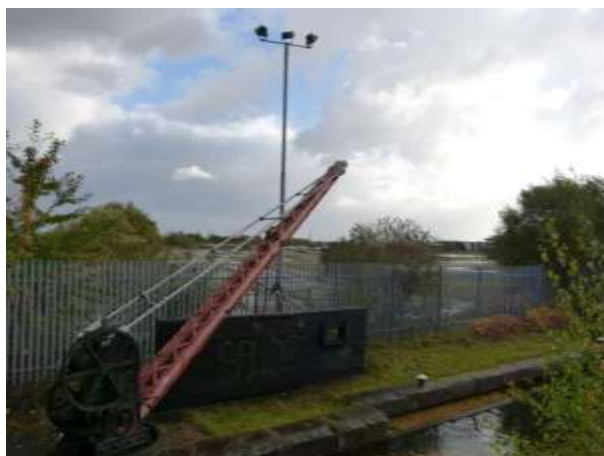
- 4.7.4 A former loading platform on the south bank of the Ship Canal is still evident and in good condition although all associated machinery and apparatus has been removed. A small crane sits on the eastern side of the Bridgewater Canal, to the immediate south of the aqueduct.

*Crane at south end of aqueduct*

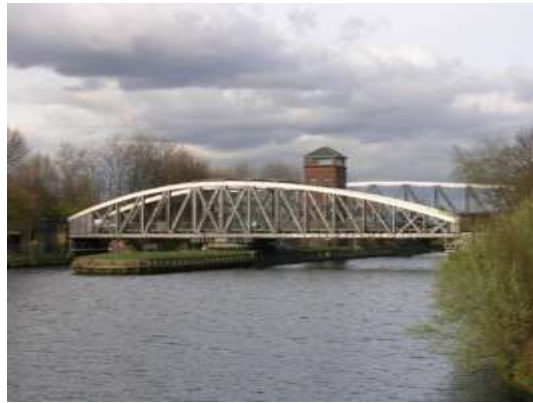
*Barton Road Bridge (Wikimedia Commons)*

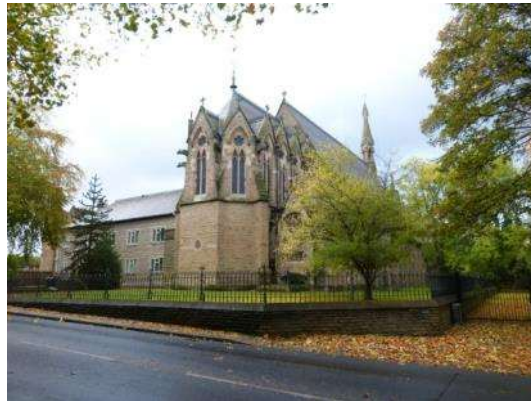
- 4.8.5 The church and presbytery stand out as the grandest buildings, exhibiting a high level of architectural detailing and craftsmanship, especially the church, and are notably complete and unspoiled. The later 20<sup>th</sup>-Century addition that links the two buildings is of no interest although has been designed to blend in and is not obtrusive.
- 4.8.6 The Church of All Saints, off Redclyffe Road, is a Roman Catholic Church (now Franciscan) constructed in 1867-8. Designed by Edward Welby Pugin in the Gothic Revival style, it is constructed of rock-faced stone with a slate roof and has an elaborate gabled chancel.

*All Saints Church*

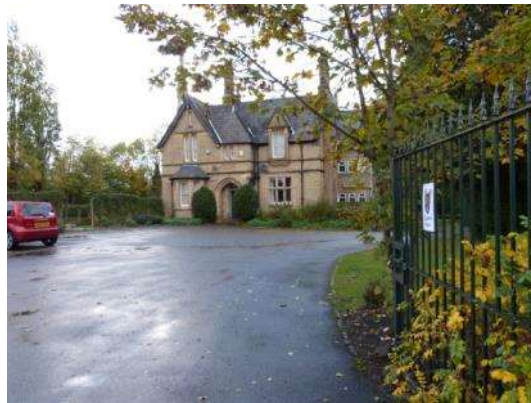
- 4.8.7 All Saints Presbytery was designed by Pugin at the same time as the church, is of similar construction and is also in the Gothic Revival style. It is now linked to the church by the 20<sup>th</sup>-Century addition. The building is a large residential house with an asymmetric principal façade that has a varied roofline of gables and dormers.

*All Saints Presbytery*

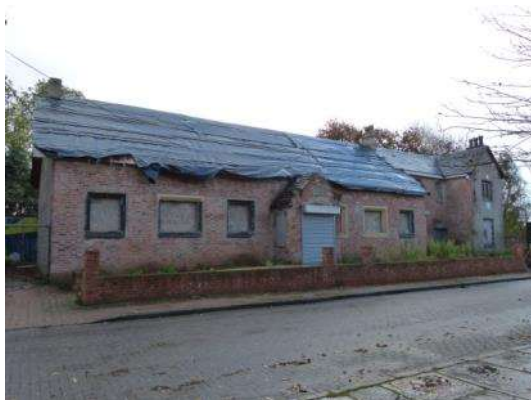
- 4.8.9 Abutting the south-west end of the School House is the Headmaster's House, which appears from the street as an L-shaped building. The gable end facing the street retains much of its render and has a large blocked up opening at ground floor level and window opening at first floor level. Recessed to the left of this gable is the front door and a window at ground floor level (both with metal roller shutters over) and two small windows at first floor level. A modern low brick wall (unfinished) sits at the boundary of the property and the pavement.

*Old School House*

- 6.2.11 The Old School House on Old Barton Road has been partially redeveloped, but is currently in poor condition and at risk. There are concerns about the quality of work and suitability for a historic building. Additionally, the work to finish the refurbishment is on hold. The external walls have previously been fully rendered but are now back to brick in most areas and the render is failing where still present. The slate roof has been fully stripped and membrane added, only a small area has been re-slatted. Windows have stone

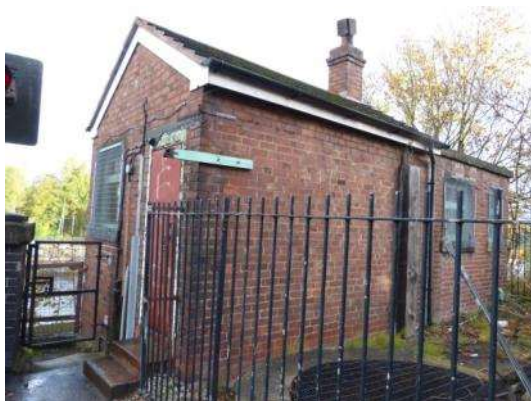
- 4.8.10 The remaining buildings on the south bank of the Ship Canal are of less significance, all demonstrating red brick and slate roofs with few embellishments. Firstly, a small, single storey ancillary brick building with pitched roof is situated at the south end of the road bridge, on the corner of Redclyffe Road and Chapel Place. On its west elevation, facing the road, is a doorway with window next to it. The north elevation faces onto the Manchester Ship Canal and has a similar window. A flat roof extension sits to the east and has two windows on its south elevation.

*Ancillary Building at south end of bridge*

- 6.2.6 There is a small single storey building at the south end of the road bridge, likely to be or have been associated with the management of the bridge. It is constructed of brickwork walls, with a tiled roof to the front half and a flat asphalt roof to the rear. Whilst it appears to be of generally sound condition, it could deteriorate. There is evidence of a former canopy to the entrance door, with redundant fixings either side, and remnants of a flashing above. Staining to the brickwork at the rear suggests the flat roof may have failed.

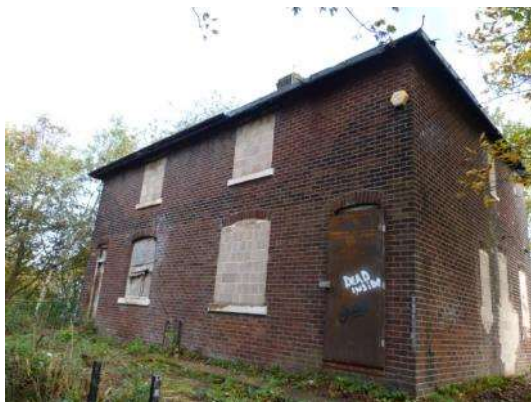
- 4.8.11 The empty pair of cottages is the only remaining building on Chapel Place. It is a brick building with hipped roof dating from between 1910 and 1930 which is now vacant and derelict. All of its openings have been blocked up, the chimney has collapsed, and roof slates and sections of guttering are missing. The west elevation is the principal elevation and has a doorway at each end flanking two bays with large window openings at ground and first floor level. The four bay, east elevation to the rear faces onto the Bridgewater Canal and has a partly demolished garden wall. The north and south elevations each have three bricked up window openings at ground floor level and one on the first floor.

*Vacant building on Chapel Place*

- 6.2.5 The cottages on Chapel Place are derelict and in very poor condition. The brickwork walls appear in reasonable condition externally. However, the roof slates are almost entirely missing and the timbers below in terrible condition. There are few gutters remaining and widespread vegetation growing from the tops of the walls. Most windows have been removed and openings infilled with blockwork. Those that remain are boarded over and have had all glazing removed. The single brickwork chimney is partially collapsed. There is also evidence of fire damage to the exposed structure.

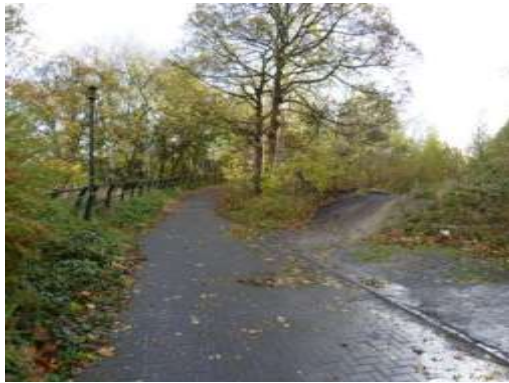
- 4.8.16 The public realm is extensive and there is a variety of hard landscaping in the Conservation Area. Herringbone block paving has been used to surface Old Barton Road and Chapel Place. Chapel Place was landscaped in the 1980s and the pathway, which follows the line of the former street and provides access to the Bridgewater Canal, has brick paving with seating and a metal gazebo. However, the area is adversely affected by fly tipping and vandalism.

*Chapel Place*

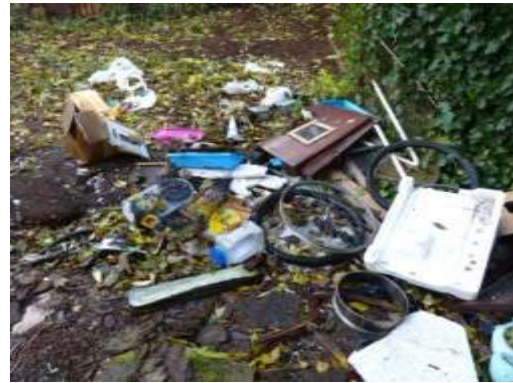
*Fly tipping off Chapel Place*

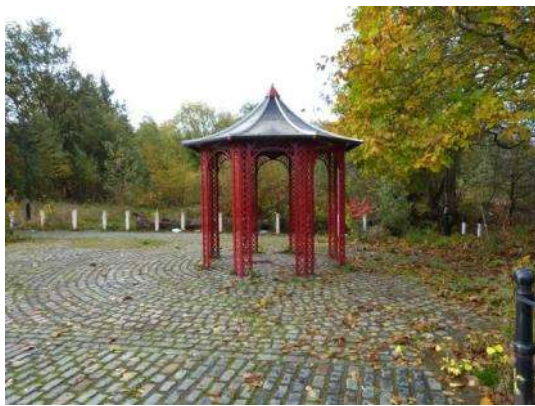
4.8.17 Metal railings line the path at Chapel Place and are contemporary with the metal gazebo and seating. This extended along the bank of the Manchester Ship Canal and railings, bollards, additional benches and public art sit on the north side of Old Barton Road.

*Metal gazebo*

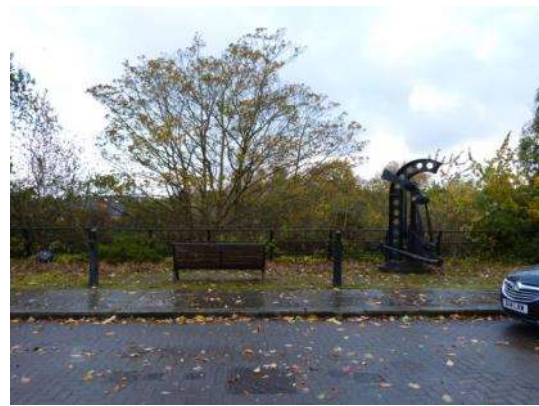
*Public realm at Old Barton Road*

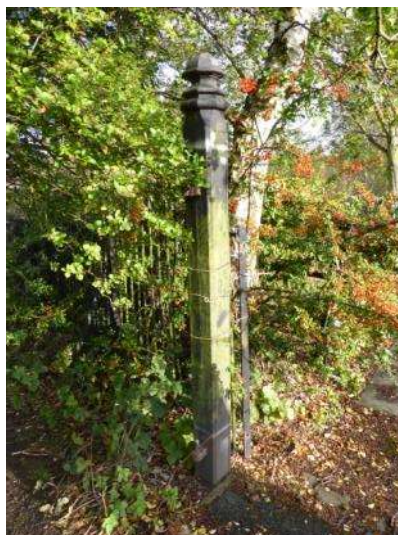
4.8.18 The remnants of older gate posts and fence posts can still be seen throughout the public realm areas although these are gradually deteriorating and returning to nature.

*Old gate post off Old Barton Road*

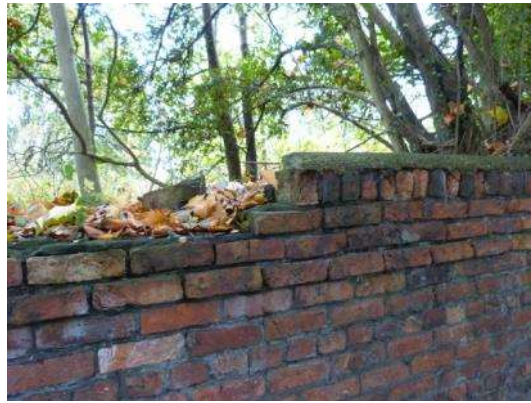
4.8.19 Red brick walls line the east side of Redclyffe Road and these are in relatively poor condition. Sections have failed; some repairs have been carried out and the wall has a cement cap along much of its length.

*Boundary wall*

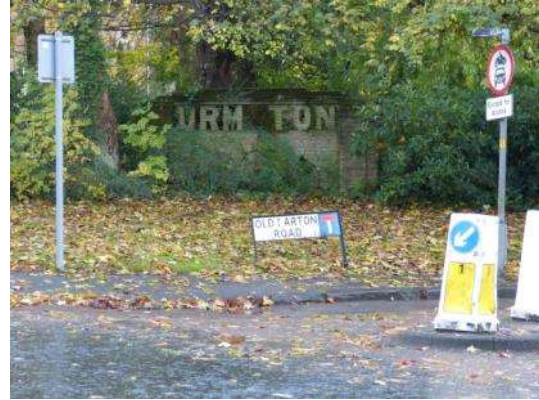
4.9.2 There is a small open space at the corner of Redclyffe Road and Old Barton Road with a brick Urmston sign (damaged and missing the letter S) and glimpsed views to the church though the trees. There is also green space surrounding the rear of the Old School House.

*Brick Urmston Sign*

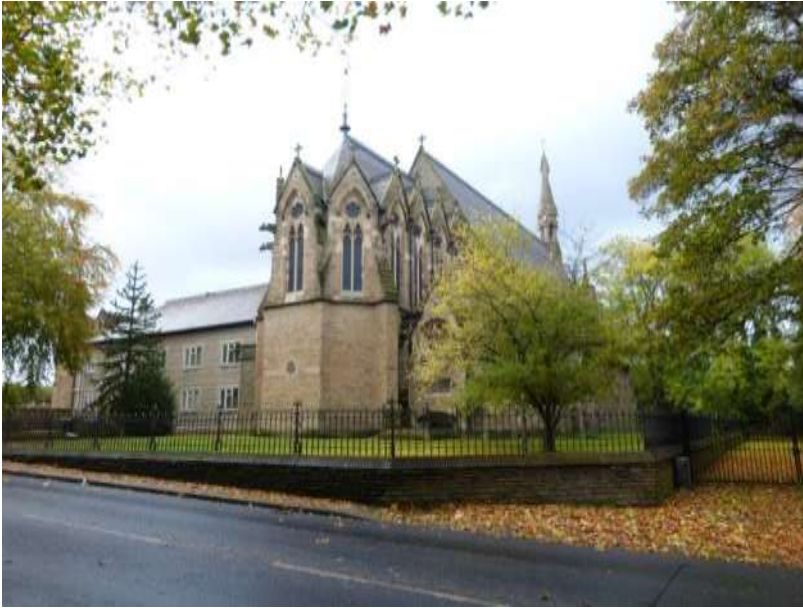
## All Saints Church

**Condition:** Good

The Church of All Saints, off Redclyffe Road, is a Roman Catholic Church (now Franciscan) constructed in 1867-8. Designed by Edward Welby Pugin in the Gothic Revival style, it is constructed of rock-faced stone with a steep pitched slate roof. It has an eight-bay nave and aisles with weathered plinth, weathered buttresses and a gabled porch. Each bay has a two-light plate tracery aisle window with hoodmolds and sill band and two-light Geometrical tracery clerestory windows with continuous hoodmold. The west rose window above the arcade of pointed lights and arched doorway are all flanked by bold weathered and gabled buttresses. The three by one bay side chapel has a steep hipped roof and similar gables above each bay which interrupt a parapet with pierced quatrefoils.

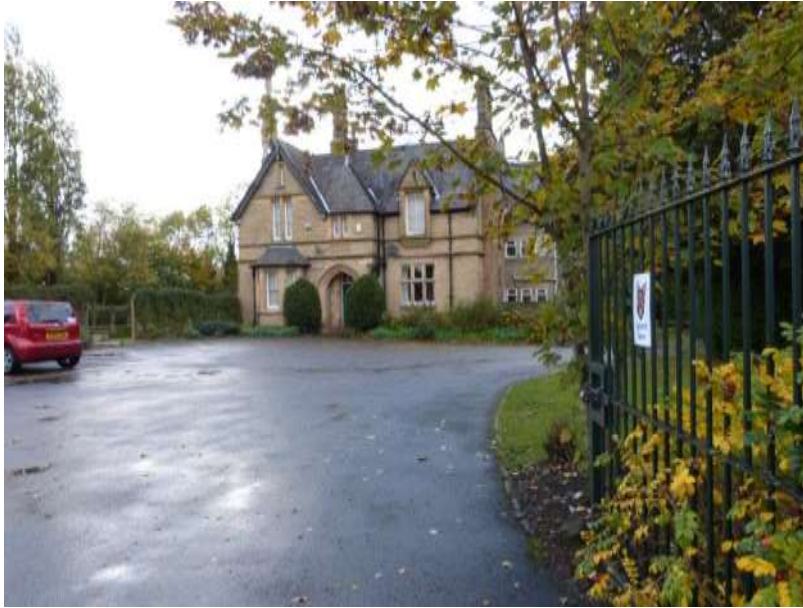
## All Saints Presbytery

**Condition:** Good

All Saints presbytery was designed by Pugin at the same time as the church, is of similar construction and is also in the Gothic Revival style. It is now linked to the church by a 20<sup>th</sup>-Century addition. The presbytery is two storeys; the south-east elevation is its principal elevation and faces onto a small car park. It extends across three bays with a gabled wing to left and recessed porch in the central bay. There is a continuous first floor band and sill band and an inscribed plaque above the porch. There is a canted bay window to left and three-light mullion and transom window to right. On the first floor there are two-light mullioned windows and a gabled oriel sash window in the right hand bay. There is a coped gable to right, prominent ridge chimney stacks and similar bay, oriel and mullion windows to the sides and rear.

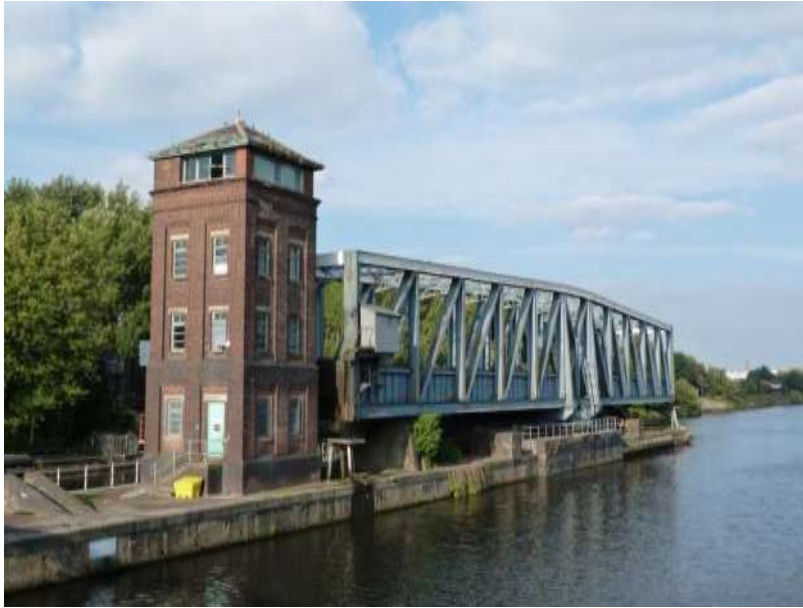
## Barton Bridge, Barton Aqueduct and Control Tower

**Condition:** Good

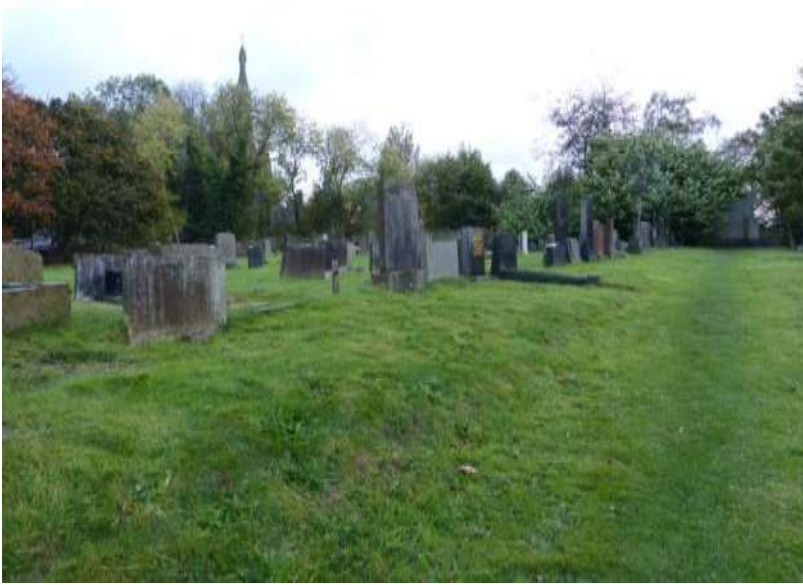
### Gravestones in St. Catharine's Graveyard

**Condition:** Fair

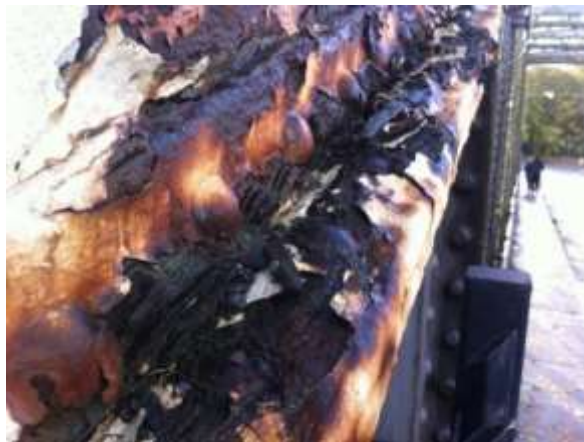
- 6.2.3 Both the road and canal bridges are in working order. However, areas of heavy corrosion were noted which appear to have been exposed to the elements for some time. Both structures should be subject to a comprehensive condition survey by a bridge engineer.

*Extensive corrosion to the road bridge ironwork*

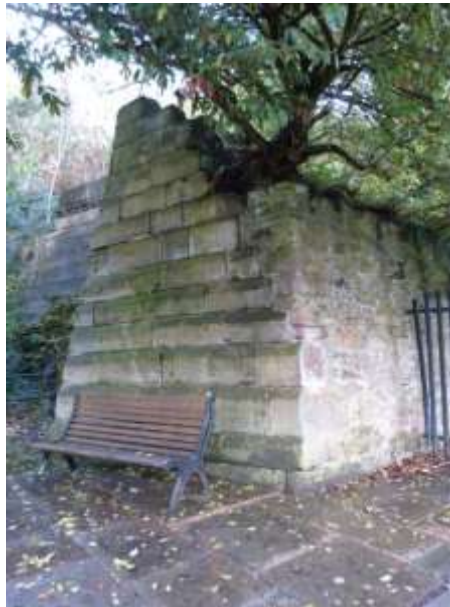
sandstone ashlar blocks, with rubble stone walling to the front section which is likely a section of core which has been made good following demolition. The masonry is in poor condition, with multiple self-seeded trees growing from the top and from joints to the elevations, which is further opening joints and jacking masonry. There are also areas of eroded pointing, cracked masonry, climbing plants and graffiti which are all adding to the decay of the structure.

*Self-seeded vegetation causing extensive damage to the former Brindley aqueduct on the north side of the canal*

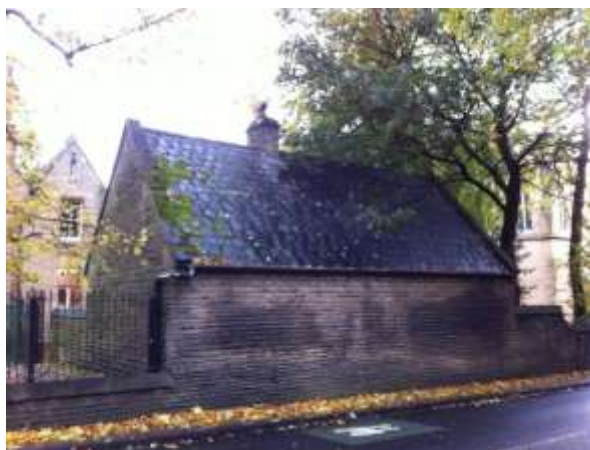
- 6.2.9 There is a small outbuilding to the presbytery, possibly a garage, of which only the rear elevations and gables could be seen; these elevations are of matching sandstone. The slate roof, with a central band of fishscale slates, and gable parapets have a heavy moss build up due to an overhanging tree. The moss should be removed and the tree pruned if feasible. The gutters are plastic and heavily blocked.

*Moss build up due to overhanging tree to Presbytery outbuilding*

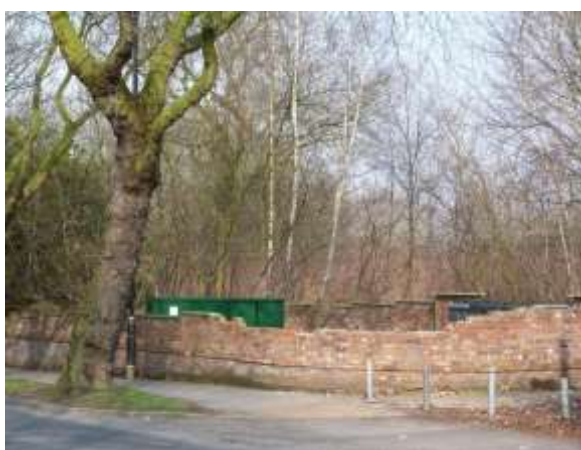
- 6.2.10 There is a substation located on the east side of Redclyffe Road has a damaged red brick wall surrounding the compound. This is an unattractive feature within the setting of the church.

*Substation and damaged wall on the east side of Redclyffe Road*

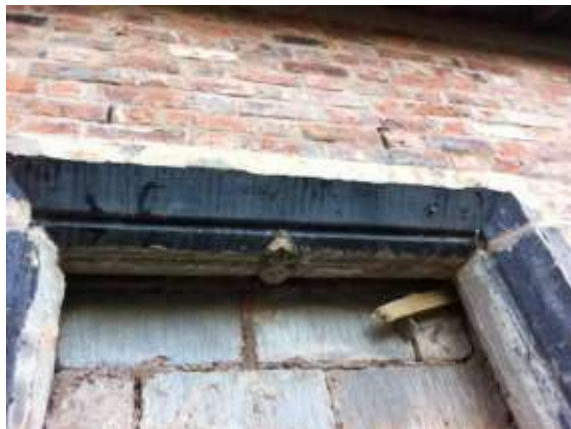
surrounds, generally painted, with evidence of original stone mullions which have been removed. Several have had new sections pieced in to the surrounds, but have used cast stone rather than natural sandstone. All window openings have been blocked up internally and no casements survive. The gable wall has been reconstructed in blockwork.

*Painted stone window surround, with evidence of former central mullion*

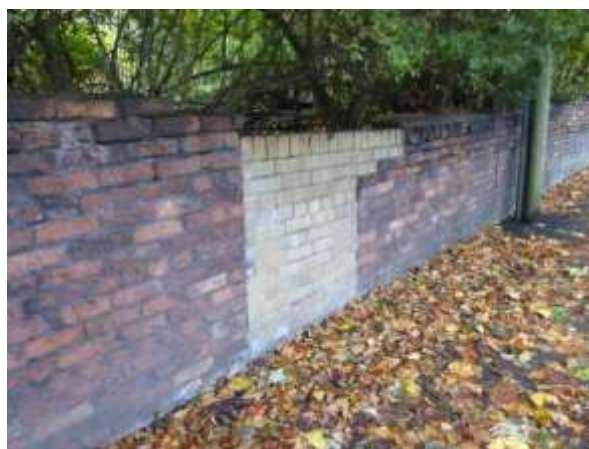
6.2.13 The brickwork boundary wall across Redclyffe Road from All Saints' Church is in a poor state of repair. There are multiple areas with spalling bricks, inappropriate re-pointing in hard cementitious mortar and modern cement haunching to the top. There are also several partially collapsed sections, as well as re-built areas in poorly matched brick and mortars.

*Boundary wall to Redclyffe Road showing unstable sections, eroded pointing and unsuitable repairs*
