Brogden Grove Conservation Area – Supplementary Planning Document SPD5.14

TRAFFORD
COUNCIL

Conservation Area Appraisal – October 2016

Conservation Area Appraisal

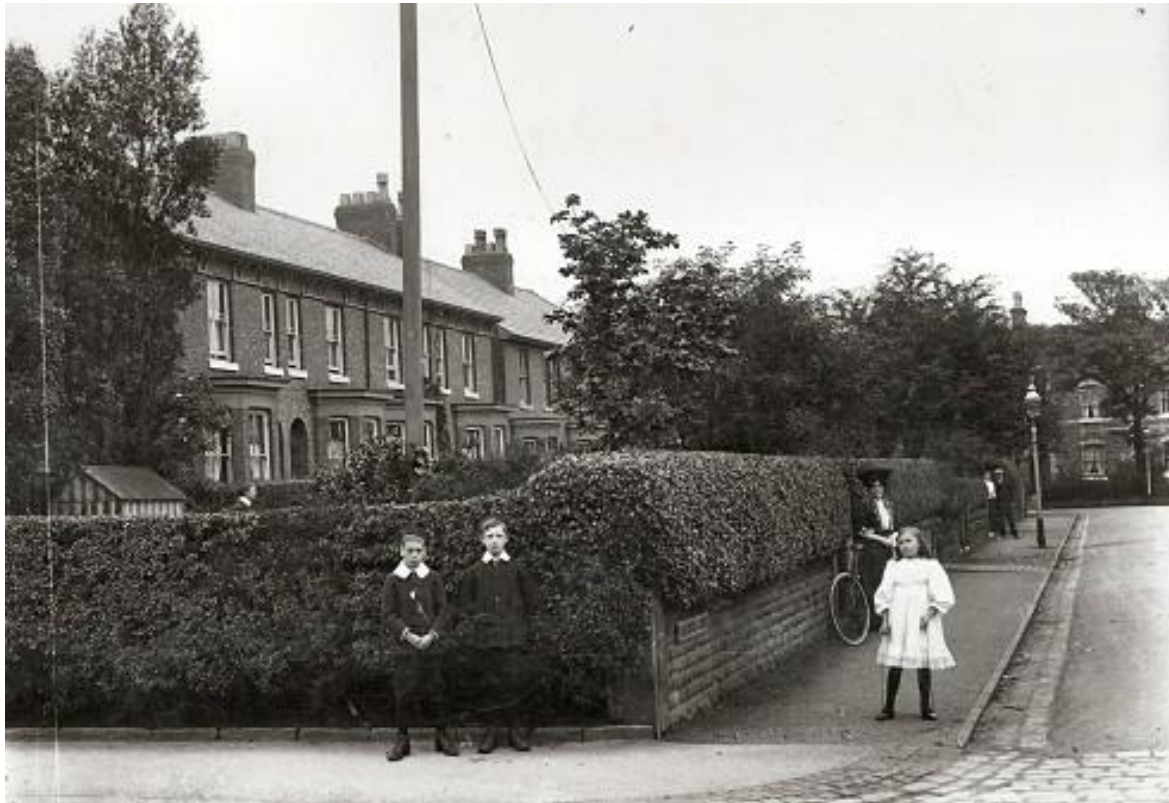
Brogden Grove, 1900 (TL0257, Trafford Lifetimes)

- 4.3.9 A photograph dated to around 1900 shows the street in its early days. The houses on the west side of Brogden Grove look fresh and new. Boundary treatments are a low stone wall, topped by clipped hedges. There are a number of small trees planted in front gardens, most of which have since been removed. The end of the road, where Brogden Grove meets Marsland Road, is marked by a strip of cobbles, which also line the gutters of the street. One short cast iron street lamp is visible.

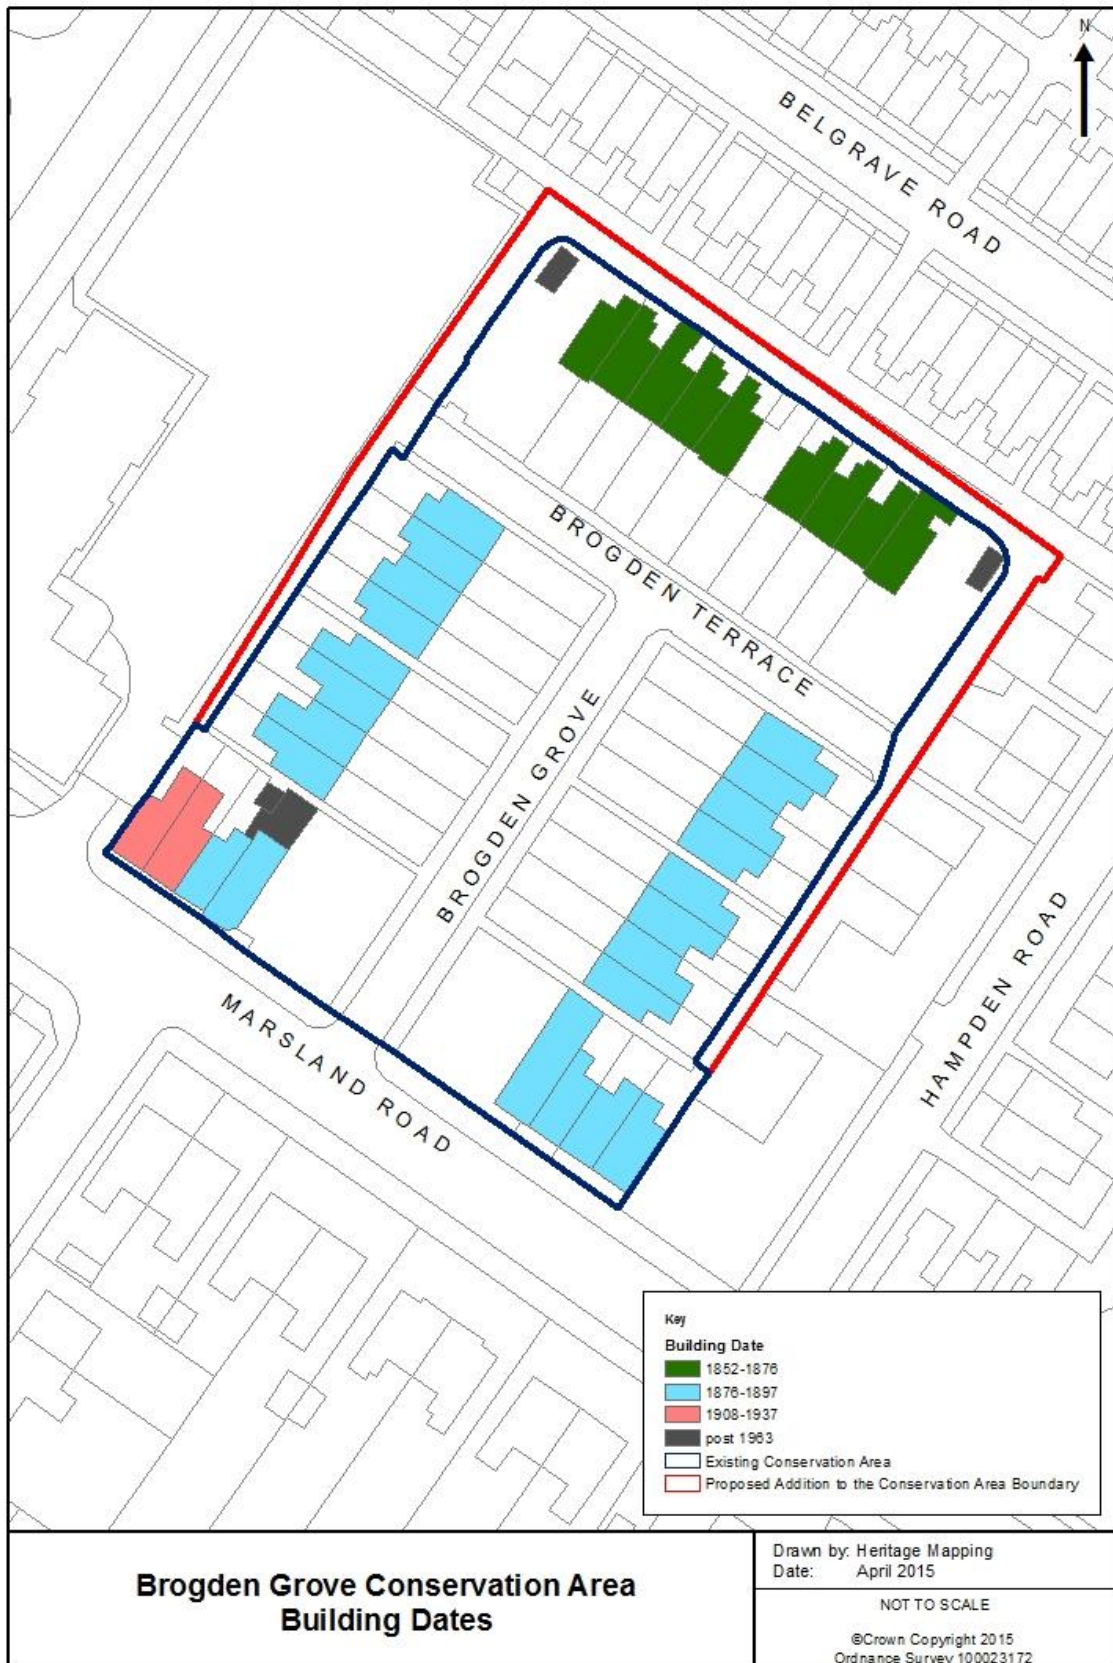
Map 6: Building Dates Plan

- 4.5.1 It is evident from cartographic evidence that Brogden Terrace was built some time in the mid- to late-19th century, and certainly by 1882 when it is depicted on the Ordnance Survey. Its coherent style clearly indicates that it was built in a single phase. The richer architectural detailing and design suggests that there was more money invested in the first phase of construction within the Conservation Area.
- 4.5.2 The plainer houses on Brogden Grove and in the south-east corner of the Conservation Area (fronting onto Marsland Road) were constructed in a second development stage at some point between 1882 and 1895. Cartographic evidence indicates that the houses on the south-west corner were built from right to left, with the eastern most two being complete by the 1908 Ordnance Survey and the western most two following shortly after.

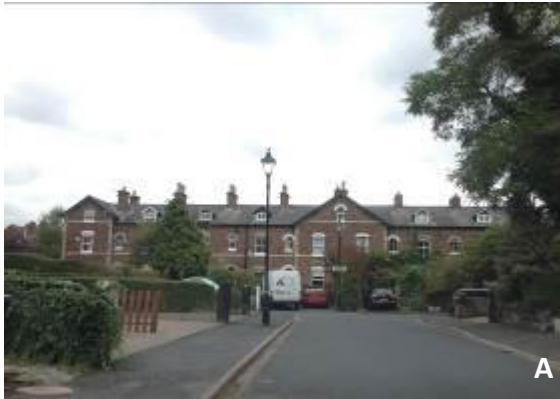
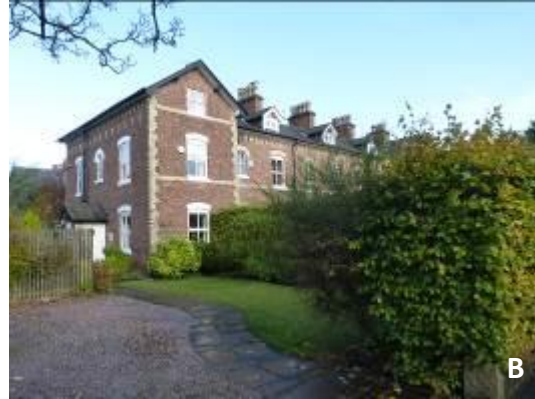
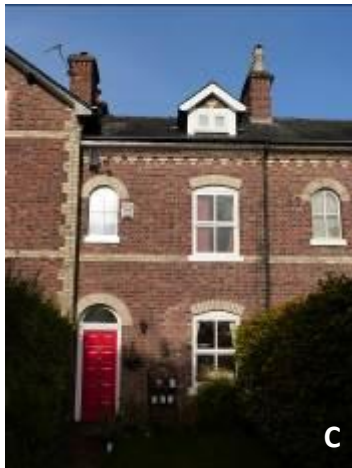
- 4.7.3 The main elevation of Brogden Terrace has echoes of the classical influences: a large central pavilion with two extending wings on either side culminating in two smaller end pavilions. This results in a well-balanced and coherent design which has been retained in its original form. The houses have two principal above-ground floors with an attic floor set under the pitched roof and lit by protruding dormer windows. The proportions and architectural detailing are of a simple classical style.

- A. *The principal elevation of Brogden Terrace, partially obscured from a distance by the mature trees.*
- B. *The north-west end pavilion house on Brogden Terrace.*
- C. *A typical two-bay, three storey terrace on Brogden Terrace.*

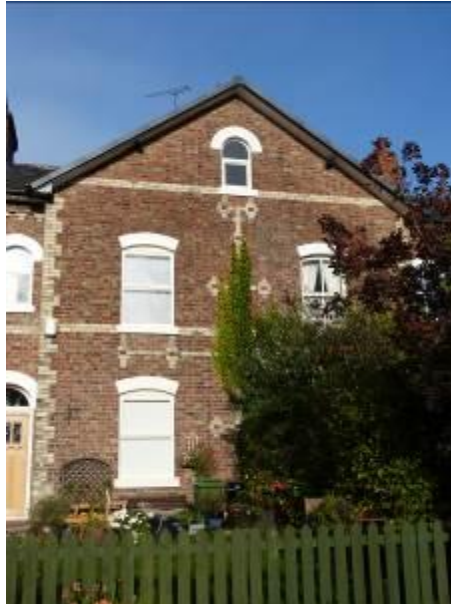
- 4.7.4 The fenestration is rhythmic and in keeping with the simple classical proportions of the whole terrace. The original windows have clearly been replaced in many of the houses in favour of UPVC double-glazing. With the exception of No. 14 Brogden Terrace, the new windows generally respect the appropriate two-over-two Victorian sash window style. However, the replacement UPVC windows are particularly 'blocky' with thick glazing bars and frames distorting the proportions of the windows. There is also some irregularity in the style of the smaller round-arched windows above the doors and also the dormer windows.

The central pavilion, with mismatched window styles

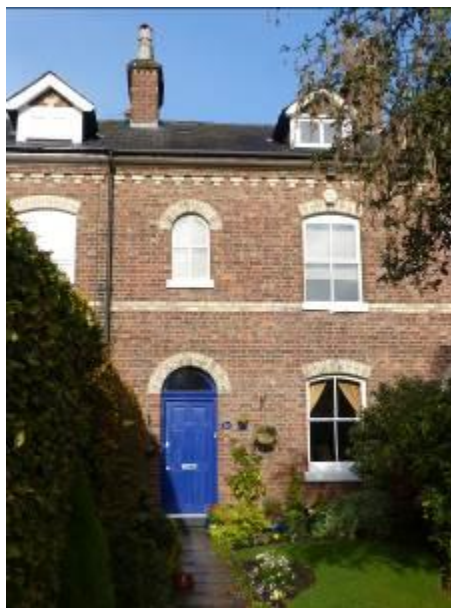
- 4.7.5 The ground floor window of No. 12 and windows on No. 15 are noteworthy features as they retain the shallow arch at the top of the window (rather than having a straight top edge and infill between the window and the shallow arched lintel). These are likely to be either original windows or very early replacements that respect the original curved top edge.

No. 12 Brogden Terrace, with an early or original window on the ground floor

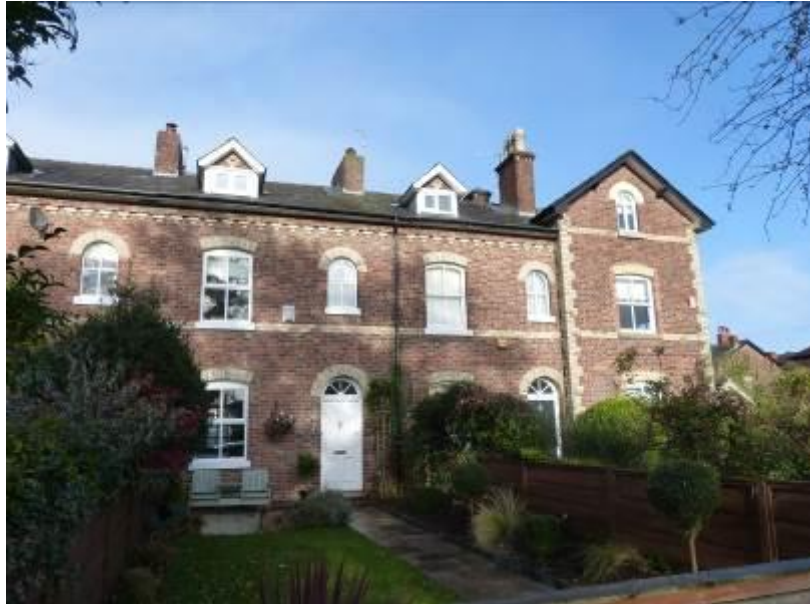
- 4.7.6 The principal brickwork is laid using red bricks in a Flemish bond with contrasting stock brick detailing: door and window lintels, stringcourse, eaves cornice, quoins and simple pattern detailing on the central pavilion and dormer gable ends. This results in richer architectural detailing than is the norm in later 19th-century terraces. The rhythmic chimney stacks are also of red brick and have a variety of chimney pots, including tall crown-topped pots and shorter simple terracotta pots. Such variety is to be expected: chimney pots are susceptible to weather damage, even more so historically.

The south-east end of Brogden Terrace, showing the dormer gables, mismatched chimney pots, varying window styles and contrasting yellow brick detailing

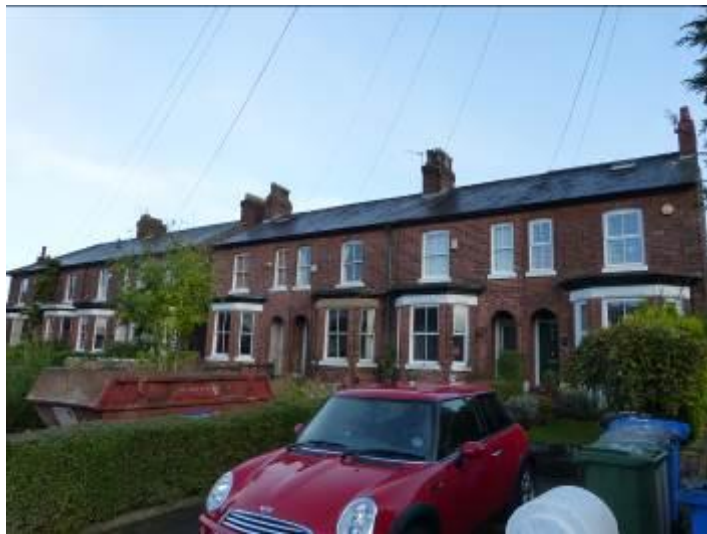
- 4.7.8 The terraces on Brogden Grove are of a simpler late 19th-century classical style and are two storeys in height over a basement (the windows of which are just visible at the base of the principal elevations). The houses are paired on each terrace with every two front doors situated next to each other under recessed round-arched porches. Each house is two bays wide with a protruding bay window at ground floor level. The brickwork is less ornate than on Brogden Terrace but still uses a Flemish bond with simple brick lintels over the doors and windows. Nos. 2 to 5 and 24 to 27 are set under a pitched roof with gable ends, whereas Nos. 6 to 9 and 20 to 23 have an exposed gable at their south-western ends and a hipped roof at their north-eastern ends.

The south-east side of Brogden Grove

- 6.2.4 The south-east side of Brogden Grove is lined with two terraces. The brickwork is in generally good condition, though some areas have been re-pointed with a hard mortar applied over the arrises of the brickwork. The gable wall to No.20 has a large number of cables passing through the brickwork, with mastic sealant applied to seal openings. There are original two storey outriggers to the rear of the terraces. However, some have had single storey additions. Several properties have enlarged existing openings to the rear elevation and fitted French doors, typically UPVC, which are not in keeping. There is vegetation to the elevation between Nos. 26 and 27 which looks to be blocking the hopper to the shared downpipe.

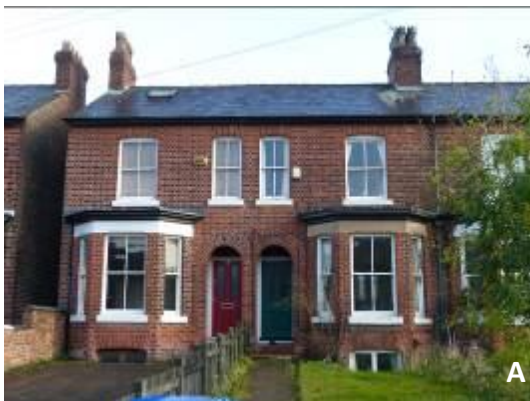
A

- A. An example of a pair of houses which have retained their timber-framed glazing
B. Nos. 5 to 8, each displaying a different style of window on first floor level

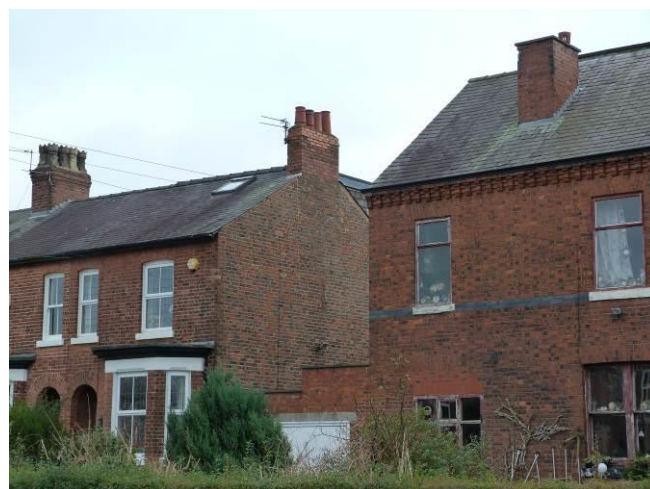
- 4.7.11 At the south-west end of the Conservation Area are two further terraces of four houses facing onto Marsland Road. Nos. 248 to 252 (even) are similar in design to Brogden Grove, but are a little larger (the rear roofline sitting higher than the adjacent end terrace). This slightly awkward meeting of the two terraces indicates their separate construction phase. The terrace exhibits the same protruding ground floor bay windows but differ in style to those on Brogden Grove by having pitched roofs.

The rear and side of 252 Marsland Road viewed from Brogden Grove, showing the difference in height

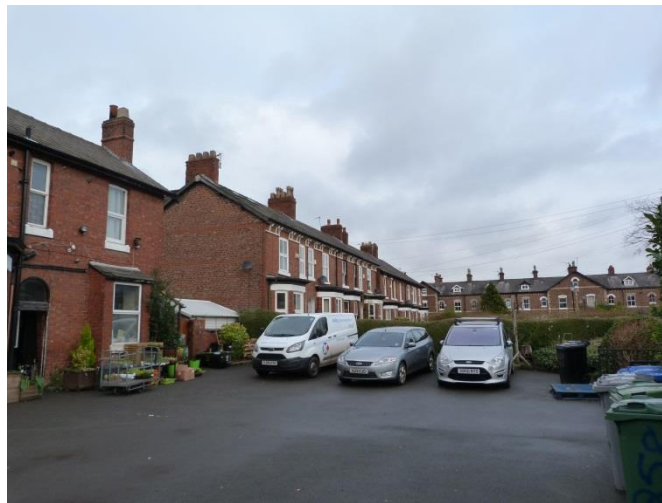
- 4.7.12 A departure from the use of yellow stock bricks for detailing in favour of grey bricks and flat arch recessed porches further indicates that this terrace was constructed under a different development phase. The roof of this terrace is especially interesting: hipped at the Brogden Grove end with an exposed gable at the other and an irregular rear elevation which is clearly visible from Brogden Grove, indicating further that the terraces at the south-east corner of the Conservation Area were not designed in tandem.
- 4.7.13 The terrace at the south-west corner of the Conservation Area similarly does not quite align with the end of the Brogden Grove terrace. It has an unusual pitched/hipped roof. The architectural style is more akin to the Brogden Grove terraces, the front doors being set under round-arched recessed porches. There is otherwise minimal architectural detailing.

The florist forecourt, from which the unusual roofline of the south-east end of the terrace can be seen.

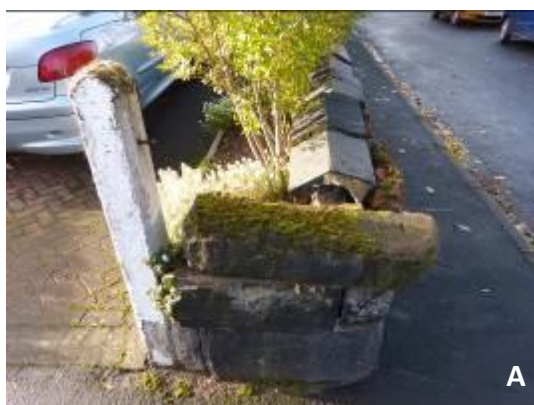
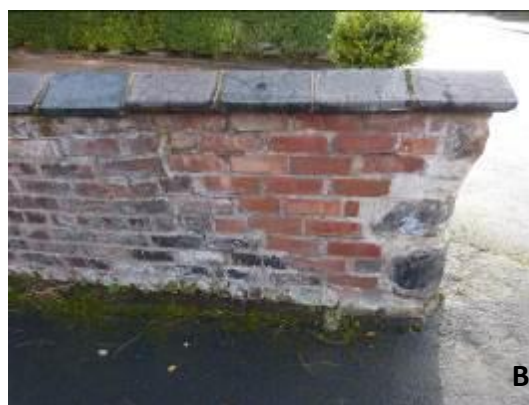
- A. A section of boundary wall which requires repositioning and pointing.
- B. Another section of boundary wall which has retained some of its original masonry blocks to the left but has been partially rebuilt with stretcher bond red brick and tiled capping.

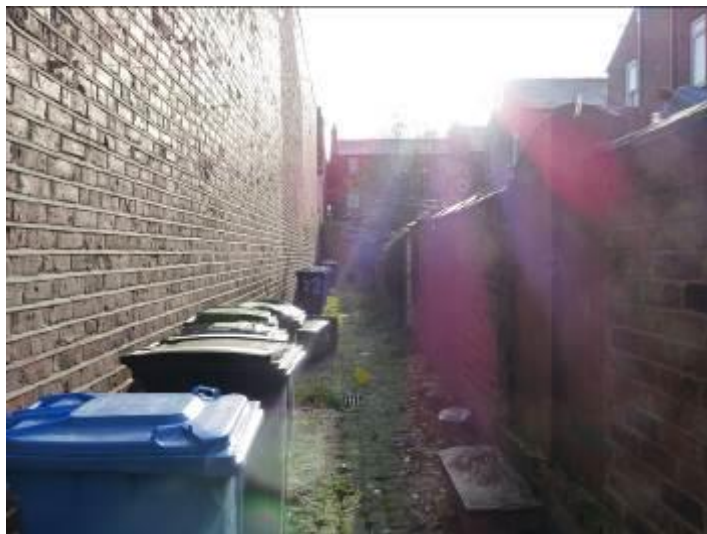
The cobbled ginnel behind south-east side of Brogden Grove.

- 6.2.20 The original cobbled alleys are still in place to the rear of all terraces and are generally well maintained, though moss and vegetation could be cleared from joints. The boundary walls facing onto these are generally of brick construction and many are in very poor condition, with some sections looking unstable and potentially dangerous.

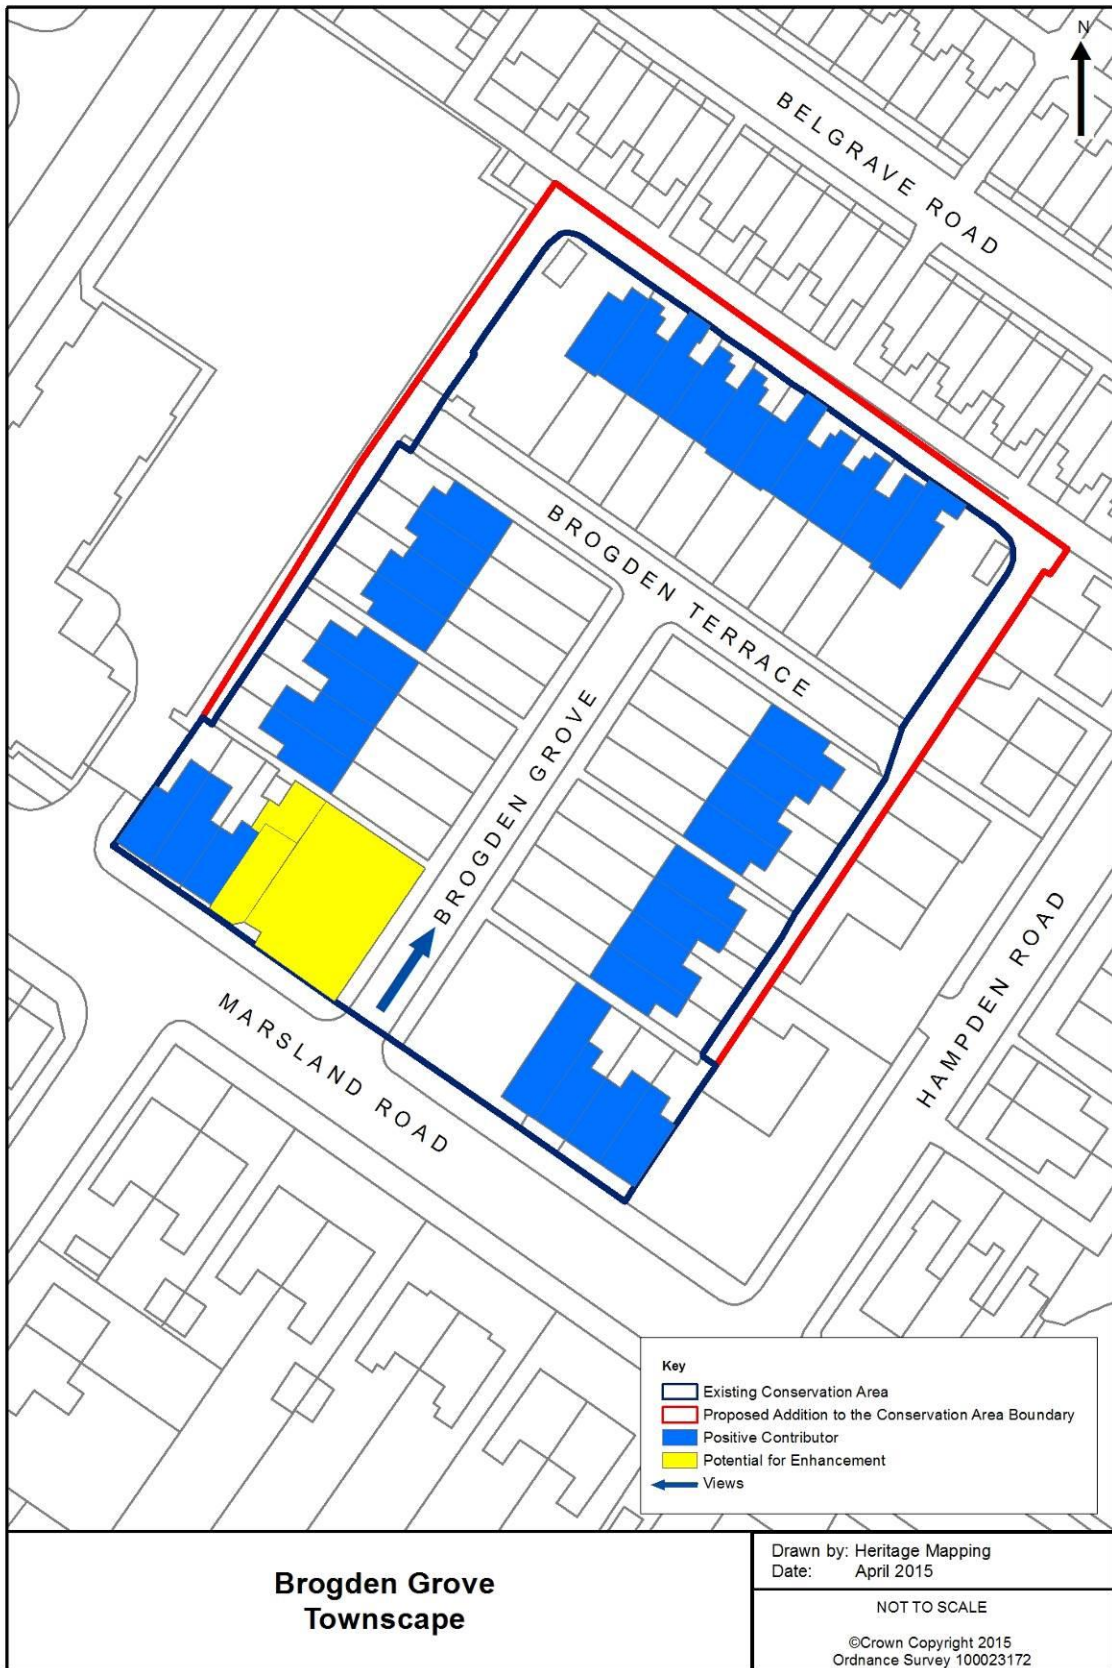
Map 7: Townscape Analysis

- 4.7.21 The relatively low planting means that the principal elevations of the terraces are mostly visible from the road and perform a key role in the composition of the streetscape. The principal view within the Conservation Area is the view north-eastwards from the far end of Brogden Grove. The terraces on either side of Brogden Grove tunnel the view towards the more ornately detailed and well balanced Brogden Terrace. Although the end terrace would not be considered a landmark outside of the Conservation Area, it is certainly its key focal point.

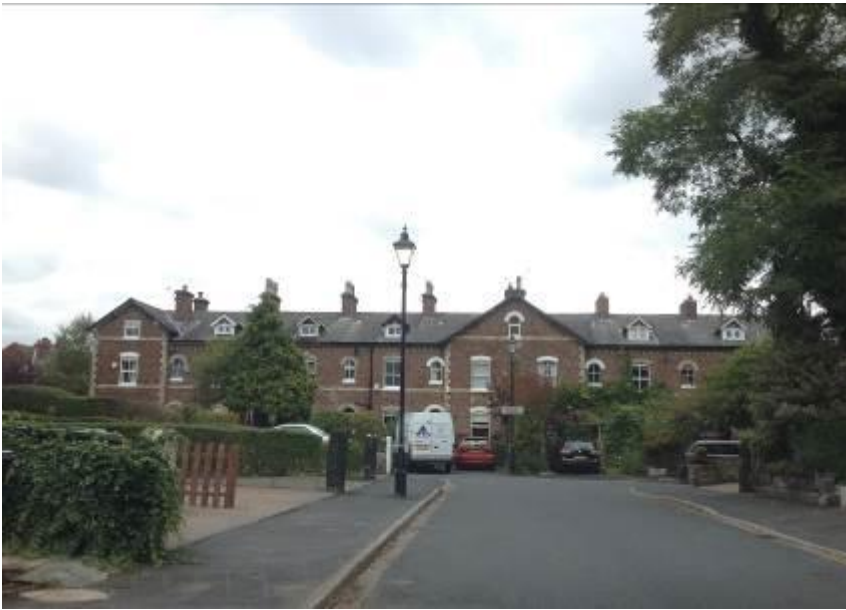
Brogden Terrace, Nos. 10-19

Condition: Good

Reason: Brogden Terrace is the central focal point for the principal view north-eastwards in the Conservation Area. Its balanced and elegant façade is a key feature that sets the Conservation Area apart as something other than a simple series of 19th-century terraces. Sash style windows (though many in UPVC replacements) are prevalent here, with windows set under curved arches which adds architectural and visual interest.

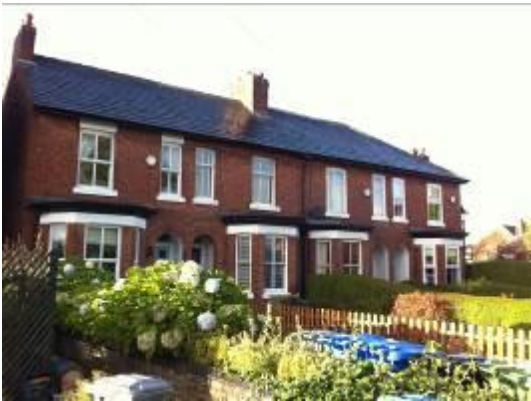
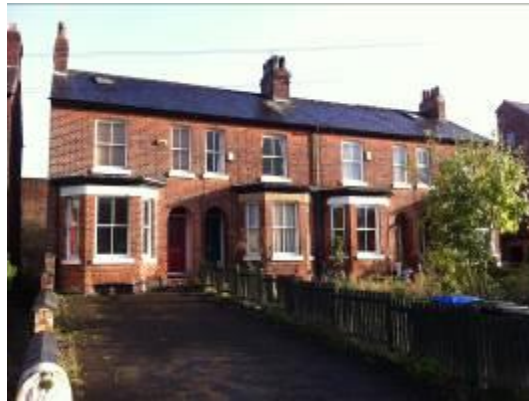
Brogden Grove, Nos. 20-27 (East Side) and Nos. 2-9 (West Side)

Condition: Good

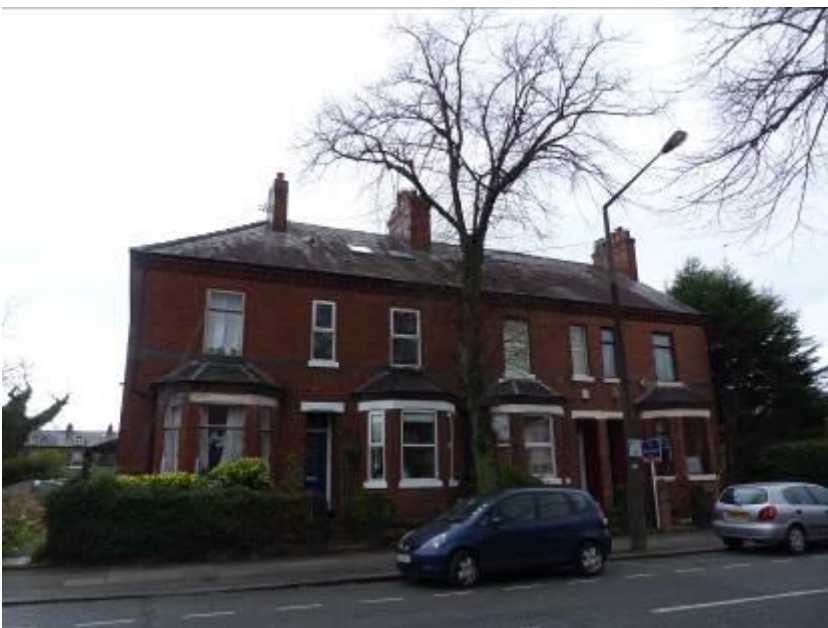
Marsland Road, Nos. 246-252

Condition: Good

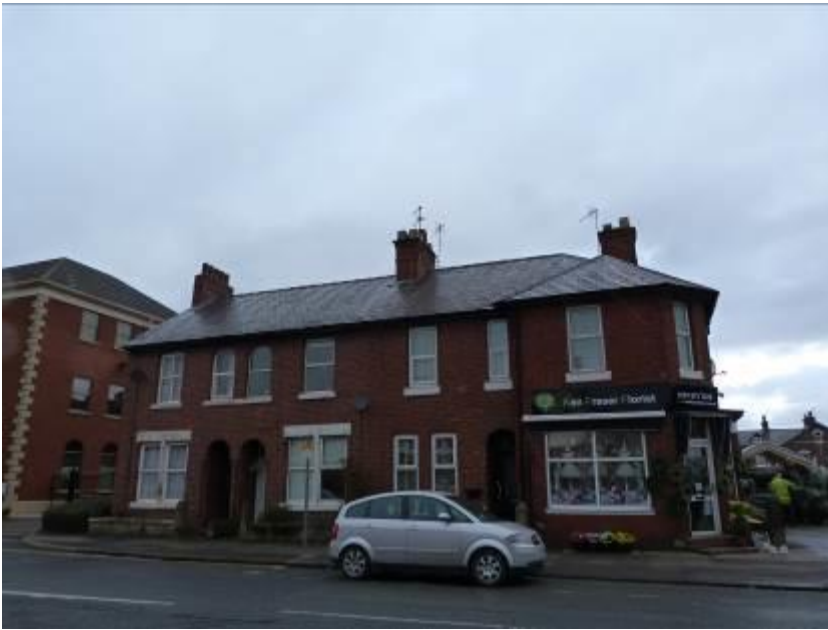
Marsland Road, Nos. 256-262

Condition: Good

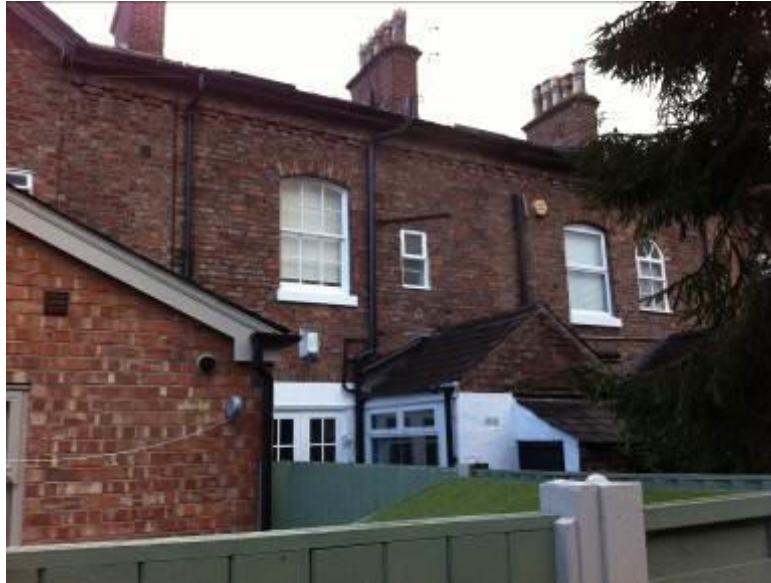
- 6.2.3 The majority of windows have been replaced with modern UPVC double glazing which, whilst generally in the style of sash windows, have chunky profiles and are not suitable for the Conservation Area. The ground floor window to the front of No.12 is a two over two timber sliding sash window with an arched head to the upper sash. This should be used as a guide for future replacement of windows. The doors are a mix of styles, typically timber panelled doors of which one style may be original. All have a fanlight above; some single light and some segmental. All are in good condition. There are several six over six timber sliding sash windows with arched heads to the upper sash on the rear elevation. Again, these should be assumed to be original and used as reference for new windows on adjoining properties.

Surviving arched sash window to rear elevation, with modern outriggers in foreground

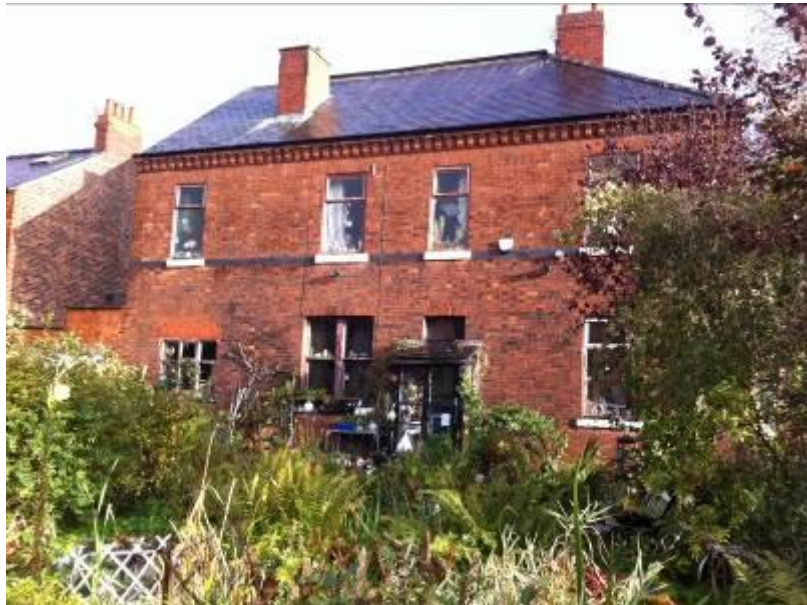
- 6.2.9 The majority of windows have been replaced with poor quality/design UPVC casements. Nos. 4, 7 and 8 do have two over two timber sash windows with fine central glazing bars to the ground floor bay windows, all of which appear in reasonable condition. The doors are as per the south-east side, with Nos. 5 and 6 possible having doors to the original design.

Modern casement windows flush with elevation, one bipartite sash window remaining to ground floor

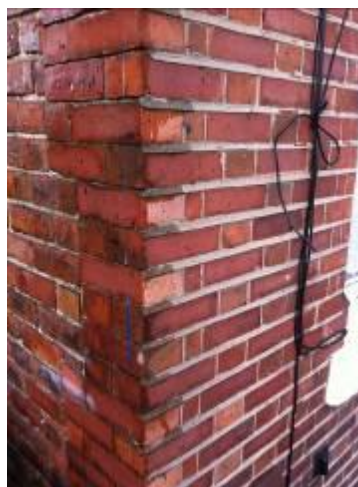
- 6.2.13 The brickwork of the Marsland Road terrace on the south- western side of Brogden Grove is in generally good condition, though the front elevation has been poorly repointed with hard cementitious mortar applied proud of the brickwork as ribbon pointing. Additionally, there are open joints to the gable wall which require repointing. The corner property is a retail unit at ground floor with large display windows and canopies over.

Hard cementitious ribbon pointing to front elevation
