Trafford Greenway Feasibility Assessment Report

Mayor's Cycling & Walking Challenge Fund

CO00201536/001 Revision 3

05/07/2023

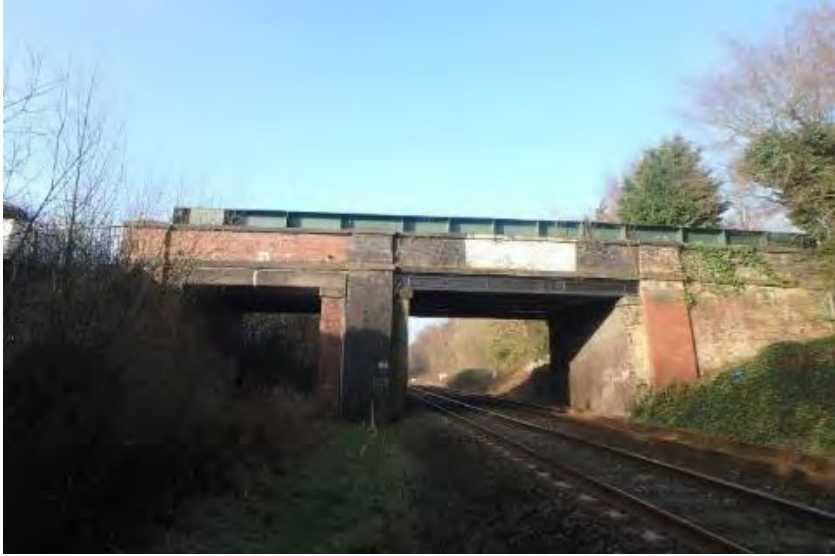
Figure 2 - New Moss Lane Bridge

Vulnerable details	None
Hidden critical elements	Jack arches, deck slab and beam supports
Interim measures	N/A
Conclusion	<p>It is anticipated that NMU users of the proposed Greenway will cross New Moss Road south to the bridge. The proposed route will not run over the bridge deck, which will continue to carry vehicular traffic on New Moss Road.</p> <p>The bridge overall is in fair condition. The bridge is currently being used as a single carriageway and is consequently considered to be suitable for pedestrian loading, including cycle and equestrian.</p> <p>The latest inspections reported tie bars between the cast iron girders under the jack arches were severely corroded, and recommended that their structural necessity should be assessed and renewed if required. The service pipe suspended was founded to be corroded and investigation of its ownership and maintenance liability was recommended.</p> <p>Localised masonry repairs and repointing works are also recommended. However, the defects are long standing, and pose no significant risk to the structural integrity of the bridge or the proposed Greenway.</p>

4	<p>Recommendation</p> <p>No change of use is anticipated for New Moss Road Bridge as part of the potential Greenway, and therefore it would be adequate for use as is.</p> <p>Some minor maintenance works were recommended in the latest inspection reports, but none are considered critical in relation to the proposed Greenway.</p> <p>The existing parapet height is 1.4m and as such not adequate for equestrians use. The existing footway widths on the bridge are not adequate for shared cyclist and pedestrian use, or for wheelchair users.</p> <p>The proposed Greenway is not currently envisaged to run over the bridge, only cross New Moss Road at its south approach. However, if the bridge is to be used as one of the access points to the Greenway, the parapet height may need to be raised.</p>

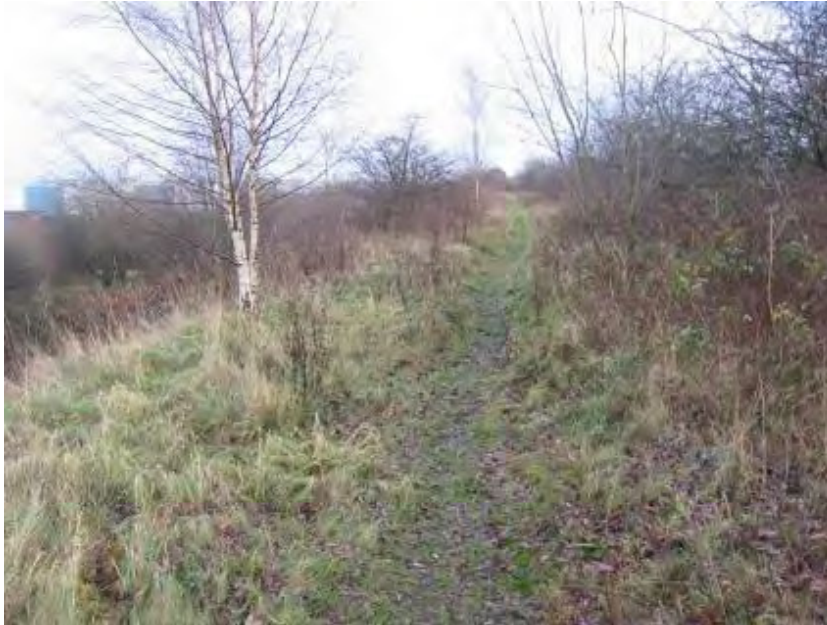
Figure 9 - 3ft Bridge Arch Culvert

The culvert between Liverpool Road Bridge and A57 Cadishead Way Bridge was not found during the site visit in September due to dense vegetation. This was echoed in previous visual examination report in October 2014.

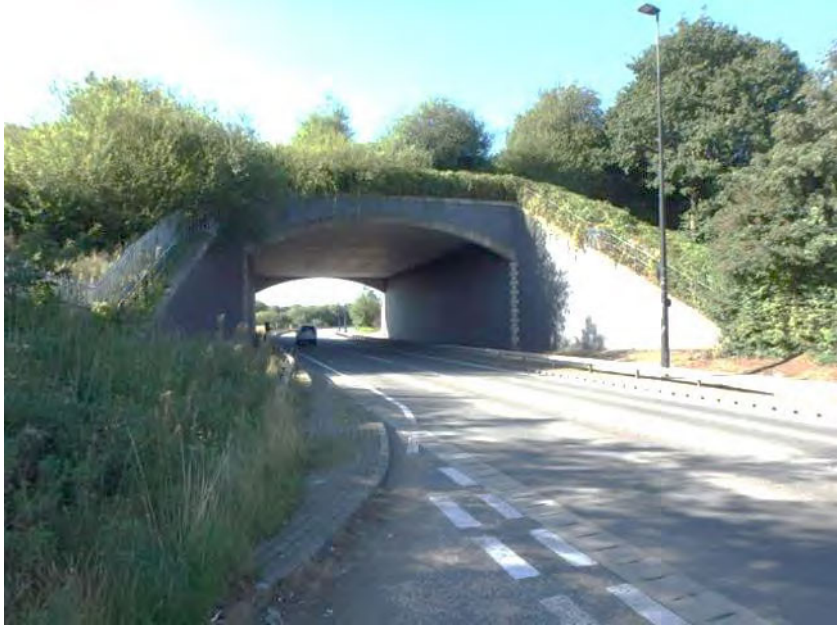
<p>Figure 10 - A57 Cadishead Way / North Bank Bridge</p>

3	Evaluation	
	Inspection Date	Salford Council PI: Feb 2017 NR Visual exam: Sept 2019
	Condition / Change in Condition	The structure overall is in good condition. There was no significant deterioration has been highlighted during the latest inspections. Only overgrown vegetation and minor area of spalling were recorded on the wing walls and brickwork facings.
	Change in Standards	Based on the available as-built drawings, the structure was constructed in circa 2003. Between 1984 and 2004, reinforced concrete structures would be designed to BS 5400 part 4, which is in line with current assessment standard CS 454.
	Change in Loading	The bridge will carry non-motorised traffic (including pedestrian, cyclist and equestrian) from the proposed Greenway, and light maintenance vehicles
	Required capacity	Pedestrian loading and light maintenance vehicles up to 7.5t
	Vulnerable details	None
	Hidden critical elements	Reinforced concrete box and wing walls behind brick facings

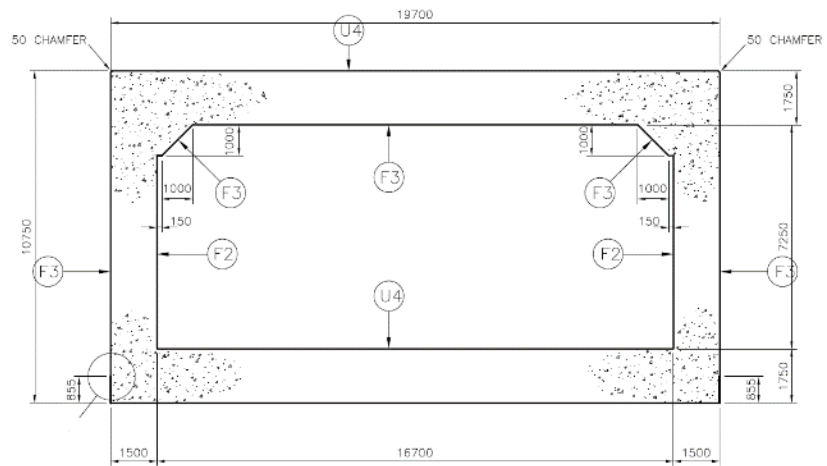
Figure 12 - Typical concrete box section (extracted from drawing no. SD 5044-4)

Conservatively for the purposes of this study, it is assumed that the bridge was designed to footway loading in accordance with BD 37/01 and associated maintenance vehicles as a minimum, which would be similar to loading requirements of the proposed Greenway. Since no significant deterioration is evident that would compromise the structural integrity of the bridge, it is considered to be suitable for the intended loading requirements.

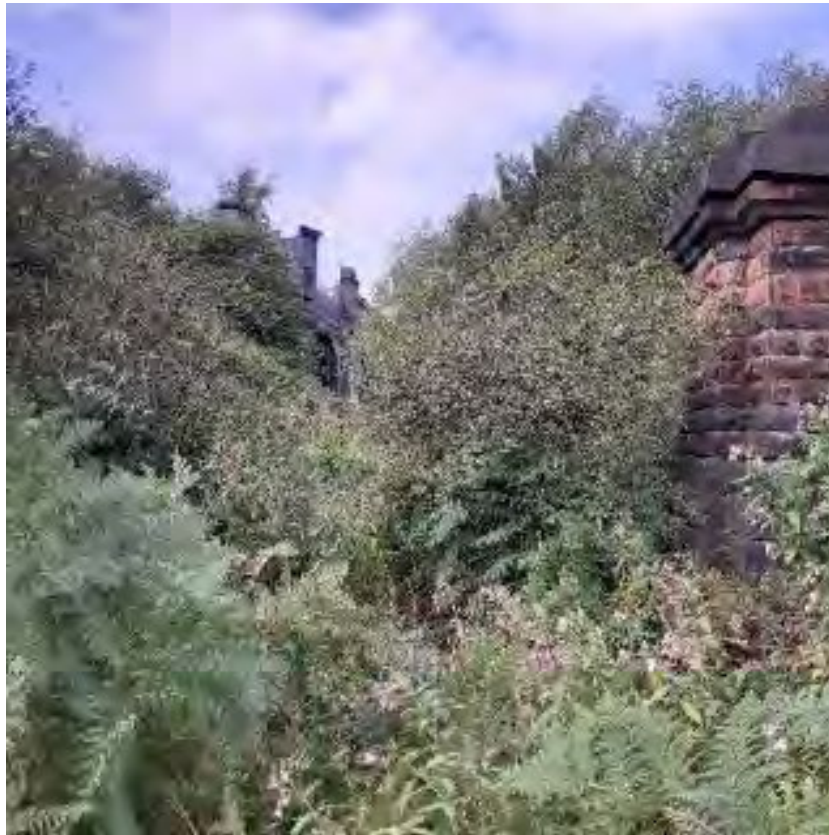
Figure 14 - Mersey Viaduct

The structure has been demolished.

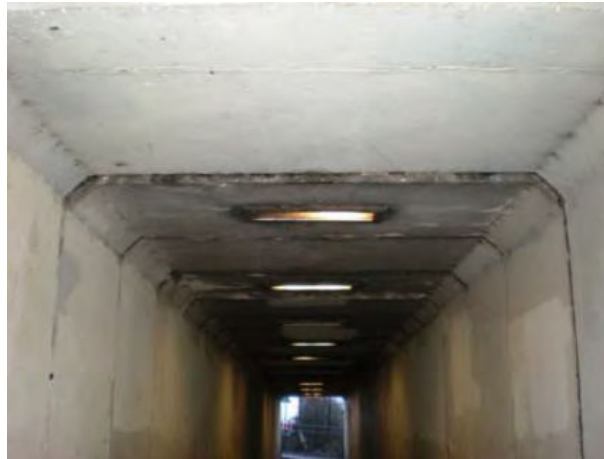
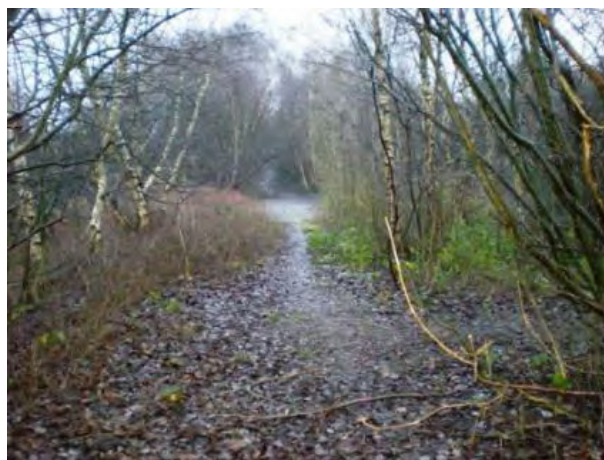
Assessment Date	Not known	Report Number	N/A
Current Assessed Capacity			
HA/ALL	Assumed historical railway loading	SV/STGO/SO	Not known
Critical Elements	Reinforced concrete box		
Parapet	The existing parapet is approximately 1.0m high, constructed over the headwalls. They are some distance away from the top of the embankments where the disused railway path located, and would not offer the necessary edge protection for the potential Greenway NMU users.		
Pier Impact	N/A		
Certification	Not available		
Calculations	Not available		
As built drawings	Drawings available		
Comments on Assessment			
No existing design or assessment records are available.			
3	Evaluation		
Inspection Date	NR Detailed exam: Jan 2014 Trafford Council GI: 2018		
Condition / Change in Condition	<p>The latest inspections reported the structure was found to be in a fair condition with only minor defects identified.</p> <p>There were drop in soffit levels between the concrete box units. However, this appeared to be long standing with no cracks in surfacing to suggest differential settlement.</p> <p>A number of joint sealants between the box units were found to be deteriorated or failed.</p> <p>There were minor areas of localised concrete spalling to the box units and wingwalls.</p> <p>Some of the lighting units within the subway are non-functional.</p> <p>There are large trees and vegetation growth throughout the disused railway track and brambles growing over the wingwalls.</p> <p>There were areas of paint failure and surface corrosion on the existing parapets.</p>

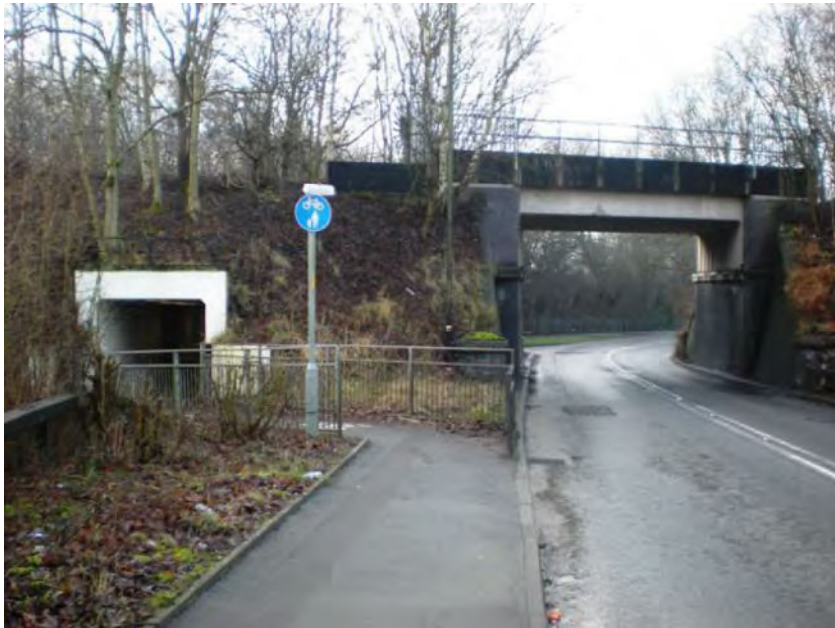
<p>Figure 18 - Lymm Road Bridge (with adjacent WJP1/7A Footpath Subway to the east)</p>

Assessment Date	Not known	Report Number	N/A
Current Assessed Capacity			
HA/ALL	Assumed historic railway loading	SV/STGO/SO	N/A
Critical Elements	Bearings		
Parapet	The existing parapet consists of a concrete wall with Key Clamp barrier extension on top. It has a total height of 2m which is suitable for all pedestrian traffic including equestrians.		
Pier Impact	N/A		
Certification	Not available		
Calculations	Not available		
As built drawings	Not available		
Comments on Assessment			
No existing design or assessment records are available.			
3	Evaluation		
Inspection Date	Detailed exam: May 2021 Visual exam: Nov 2018		
Condition / Change in Condition	<p>The structure overall is in fair condition.</p> <p>There is a long-sanding issue that the beams have been displaced and so not equally spaced. However, no deterioration is recorded.</p> <p>Some evidence of leaking between beams.</p> <p>The latest detailed and visual examination identified minor spalls with exposed reinforcement to the concrete surfaces.</p> <p>There is also minor mortar loss throughout the brickwork sections of the structure.</p> <p>There are large trees and vegetation growth throughout the former track bed and small trees growing behind the wingwalls.</p> <p>The existing surfacing is a gravel path. It is suitable for pedestrians, cyclists and horses but unsuitable for wheelchair users and child buggies.</p> <p>Downpipes are missing to the abutments causing water staining.</p>

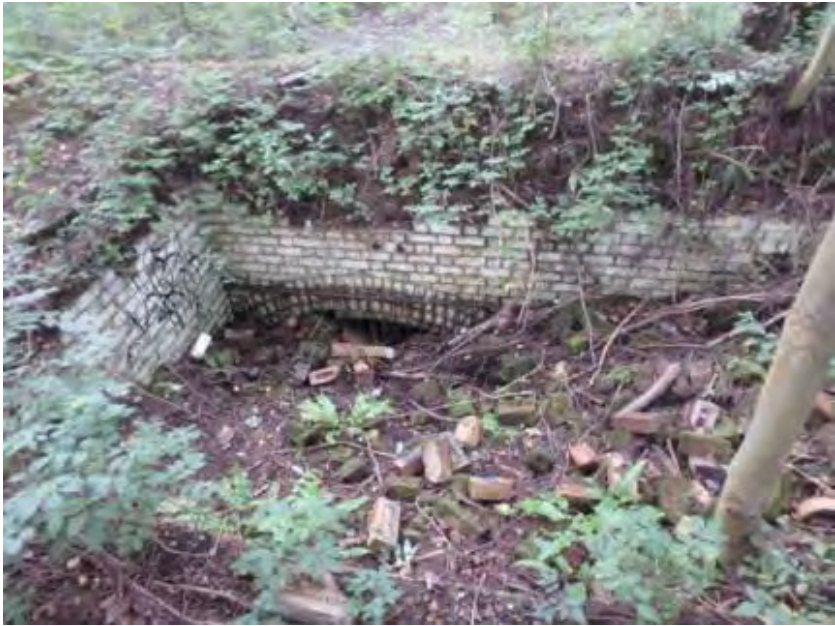
<p style="text-align: center;">Figure 21 - Partington Station Subway</p>				
	Reason for Structural Review	Assess suitability for carrying the proposed Greenway.		
2	Existing Assessment Details or Design Records			
	Inspection for Assessment Date	Not known	Recorded Condition	None
	AIP for Assessment	Not available	Status	N/A
	Assessment Date	Not known	Report Number	N/A

Current Assessed Capacity			
HA/ALL	Assumed historic railway loading	SV/STGO/SO	N/A
Critical Elements	None		
Parapet	There are currently no parapets on this structure.		
Pier Impact	N/A		
Certification	Not available		
Calculations	Not available		
As built drawings	Not available		
Comments on Assessment			
No existing design or assessment records are available.			
3	Evaluation		
Inspection Date	Detailed exam: Jan 2012 Visual exam: Aug 2019		
Condition / Change in Condition	<p>The structure overall is in fair to poor condition The latest detailed and visual examination identified that the structure has been partially infilled at both ends to prevent access to the structure.</p>

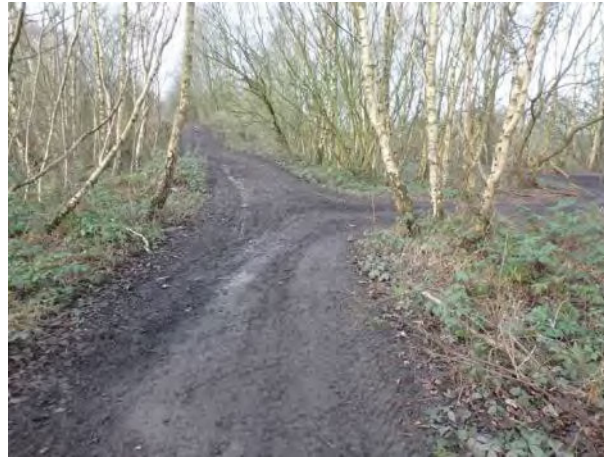
Figure 25 - View over the structure

<p style="text-align: center;">Figure 24 - View inside the structure</p> <p>There are trees and vegetation growing behind the wingwalls.</p> <p>There is also an exposed gas pipe to the north side adjacent the wingwalls.</p> <p>It was identified during the most recent site visit that the lock is missing to the access gate.</p> <p>Sections of the existing timber fencing are damaged or missing.</p>

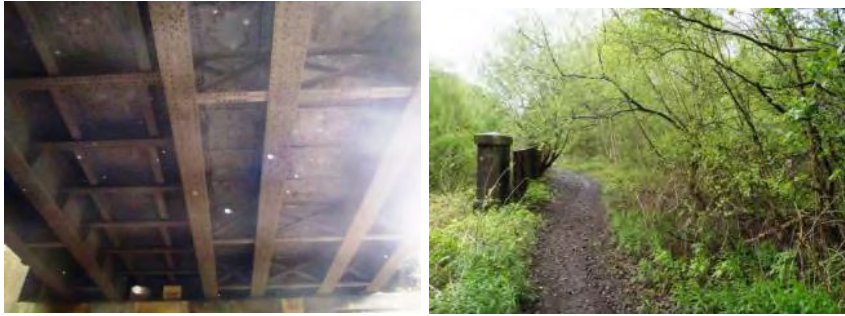
Assessment Date	Not known	Report Number	N/A
Current Assessed Capacity			
HA/ALL	Assumed historic railway loading	SV/STGO/SO	N/A
Critical Elements	Steel deck plates		
Parapet	The existing parapet is 1.4m high, which is suitable edge protection for cycle and pedestrians, however it is below the requirement for equestrian usage (1.8m).		
Pier Impact	N/A		
Certification	Not available		
Calculations	Not available		
As built drawings	Not available		
Comments on Assessment			
No existing design or assessment records are available.			
3	Evaluation		
Inspection Date	Detailed exam: May 2015 Visual exam: Aug 2019		
Condition / Change in Condition	<p>The overall condition of the structure is considered to be fair to poor. This is primarily a result of the steel deck plates which are expected to be severely corroded on the topside as they are currently covered by the pathway above and inaccessible for inspection.</p> <p>The latest inspections identified that there was extensive surface corrosion throughout all metal elements of the structure.</p> <p>There is minor mortar loss throughout the wingwalls and abutments.</p> <p>There is extensive vegetation growth to the top of the structure including large trees.</p> <p>The existing surfacing is a gravel path. It is suitable for pedestrians, cyclists and horses but unsuitable for wheelchair users and child buggies.</p>

Figure 27 - View under and over the structure		
Change in Standards	No design or assessment records are available to confirm the standards previously used for this structure.

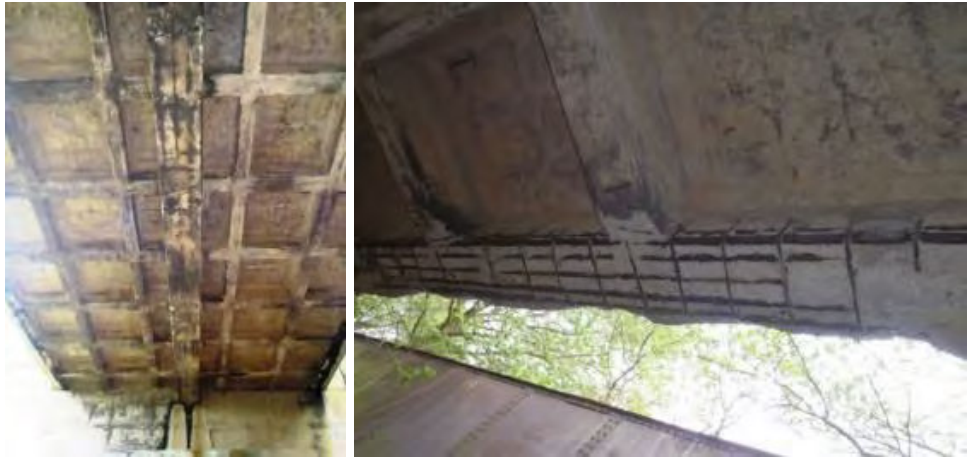
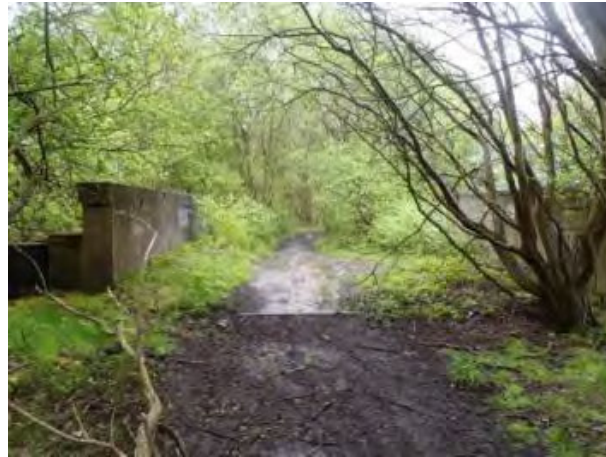
Current Assessed Capacity			
HA/ALL	Assumed historic railway loading	SV/STGO/SO	N/A
Critical Elements	Bridge deck and abutments		
Parapet	The existing parapet is 1.4m high, which is suitable edge protection for cycle and pedestrians, however it is below the requirement for equestrian usage (1.8m).		
Pier Impact	N/A		
Certification	Not available		
Calculations	Not available		
As built drawings	Not available		
Comments on Assessment			
No existing design or assessment records are available.			
3 Evaluation			
Inspection Date	Additional detailed exam: May 2015 Visual exam: Aug 2019		
Condition / Change in Condition	<p>The structure overall is in significantly poor condition. The latest detailed and visual examination identified that there were extensive areas of spalling with exposed reinforcement throughout the structure.</p> <p>There is extensive vegetation growth to the top of the structure including large trees.</p>

Change in Standards	<p>No design or assessment records are available to confirm the standards previously used for this structure.</p> <p>There were no formal design standards used until 1923, with girder bridges designed on an empirical basis. BS 153 was introduced in 1923, which was the precursor to BS5400 that was first issued in 1978.</p> <p>The first design code for concrete structures was introduced in 1934, with the limit state approach being applied since publication of CP 110 in 1972.</p> <p>The latest standards for assessment of concrete highways bridges are CS 454 and CS 455 (reinforced concrete)</p>	
Change in Loading	The bridge will carry non-motorised traffic (including pedestrian, cyclist and equestrian) from the proposed Greenway, and light maintenance vehicles	
Required capacity	Pedestrian loading and light maintenance vehicles up to 7.5t	
Vulnerable details	Multiple areas of exposed and corroding reinforcement

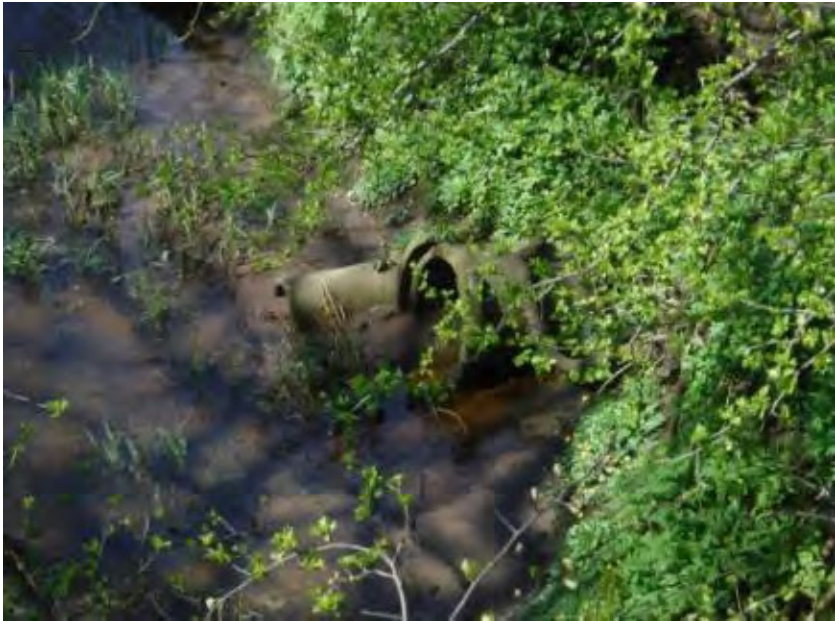
<p style="text-align: center;">Figure 31 - Culvert 900mm</p>				
	Reason for Structural Review	Assess suitability for carrying the proposed Greenway.		
2	Existing Assessment Details or Design Records			
	Inspection for Assessment Date	Not known	Recorded Condition	None
	AIP for Assessment	Not available	Status	N/A
	Assessment Date	Not known	Report Number	N/A

Current Assessed Capacity			
HA/ALL	Assumed historic railway loading	SV/STGO/SO	N/A
Critical Elements	The brickwork section of the culvert, approximately 29m long from the upstream end		
Parapet	There are currently no parapets on this structure.		
Pier Impact	N/A		
Certification	Not available		
Calculations	Not available		
As built drawings	Not available		
Comments on Assessment			
No existing design or assessment records are available.			
3	Evaluation		
Inspection Date	Detailed exam: Nov 2016 Visual exam: Jul 2021		
Condition / Change in Condition	<p>The structure overall is in fair to poor condition.</p> <p>The latest inspection identified that there was mortar loss and missing and displaced bricks throughout the brickwork section of the culvert. Recommendation to replace the worst 10m length.</p> <p>There is also debris in the invert although it does not appear to be restricting flow at this time.</p> <p>There is mortar loss and calcite staining and algae growth to the wingwalls and headwalls.</p> <p>The existing surfacing is a gravel path. It is suitable for pedestrians, cyclists and horses but unsuitable for wheelchair users and child buggies.</p>

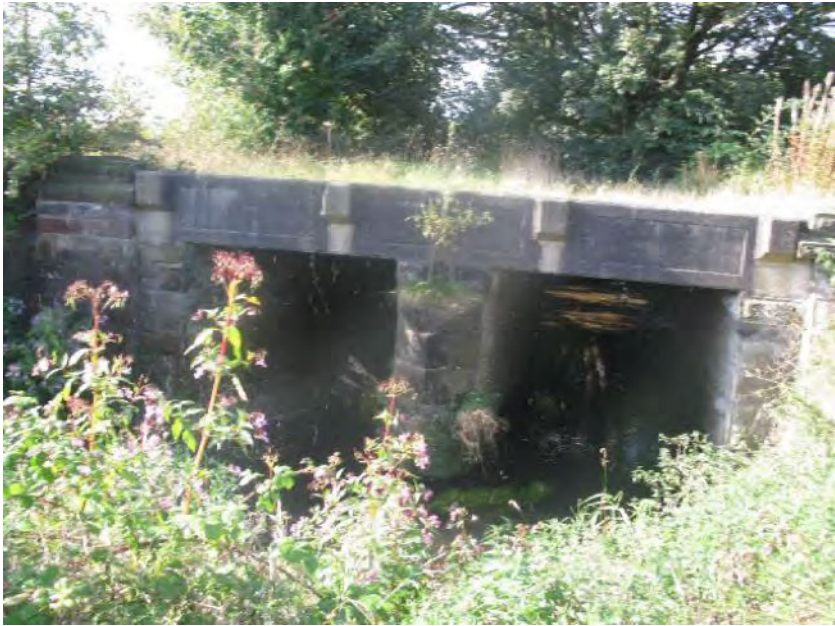
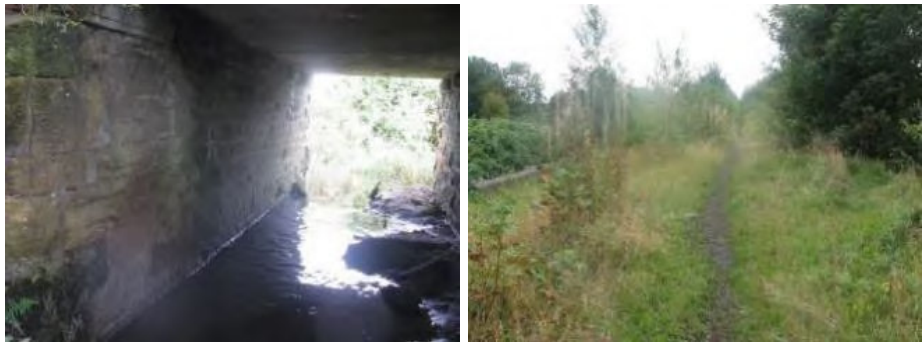
Current Assessed Capacity			
HA/ALL	Assumed historic railway loading	SV/STGO/SO	N/A
Critical Elements	Bridge deck, pier and abutments		
Parapet	There are currently no parapets on this structure.		
Pier Impact	N/A		
Certification	Not available		
Calculations	Not available		
As built drawings	Not available		
Comments on Assessment			
No existing design or assessment records are available.			
3 Evaluation			
Inspection Date	Detailed exam: Aug 2014 Visual exam: July 2020		
Condition / Change in Condition	<p>The structure overall is in fair to poor condition</p> <p>The latest detailed examination identified that there was minor mortar loss throughout the abutments, wingwalls and pier along with odd minor fractures.</p> <p>There are odd fractured bed stones.</p> <p>There is silt build up against the abutments beginning to restrict flow in the watercourse.</p> <p>The parapet has been removed from the top of the structure (possibly stolen).</p> <p>There is vegetation growth to the top of the structure including trees.</p>

Figure 35 - View under and over the structure			
Change in Standards	<p>No design or assessment records are available to confirm the standards previously used for this structure.</p> <p>There were no formal design standards used until 1923. BS 153 was introduced in 1923, which was the precursor to BS5400 that was first issued in 1978.</p>

The first design code for concrete structures was introduced in 1934, with the limit state approach being applied since publication of CP 110 in 1972. The latest standard for assessment of highways bridges is CS 454 and CS 455 for reinforced concrete structures.
	Change in Loading	The bridge will carry non-motorised traffic (including pedestrian, cyclist and equestrian) from the proposed Greenway, and light maintenance vehicles
	Required capacity	Pedestrian loading and light maintenance vehicles up to 7.5t
	Vulnerable details	None
	Hidden critical elements	None
	Interim measures	N/A
	Conclusion	The structure is in fair condition. Owing to the significant reduction in loading from trains to NMU and small maintenance vehicles, the structure is considered adequate for carrying the proposed Greenway, provided the maintenance interventions listed below are undertaken.
4	Recommendation	
	<p>It is recommended that the following works are undertaken to render the structure suitable for carrying the proposed Greenway.</p> <p>Essential works, estimated costs: £13,000</p> <ul style="list-style-type: none"> ▪ Install equestrian parapets over the structure ▪ Footpath surfacing improvement to an acceptable standard for Greenway usage <p>Works that can be deferred, estimate costs: £7,000</p> <ul style="list-style-type: none"> ▪ Repairs and re-pointing of stonework ▪ Clear silt in invert ▪ Vegetation clearance

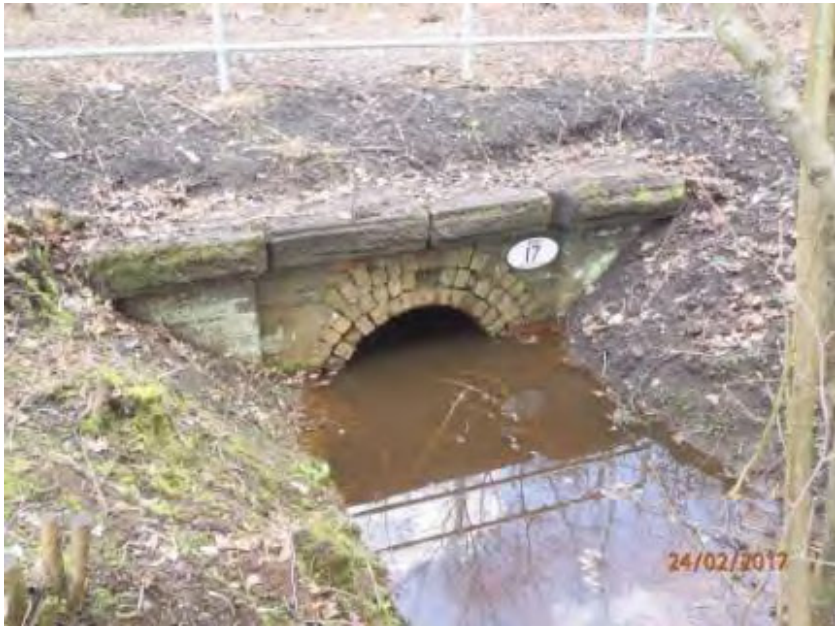
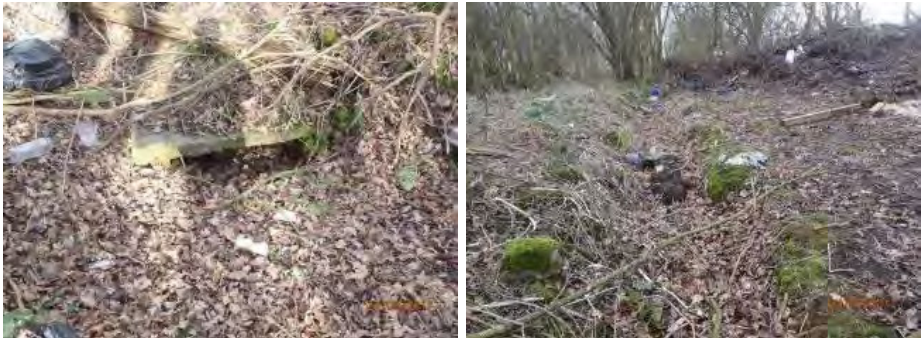
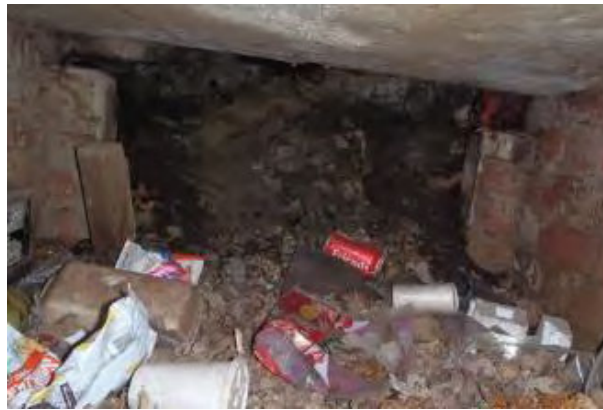
<p>Figure 36 - Culvert 900mm</p>				
	Reason for Structural Review	Assess suitability for carrying the proposed Greenway.		
2	Existing Assessment Details or Design Records

Assessment Date	Not known	Report Number	N/A
Current Assessed Capacity			
HA/ALL	Assumed historic railway loading	SV/STGO/SO	N/A
Critical Elements	Bridge deck and abutments		
Parapet	There is only an existing parapet to the downstream end of the structure, which is inadequate to current standards.		
Pier Impact	N/A		
Certification	Not available		
Calculations	Not available		
As built drawings	Not available		
Comments on Assessment			
No existing design or assessment records are available.			
3	Evaluation		
Inspection Date	Detailed exam: Feb 2017		
Condition / Change in Condition	<p>The condition of the structure is considered to be poor The upstream end appears to have collapsed and is now non-functional. There is significant deterioration of pointing throughout the structure. There is spalling to 4 of the face rings and 1 loose brick on the downstream end. It is proposed to demolish and backfill the structure with site won material.</p>

Required capacity	Pedestrian loading and light maintenance vehicles up to 7.5t	
Vulnerable details	None	
Hidden critical elements	None	
Interim measures	N/A	
Conclusion	The structure overall is in poor condition and appears to be no longer functional. It is therefore proposed to demolish and backfill with site won material	
4	Recommendation	
	<p>Further investigation should first be made to verify that the structure is no longer functioning and is redundant. When this is verified, it is recommended that the structure is demolished and backfilled using site won material. Grading of the embankments at each end of the culvert will eliminate the need for parapets.</p> <p>Essential works, estimated costs: £10,000</p> <ul style="list-style-type: none"> ▪ Demolition and infill

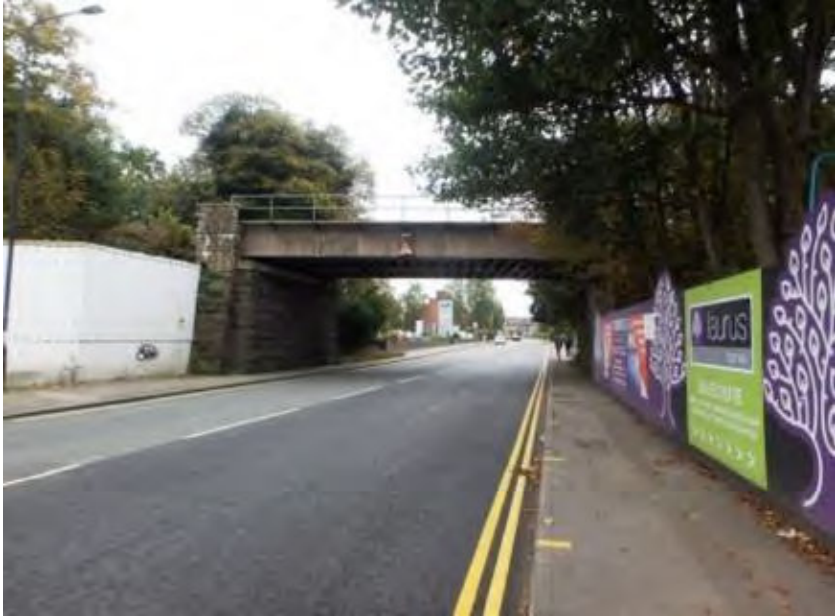
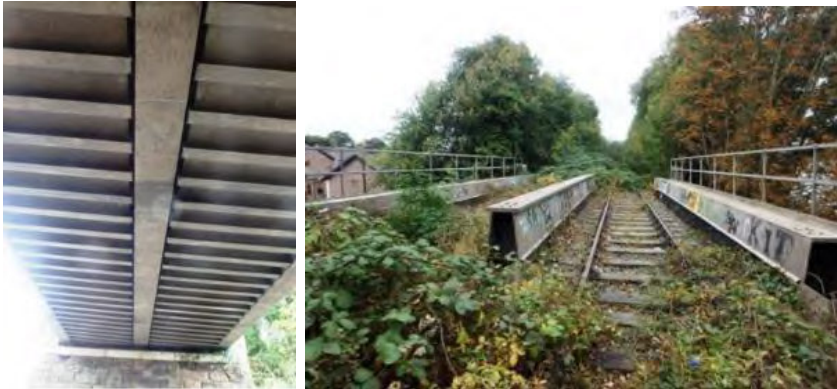
<p style="text-align: center;">Figure 39 - Manchester Road</p>

Assessment Date	Not known	Report Number	N/A
Current Assessed Capacity			
HA/ALL	Assumed historic railway loading	SV/STGO/SO	N/A
Critical Elements	Bridge deck and abutments		
Parapet	The existing parapet is 1m high, comprising open post and rail, which is not suitable of cyclist (1.4m) or equestrian use (1.8m).		
Pier Impact	N/A		
Certification	Not available		
Calculations	Not available		
As built drawings	Not available		
Comments on Assessment			
No existing design or assessment records are available.			
3	Evaluation		
Inspection Date	Detailed exam: Oct 2017 Visual exam: July 2021		
Condition / Change in Condition	<p>The structure overall is in fair condition.</p> <p>The latest detailed examination identified that there were minor areas of corrosion throughout the metal elements of the structure.</p> <p>There is also corrosion to the steel bolts throughout.</p> <p>The masonry elements of the structure have minor mortar loss throughout and small areas of seepage and fractures.</p> <p>There are scrape marks to the bottom faces of the girders and the structure is missing bridge strike information plates.</p> <p>Boundary fencing is missing adjacent to the wingwalls.</p> <p>There is extensive vegetation growth to the top of the structure and behind the wingwalls.</p> <p>The disused railway track bed and sleepers are still in place.</p>

Interim measures	N/A
Conclusion	<p>The structure in fair condition overall.</p> <p>Owing to the significant reduction in loading from trains to NMU and small maintenance vehicles, the structure is considered adequate for carrying the proposed Greenway, provided the maintenance interventions listed below are undertaken.</p>
4	<p>Recommendation</p> <p>It is recommended that the following works are undertaken to render the structure suitable for carrying the proposed Greenway:</p> <p>Essential works, estimated costs: £25,000</p> <ul style="list-style-type: none"> ▪ Install appropriate parapets or safety fences along the proposed Greenway over the bridge and its approaches over the high embankments ▪ Clear overgrown vegetation and trees, and treat roots as appropriate, over the disused railway track and the embankments ▪ Removal of existing track bed from over the structure and footpath surfacing to an acceptable standard for NMU usage <p>Works that can be deferred, estimate costs: £39,000</p> <ul style="list-style-type: none"> ▪ Patch painting of impact damaged areas of girders ▪ Painting of discreet areas of corrosion throughout the steelwork ▪ Filling of fractures in abutments

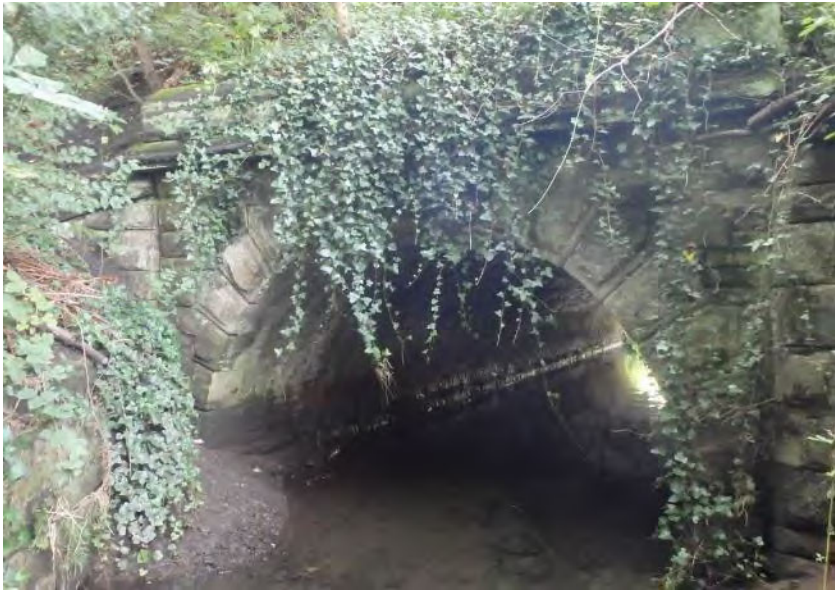
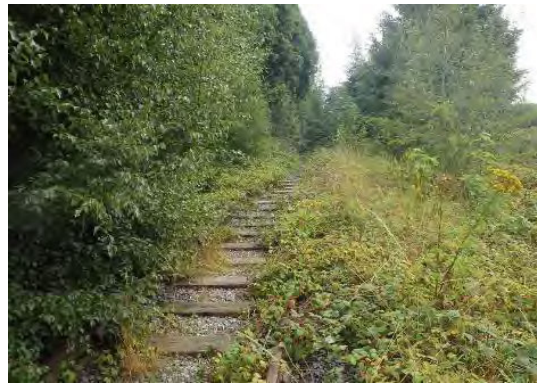
HA/ALL	Assumed historical railway loading	SV/STGO/SO	N/A
	Critical Elements	Arch ring, spandrels and abutments		
	Parapet	The existing parapet is less than 0.5m high, which is below the required edge protection for cyclist (1.4m) or equestrian usage (1.8m).		
	Pier Impact	N/A		
	Certification	Not available		
	Calculations	Not available		
	As built drawings	Not available		
	Comments on Assessment			
	No existing design or assessment records are available.			
3	Evaluation			
	Inspection Date	Detailed exam: Aug 2015 Visual exam: Aug 2019		
	Condition / Change in Condition	<p>The structure overall is deemed to be in fair condition. The latest detailed examination identified that there are areas of mortar loss throughout the structure and areas of water staining. Spalling bricks to arch soffit.</p>

<p>Figure 42 - View under the structure</p> <p>Displaced copings and spandrels pushing out. The structure has been inaccessible since the last detailed examination due to excessive vegetation growth throughout the structure. The parapets are below the required height for all users. The original railway track bed, railings and sleepers are still in place.</p>

4	Recommendation	
	<p>It is recommended that the following works are undertaken to render the structure suitable for carrying the proposed Greenway:</p> <p>Essential works, estimated costs: £17,500</p> <ul style="list-style-type: none"> ▪ Removal of existing railway track bed, railings and sleeps, and vegetation and footpath surfacing improvement to an acceptable standard for Greenway usage ▪ Install appropriate parapets or safety fences along the proposed Greenway over the bridge ▪ Removal of significant vegetation from behind the training walls <p>Works that can be deferred, estimated cost: £9,500</p> <ul style="list-style-type: none"> ▪ Repair of missing coping stones to training walls ▪ Repointing and repair of bulging spandrel wall

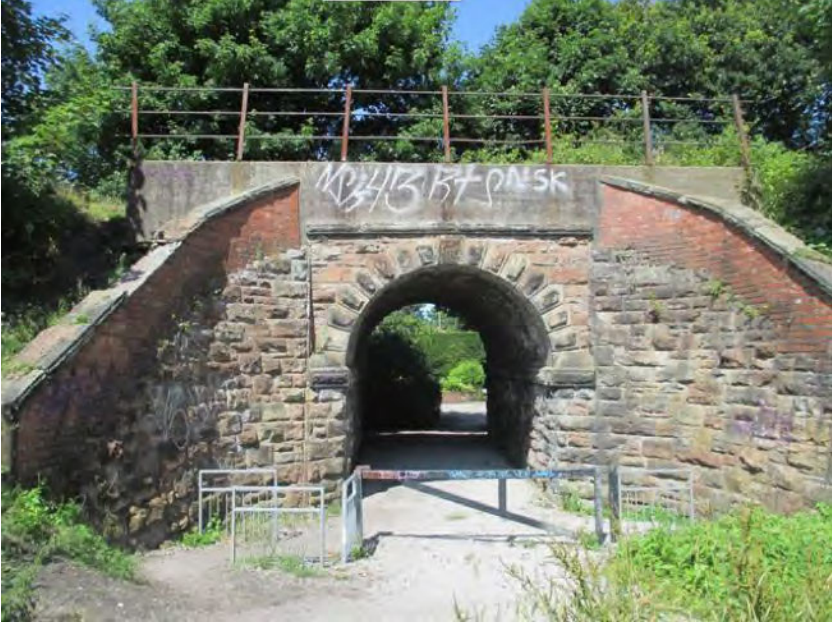
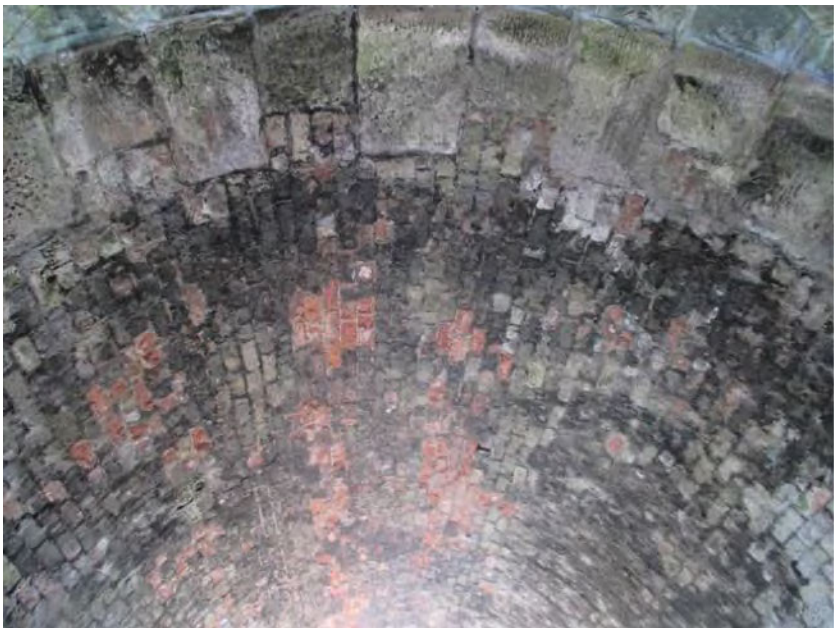
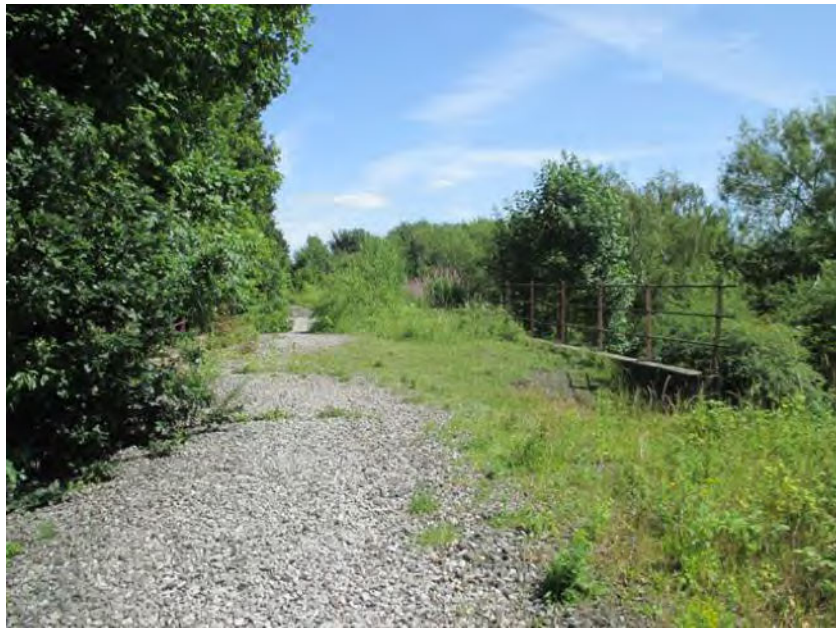
HA/ALL	Assumed historical railway loading	SV/STGO/SO	N/A
	Critical Elements	Bridge deck and abutments		
	Parapet	The existing parapets comprise 1.88m high open metal posts and rails. The parapet height is adequate for both cyclist (1.4m) and equestrian (1.8m) use. However, the condition and design may be unsuitable for Greenway.		
	Pier Impact	N/A		
	Certification	Not available		
	Calculations	Not available		
	As built drawings	Not available		
	Comments on Assessment			
	No existing design or assessment records are available.			
3	Evaluation			
	Inspection Date	Detailed exam: Jul 2015 Visual exam: Jul 2019		
	Condition / Change in Condition	<p>The structure overall is in fair condition. The latest inspections identified that there are areas of mortar loss throughout the structure and odd areas of spalling and erosion. Some historical fractures to northern wing walls and odd missing stones to all wingwalls.</p> <p>There is also significant vegetation and tree growth behind the wingwalls. The existing surfacing is a gravel path. It is suitable for cycle and pedestrian traffic. However, it would be unsuitable for wheelchair users.</p>

Change in Standards	No design or assessment records are available to confirm the standards previously used for this structure. Arch bridges were historically designed and assessed by empirical methods, with the modified MEXE method being introduced in 1963 for highway bridges, and which remains one of the four acceptable analysis methods recommended by the current standard CS 454.	
Change in Loading	The bridge will carry non-motorised traffic (including pedestrian, cyclist and equestrian) from the proposed Greenway, and light maintenance vehicles	
Required capacity	Pedestrian loading and light maintenance vehicles up to 7.5t	
Vulnerable details	None	
Hidden critical elements	None	
Interim measures	N/A	
Conclusion	The bridge is in fair condition overall. Given that the bridge was originally designed to carry trains, and since no significant deterioration is evident that would compromise the structural integrity, it is considered to be suitable for the loading requirements of the proposed Greenway.

4	Recommendation
	<p>It is recommended that the following works are undertaken to render the structure suitable for carrying the proposed Greenway:</p> <p>Essential works, estimate cost: £27,500</p> <ul style="list-style-type: none">▪ Footpath surfacing improvement to an acceptable standard for Greenway usage▪ Install appropriate parapets or safety fences along the proposed Greenway over the bridge and its approaches over the embankments▪ Clear overgrown vegetation and trees, and treat roots as appropriate, over the disused railway track and the embankments <p>Works that can be deferred, estimate costs: £8,500</p> <ul style="list-style-type: none">▪ Masonry repairs and repointing to arch ring and abutments▪ Repair of fractures in NE and SE wing walls

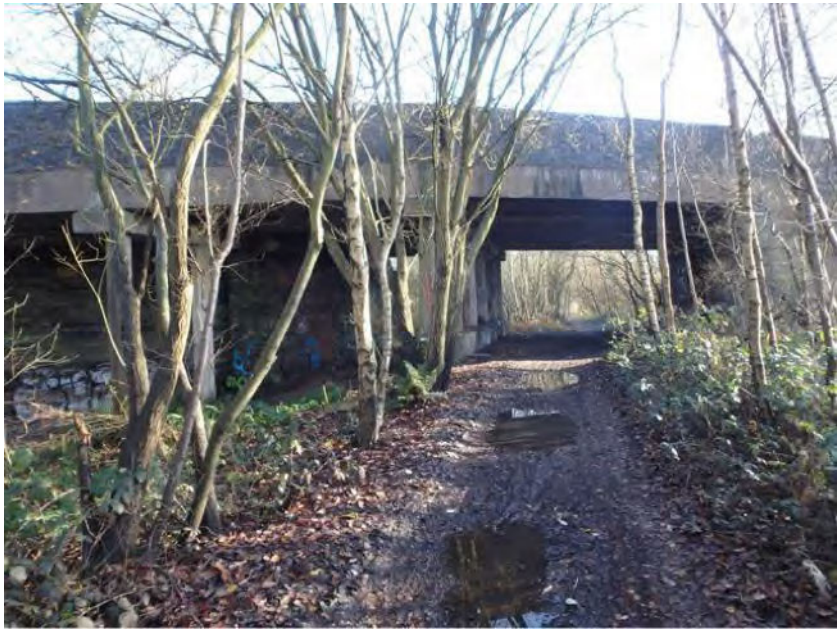
<p>Figure 47 - Sinderland Bridge (disused railway track under span 3)</p>		
2	Evaluation	
	Inspection Date	Visual exam: Nov 2019
	Inspection Summary	The latest inspections reported the structure was found to be in good condition, defects identified included:

- Fire damage to the column base
- Ponding under the structure (not found during 2022 site walkover) caused by a salt glazed pipe under a farm track
- Missing brickwork to the parapet

Defects identified from the latest inspections do not appear to affect span 3, where the disused railway track is located. Loss of bricks to the bridge parapets should be monitored, and if any bricks become loose particular over span 3, loose bricks should be removed or reinstated. It is considered currently no defects on the structure pose a risk to potential users of the Greenway, and thus no maintenance works for the structure are required. General de-vegetation and footpath surfacing improvement are envisaged to be undertaken as part of the overall Greenway alignment / route improvement works.

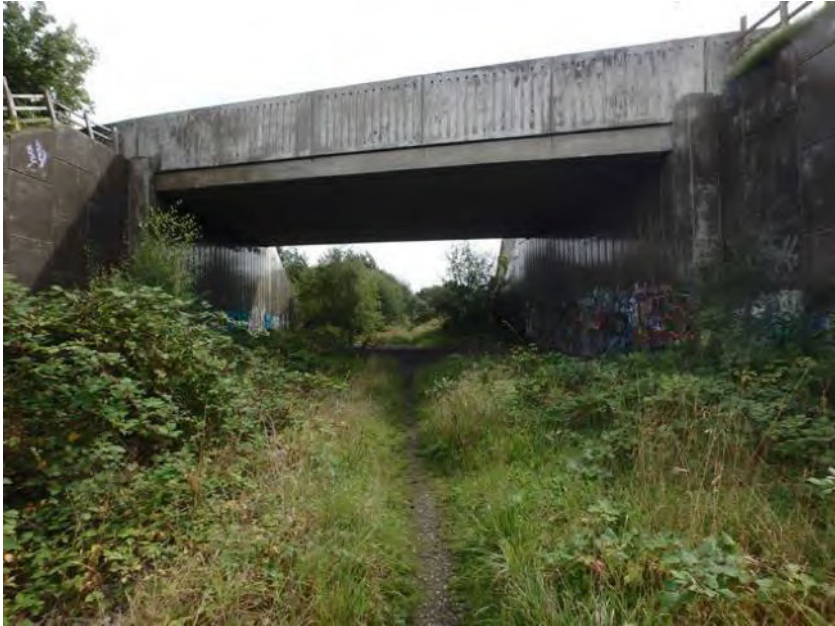
<p>Figure 54 - Sinderland Lane (Stamford Brook Railway Bridge)</p>		
2	Evaluation	
	Inspection Date	Visual Examination: Aug 2019
	Inspection Summary	<p>The structure was found to be in good condition. Defects found on the structure include:</p> <ul style="list-style-type: none"> ▪ Vegetation growth throughout ▪ Fire damage to the concrete on the abutments and wingwall ▪ Unstable timber fence

It is recommended that the loose timber fences over the wing walls are repaired or replaced to ensure no risks of them falling onto the proposed Greenway.
 General de-vegetation and footpath surfacing improvement are envisaged to be undertaken as part of the overall Greenway alignment / route improvement works.

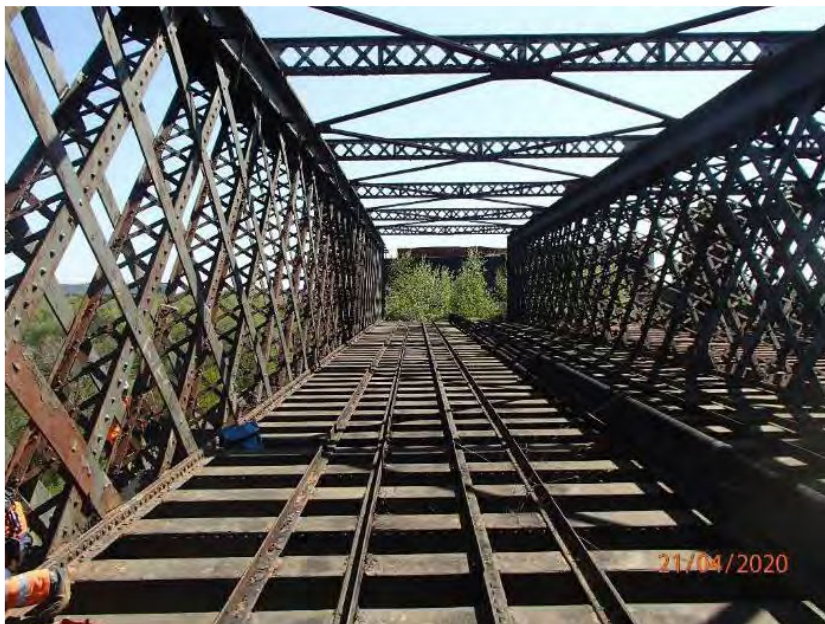
Overall, the structure is considered to be in poor condition, primarily as a result of defects in the wrought iron trough decking of span 3, which has a significant number of large holes resulting from corrosion. These are visible from ground level, and are mentioned in previous inspection reports.

Figure 59 - Photo showing a view looking east along the northernmost deck showing the existing lattice girders and metal deck troughing

Demolish one deck (between two lattice girders) and refurbish the other remaining deck. The choice of which deck to retain will be dependent upon the condition and defects recorded at the inspection for assessment. The deck and girders which together are in the most favourable condition will be assessed to determine what repairs are required to make the structure serviceable for the proposed loadings.

It is anticipated that the deck to be refurbished will be constructed as a reinforced concrete slab spanning transversely between the lattice girders (See refurbishment section below)
