Trafford Greenway Feasibility Assessment Report

Mayor's Cycling & Walking Challenge Fund

CO00201536/001 Revision 3

05/07/2023

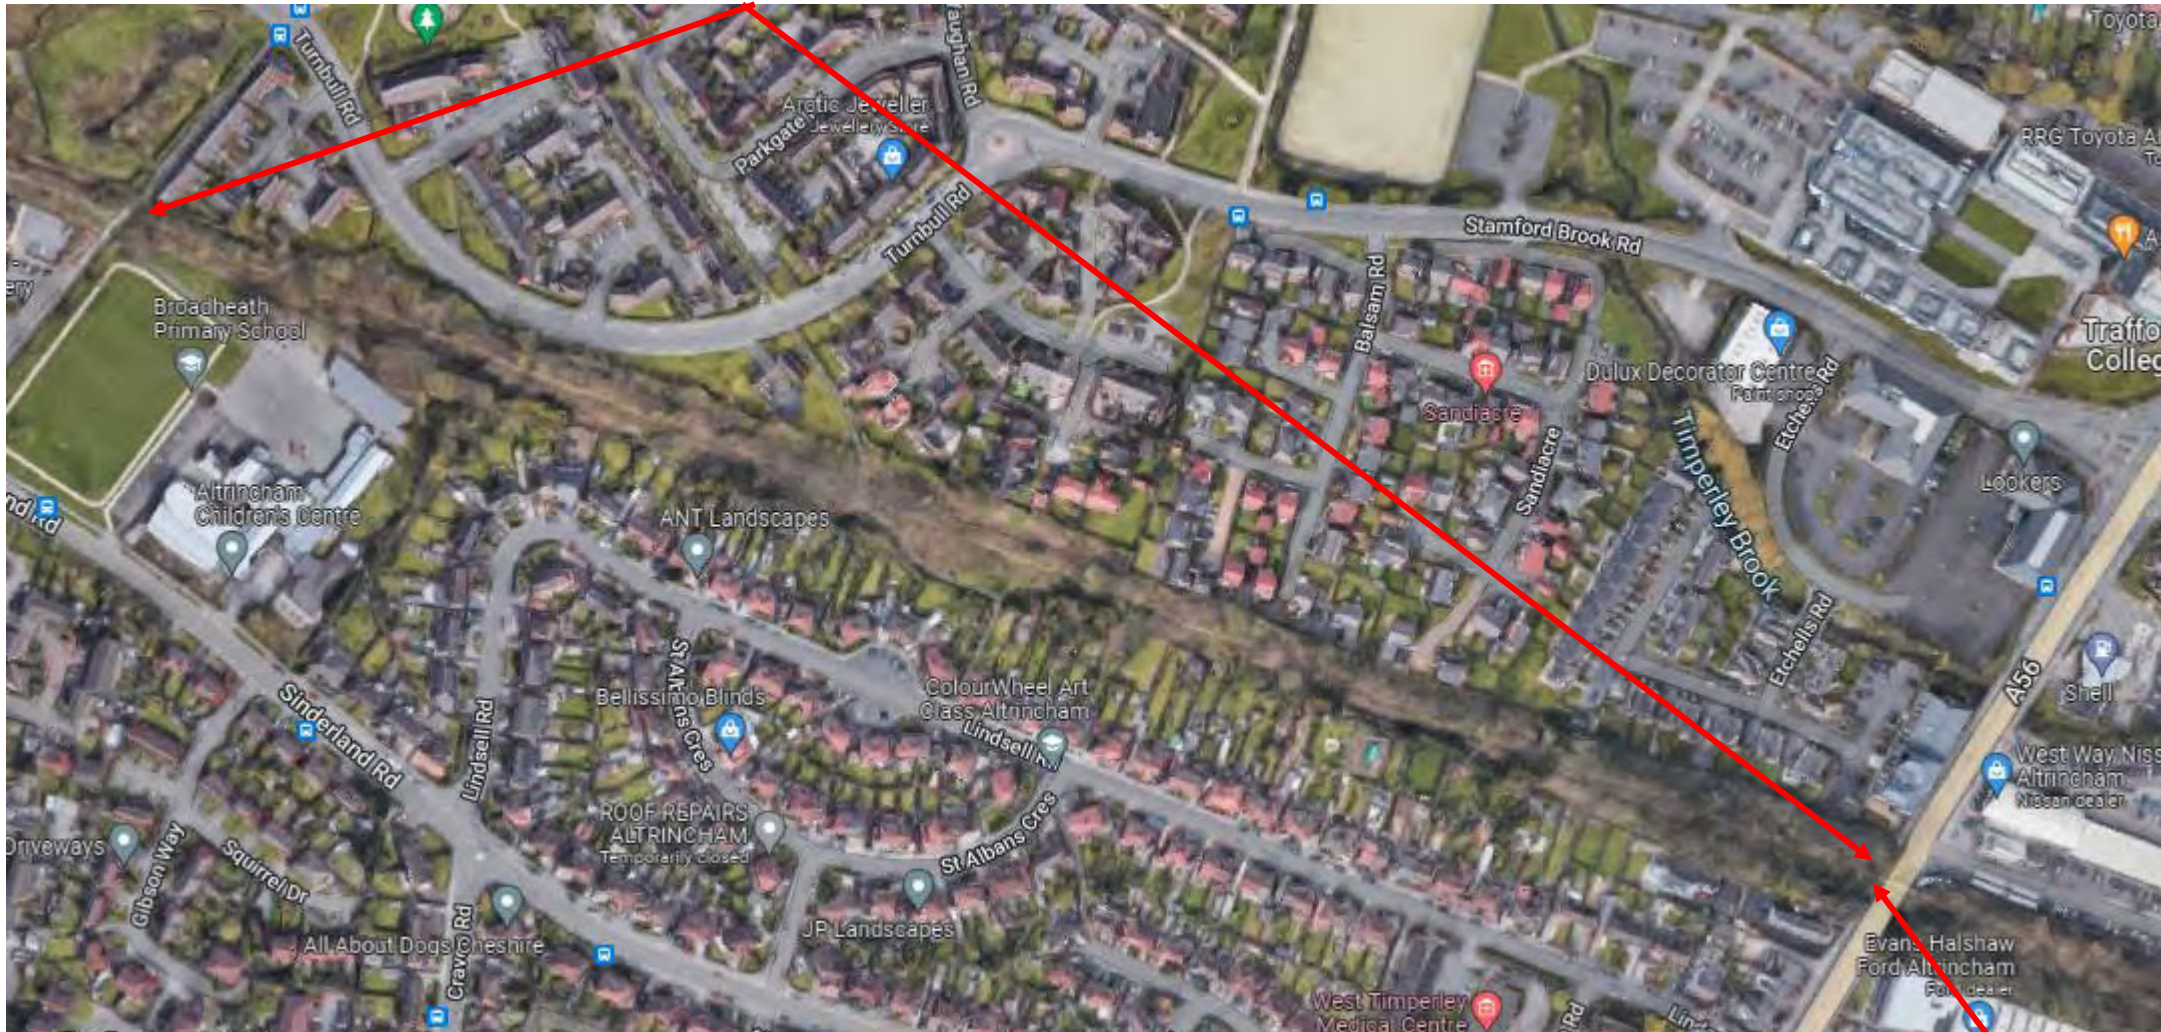
Segment 9 – Broadheath Community School – A56 Manchester Road

- The dis-used railway is not usable as a footpath and no alternative footpath was seen during the site visit. No footpath shown in Google Maps either. There are sections of track and sleepers still in place. Significant works would be required to convert the dis-used rail route into a greenway.
- Access over the bridge over A56 Manchester Road is prevented by locked gates

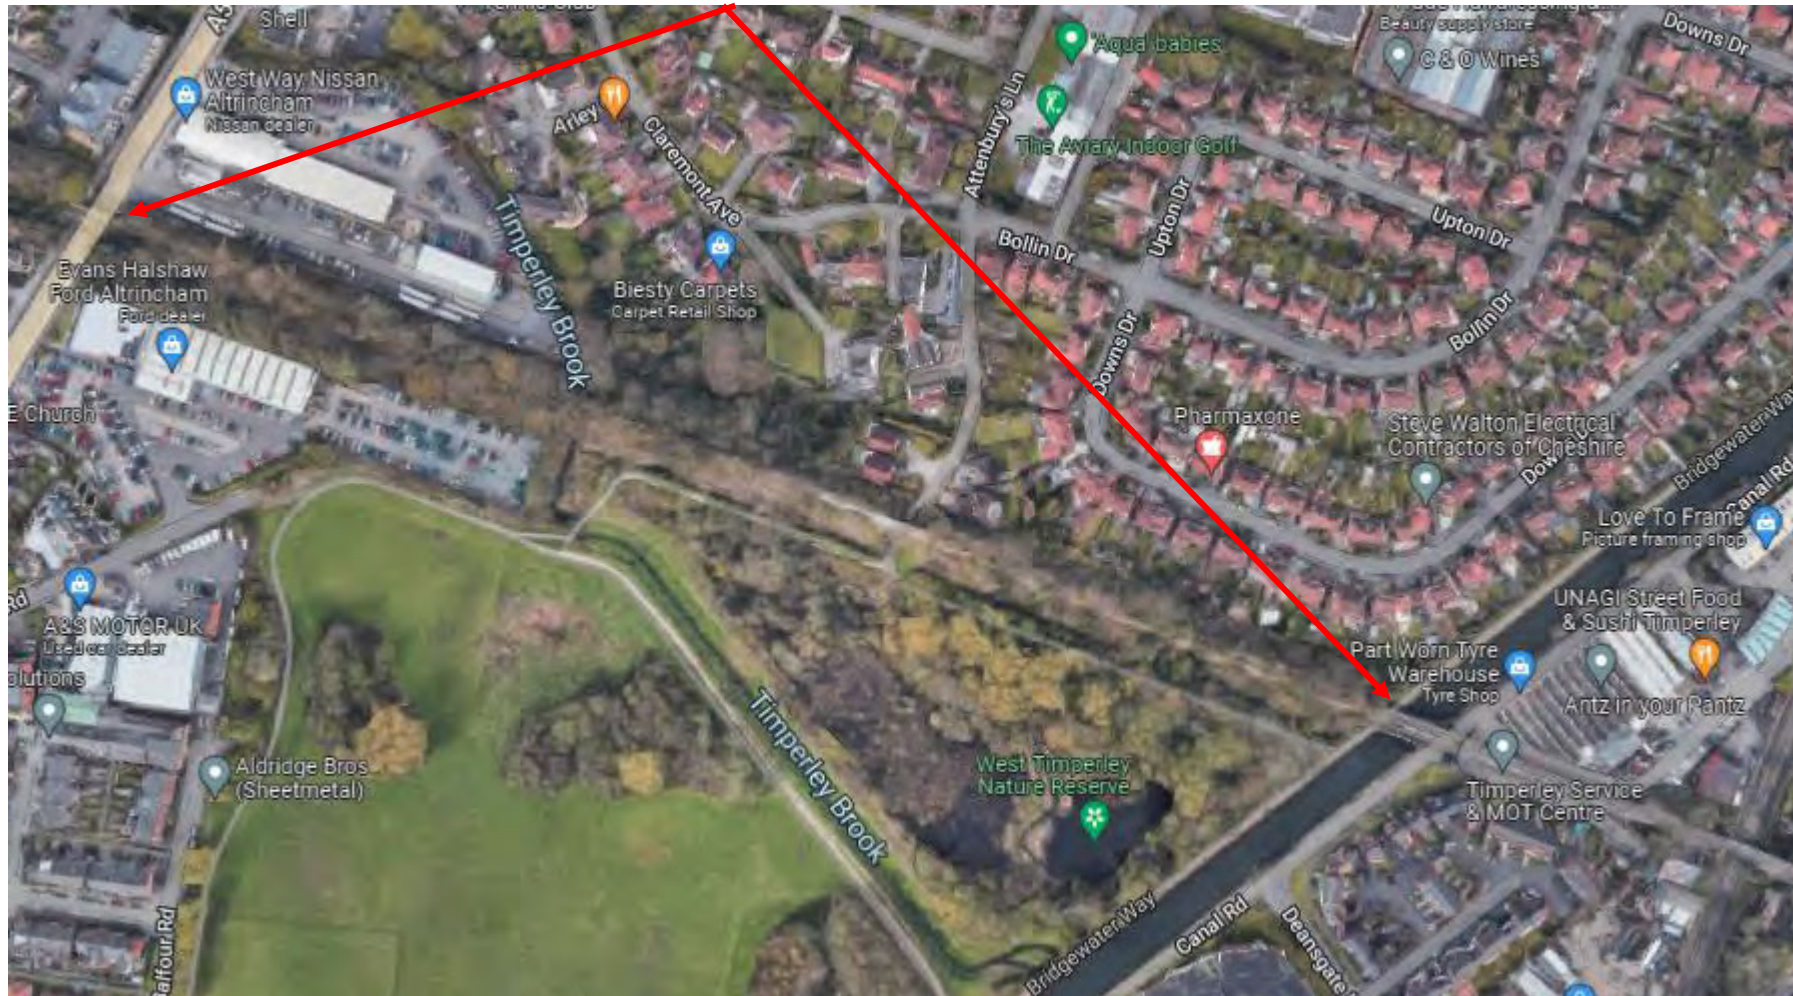
Segment 10 – A56 Manchester Road – Bridgewater Way Canal

- The dis-used railway is not usable as a footpath and no alternative footpath was seen during the site visit. No footpath shown in Google Maps either. There are sections of track and sleepers still in place. Significant works would be required to convert the dis-used rail route into a greenway.
- There are some footpaths around the route

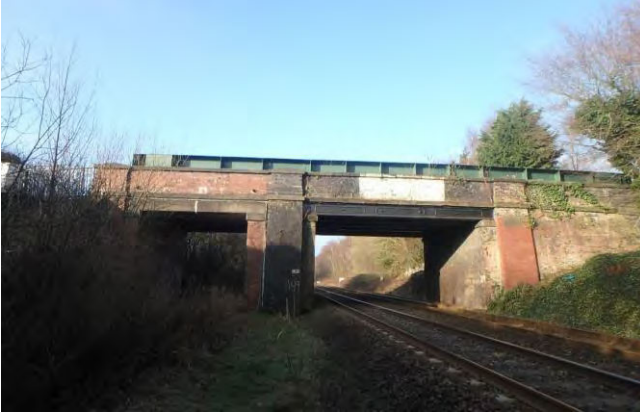
New Moss Road Bridge

The structure is in fair condition.

Sources	Item	Condition	Amey Comments
1 2021 DE	Main Girders	Fair	Scaling to the bottom flanges of the outer girders, patches & spots of corrosion to the outer faces of the outer girders.
2 2021 DE	Brick Jack Arches	Fair	Span 1 Brick jack arches, generally in a fair condition showing general weathering and area's of hollow sounding brick. Tie bars between the arches are severely corroded.
3 2021 DE	Concrete Deck	Fair	Minor casting defects, small areas of leeching to the elevations
4 2021 DE	Bolts	Good	Tie bar ends on the outer faces of the main girders, no defects noted.
5 2021 DE	Abutments	Fair	Downside: Only minor defects noted. Upside: Brickwork repairs have been carried out to the buttresses and fractures repointed, some fractures remain.
6 2021 DE	Pier	Fair	Brickwork repairs have been carried out to the buttresses and fractures repointed, some fractures remain
7 2021 DE	Wing Walls	Fair	Downside: Only minor defects noted. Upside:

8 2021 DE	Pointing	Fair	Odd bricks spalled and isolated open joints, missing brickwork Approximately 17m2 total showing slight deterioration
9 2021 DE	Parapets	Fair	Minor defects noted to the outer faces, i.e weathered joints. Diagonal hairline fractures at repair full height of Parapet to the road face of the low mileage parapet. Spalled and displaced brickwork to end of the high mileage parapet. Parapets steel cappings were in fair condition.
10 2021 DE	Bedstones and Cills	Fair	Two cracked bedstones on the pier of span No 1. Slight weathering to the remainder of the bedstones Concrete cills of span 2. No defects noted other than wetness & water stains
11 2021 DE	Bearings	Cannot Determine	Not examined, built into the brickwork.
12 2021 DE	Waterproofing	Cannot Determine	Some evidence of water percolation to span 2.
13 2021 DE	Drainage	Fair	Water staining to the pier face beneath span 2.
14 2021 DE	Painting	Poor	Paintwork defective particularly in areas of corrosion.

15 2021 DE	Track/Road Condition	Fair	No defects noted to the track. The protective raised concrete kerbs are damaged towards the upside end.
16 2021 DE	Ballast Walls	Fair	No defects noted other than slight weathering.
17 2021 DE	Vegetation	Fair	Tree growth adjacent to the downside high mileage wing wall. Trees also growing in close proximity to the disused span from the track bed.
18 2021 DE	Pipe and Carriers	Poor	Pipe support is missing. Severe corrosion throughout the 3 remaining pipe carriers, but were firm when sounded with a prodder. Long standing defect. Severe corrosion throughout the un-lagged part of the pipe traversing jack arch No 2. Long standing defect.
19 2021 DE	Carbon Fibre Strengthening	Good	Carbon fibre strengthening strips to concrete deck to span 2 majority in good condition with no deformation noted. 250mm of staining present to high mile strip.

Category	Location	Est Cost £	Description
1 Steelwork	Tie Bars	nil	Investigate the need for the corroded tie bars and remove. Renew if required. £10,000 estimated by NR but not required for Greenway.
2 Pipe and Carriers	Service pipe	nil	Investigate ownership and liability for the service pipe suspended off the soffit and remove or reinstate/refurbish. £1,000 estimated by NR but not required for Greenway.
3 Masonry	Pier, Abutments, Parapets & Wing Walls	nil	Masonry repairs including pointing open joints, replacing spalled damaged bricks. £10,000 estimated by NR but not required for Greenway.
		Total £0

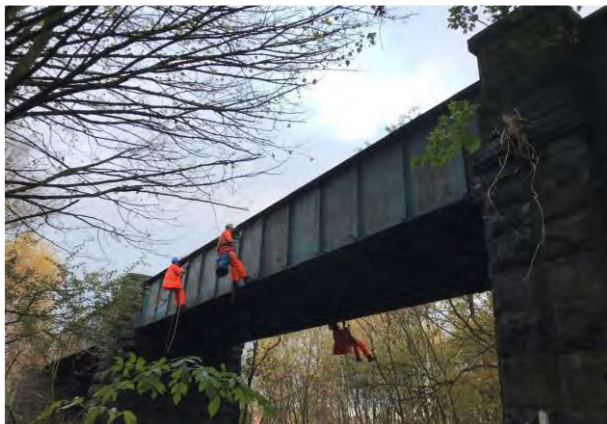
Moss Lane Bridge

The structure carries a footpath over the redundant railway. It is assumed that the structure was originally designed to pedestrian loading to historical standards, which would be less conservative than loading requirements to current standards. Latest inspections reported moderate/severe sections losses to girders, full section loss at bearing stiffener. Assessment and Inspection for Assessment recommended.

The structure is in fair to poor condition. Girder section losses could affect load carrying capacity.

Sources	Item	Condition	Amey Comments
1 2020 DE	Bearing	Fair	Bearings in good condition.
2 2020 DE	Main Girders	Fair	Girders in fair condition with areas in poor condition.
	<i>Span 1</i>		3mm loss of section to underneath of bottom flange at supports. Knife edging and notches to internal end of bottom flange at supports, up to 200x80mm section loss. 2-4mm section loss to internal top surface of bottom flange to full length of girder. Isolated de-lamination and notch to internal edge of top flange of HM girder, section loss of 200x50mm. Rivet heads typically corroded 1-3mm.
	<i>Span 2</i>		4mm loss of section to underneath of bottom flange at supports. Knife edging and notches to internal edge of bottom flange at supports, up to 150x40mm section loss. 2-4mm section loss to internal top surface of bottom flange to full length of girder. Rivet/bolt heads typically corroded 1-3mm.
	<i>Span 3</i>		Areas of up to 3mm loss of section to underside and edges of bottom flange at supports and midspan. The thickness of the internal edge of the bottom flange is down to 5mm at High Mileage Pier 3 support. 50mm diameter hole to the web, located 800mm from the top flange. Web thickness is down to 6mm in the area surrounding this hole. 2-4mm section loss to internal top surface of bottom flange, to full length of girder. Water seepage through the deck is evident. Rivet/bolt heads typically corroded 1-3mm.

<i>Span 4</i>		Area of complete loss of section to the web of the low mileage girder over the support at pier 3, 1261mm x 76mm is visible. Notches to main girders at the interface with the transverse concrete repair beam, up to 250x100mm section loss. Areas of up to 3mm loss of section to underneath and edges of bottom flange at supports and midspan. 2-4mm section loss to internal top surface of bottom flange to full length of girder. Water seepage through the deck is evident. Rivet/bolt heads typically corroded 1-3mm.
3 2020 DE	Parapets and Pilasters	Fair	1.328m minimum height is below the required 1.8 for equestrian use
4 2020 DE	Water Proofing	Cannot Determine	Areas of seepage were observed to the abutments, which suggests that the waterproofing system may have failed in these areas.
5 2020 DE	Abutments	Fair	Abutment in fair condition. General weathering to masonry with 5-10mm losses. Areas of open joints throughout, up to 40mm deep. Areas of light vegetation growth.

6 2020 DE	Bedstones and Cills	Fair	Generally fair condition.
7 2020 DE	Piers	Fair	Piers in fair condition Some masonry pilasters have been partially or wholly removed. Steel plates have been welded between MGE's where this is the case. General weathering to masonry with 5-10mm losses. Areas of open joints throughout, up to 40mm deep. Areas of light vegetation growth.
8 2020 DE	Wing and Retaining Walls	Fair	Wingwalls in fair condition. General weathering to masonry with 5-10mm losses. Areas of open joints throughout, up to 40mm deep. Areas of light vegetation growth.
9 2020 DE	Drainage	Poor	No current drainage infrastructure noted. Inadequate drainage evident.
10 2020 DE	Painting	Poor	Generally poor condition
11 2020 DE	Pointing	Fair	Generally, in fair condition. Areas of open joints throughout, up to 40mm deep.
12 2020 DE	Rivets and Bolts	Fair	Rivet/bolt heads typically corroded 1-3mm. Some rivets/bolts missing.

14	2020 DE	Trough Decking	Fair	Troughing is in fair condition. Typical loss of 3mm to bottom surface of troughing at support and midspan.
15	2020 DE	Vegetation and Debris	Good	Minor vegetation growth
16	2020 DE	Wing Safety Fencing	Poor	Poor condition. Safety fencing to north abutment approach is missing

Element	Risk	Comments
1 Girders / trough deck connections	High	Condition at connections would affect u-frame restraint to girders. Recommend trial holes to investigate as part of inspection for assessment

Category	Location	Est Cost £	Description
1 Painting	Bridge deck girders and troughing	£190,000	Blast clean all metalwork, carry out metalwork repairs where required, prime and overcoat throughout.
2 Vegetation	Throughout structure	£1,000	Cut back vegetation and treat roots
3 Steelwork repairs	Bridge deck girders and troughing	£15,000	Repair holes to steelwork
4 Other	Retaining wall	£3,000	Undermining of concrete retaining wall to ballast retention
5 Handrail renewal/repair	Bridge approaches	£3,000	Install missing safety fencing
6 Handrail renewal/repair	Parapet	£10,000	Increase parapet height to 1.8m by installing 0.4m high Kee Clamp handrail to the girder flange
7 Footpath surfacing improvement	Surfacing	£15,000	Assumed laying of semi-bound surfacing material, e.g. Ultitrec
8 Inspection for assessment	Design	£8,500	Inspection includes special access and trial holes for hidden critical elements
9 Bridge deck assessment	Design	£25,000	CS454 assessment for bridge deck

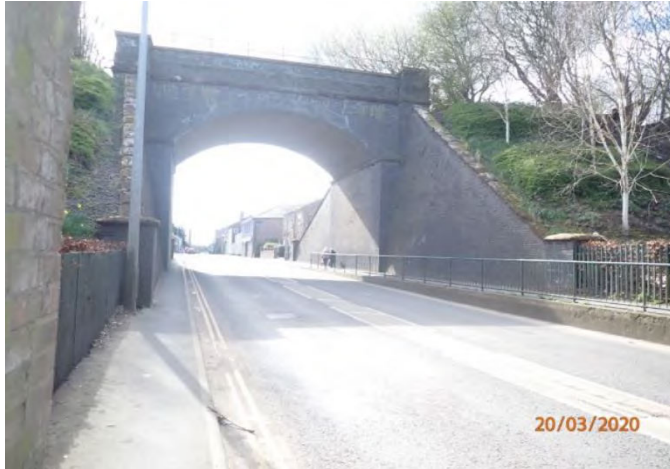
Liverpool Road Bridge

The structure is in fair condition.

Sources	Item	Condition	Amey Comments
1 2020 DE	Arch Ring	Poor	Numerous longitudinal fractures up to 1mm wide. Some minor weathering to the bricks up to 5mm.
2 2020 DE	Parapets and Pilasters	Poor	1m Vertical 3mm fracture up side. 1m diagonal 5mm fracture up side. 7m2 hollow sounding brick work to upside. 5m2 hollow sounding brickwork to down side. Odd spalled brick up to 5mm depth. Non offensive graffiti.
3 2020 DE	Spandrels	Poor	Various vertical fractures on the upside and downside spandrels up to 1mm thick. Areas of seepage to both spandrels.
4 2020 DE	Water Proofing	Cannot Determine	Signs of failure
5 2020 DE	Abutments	Fair	2 missing bricks on the high mileage abutment. Various vertical fractures up to 1mm depth. Odd bricks weathered up to 5mm deep.
6 2020 DE	Bedstones and Cills	Fair	Weathered brickwork throughout up to 15mm deep. 2 no bedstones vertically fractured open 2mm to the high mileage abutment.

7 2020 DE	Wing and Retaining Walls	Fair	Numerous spalled copings up to 80mm depth. 2 no bricks missing below the copings on the downside low mileage wing wall. 2.1m diagonal 1mm fracture on the upside high mileage wall.
8 2020 DE	Drainage	Cannot Determine	Signs of failure
9 2020 DE	Handrails	Poor	Bridge handrails have missing sections and moderate corrosion to all.
10 2020 DE	Painting	Fair	Paint breakdown to handrails and posts.
11 2020 DE	Pointing	Fair	Arch ring: 2m2 open joints up to 10mm depth Parapet (upside): 15m2 open joints up to 20mm depth Parapet (downside): 14m2 open joints up to 20mm depth Spandrel (upside): 1m2 open joints up to 15mm depth Spandrel (downside): 1m2 open joints up to 10mm depth Abutment (high mileage): 11m2 open joints up to 10mm depth Abutment (low mileage) : 8m2 open joints up to 10mm depth Wing wall (up side high mileage): 15m2 open joints up to 15mm depth Wing wall (up side low mileage): 18m2 open joints up to 20mm depth Wing wall (down side high mileage): 15m2 open joints up to 20mm depth Wing wall (down side low mileage): 5m2 open joints up to 10mm depth

12 2020 DE	Rivets and Bolts	Fair	Areas of moderate corrosion to all bolts to handrails.
13 2020 DE	Track/Road	Fair	Mature trees growing on the top surface, otherwise no defects recorded.
14 2020 DE	Vegetation	Fair	Mature trees growing on the top surface. Light weeds and grasses growing to parapet faces.
15 2022 Visit	Other	Fair	Access to the structure is prevented by Pallsade fencing. Fencing will need to be removed for the Greenway.

Category	Location	Est Cost £	Description	
1	Masonry re-pointing	Arch barrel, abutments, wing walls and parapets	£15,000	Re-point all open joints and fractures throughout structure.
2	Brickwork/stone repairs	Parapets and pillasters, abutments and newels	£7,500	Replace missing and weathered bricks across structure.
3	Parapets	Parapets	£10,000	Replace the metal parapet extension
4	Approach fencing	On approaches to the bridge	£8,000	Install 10 m approach fencing on all 4 corners
5	Vegetation	Over bridge deck and embankments	£1,500	Remove vegetation and treat roots, point the root joints.
6	Footpath surfacing improvement	Surfacing	£10,000	Assumed laying of semi-bound surfacing material, e.g. Ultitrec
7	Traffic management	Liverpool Road	£5,000	TM for masonry works
8	Remove gates	At each end of bridge	£500	Remove the pallisade fencing gates currently blocking access across the bridge
		Total	£57,500	
		Total essential	£30,000

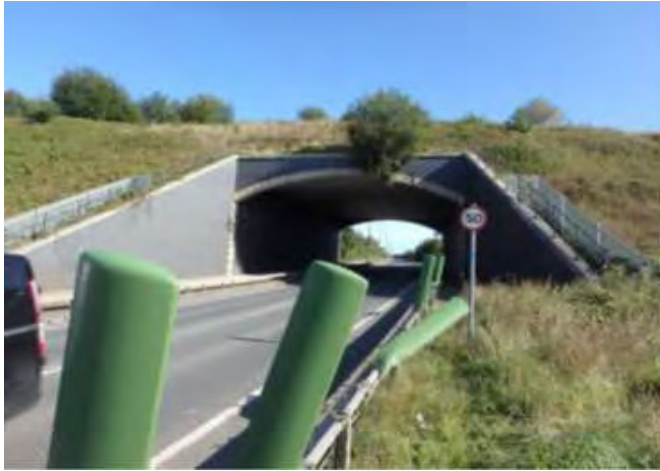
A57 Cadishead Way / North Bank Bridge

The structure appears to be in a good condition.

Sources	Item	Condition	Amey Comments
1 2017 PI	Deck	Good	Minor shrinkage cracking noted, less than 0.3mm. Minor spalling revealing a rusting plate over construction joint, monitor during future inspections
2 2017 PI	Spandrels	Good	Non-structural masonry facade displays isolated brickwork defects (popped brickwork). Steel arch lintel element on Southwest head wall have localised mortar failures and the lintels are not in line with arch radius.
3 2017 PI	Abutments	Good	No defects noted.
4 2017 PI	Wing and Retaining Walls	Good	No defects noted.
5 2017 PI	Pointing	Good	No defects noted.
6 2017 PI	Parapets/Safety Fence	Poor	Minor weathering present to paintwork of safety fence, however, no pedestrain parapet providing adequate edge protection for proposed greenway.
7 2017 PI	Bedstones and Cills	Good	No defects noted.
8 2017 PI	Bearings	N/A	
9 2017 PI	Waterproofing	Good	No signs of waterproofing failure from the available photos

10 2017 PI	Drainage	Good	No signs of drainage issues from the available photos
11 2017 PI	Track and Road Condition	Good	Minor debris build up on South abutment walkway.
12 2017 PI	Palisade Fence	Good	No defects noted. Consider removing to enable access ramp from the A57 to be constructed.
13 2017 PI	Vegetation	Good	Minor vegetation/saplings over wing wall

Element	Risk	Comments
1 Box culvert (abutments) & wing walls	Low	RC element is hidden behind the brick cladding. However, due to the young age of the structure the risk of corrosion is considered low.

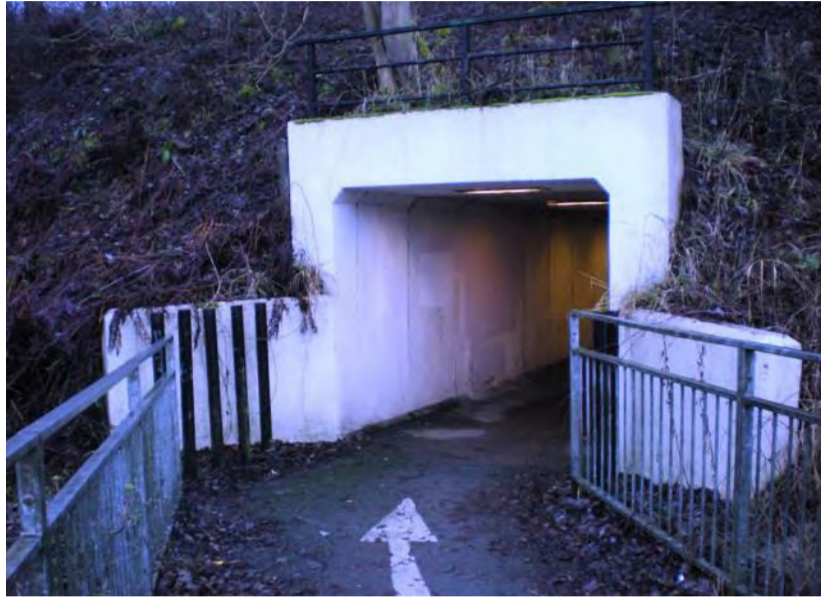
Footpath Subway / Lynn's Subway

The structure is in fair condition.

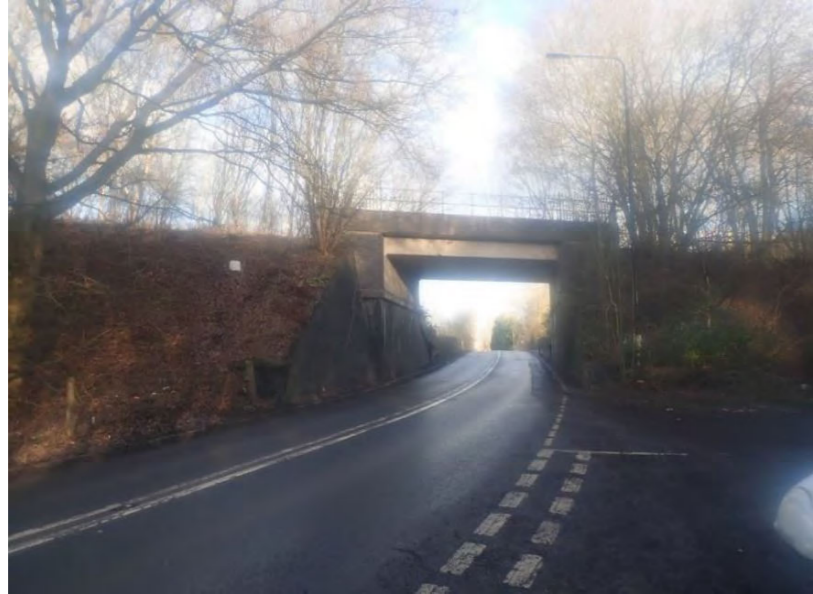
Lymm Road

Note: the structure is on the disused railway but may be unsuitable for the Greenway route as an alternative path may be preferable

The structure is in a fair condition.
