Trafford Greenway Feasibility Assessment Report

Mayor's Cycling & Walking Challenge Fund

CO00201536/001 Revision 3

05/07/2023

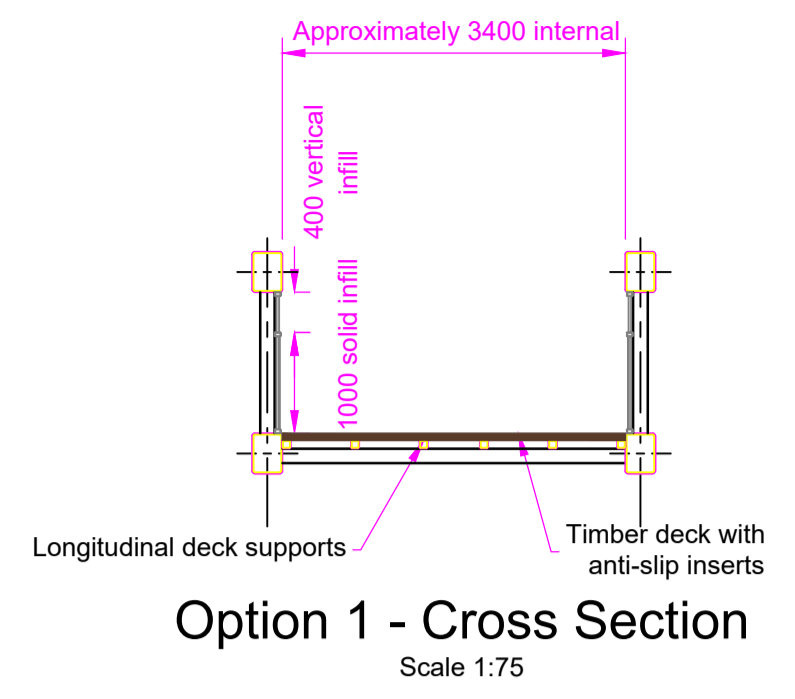
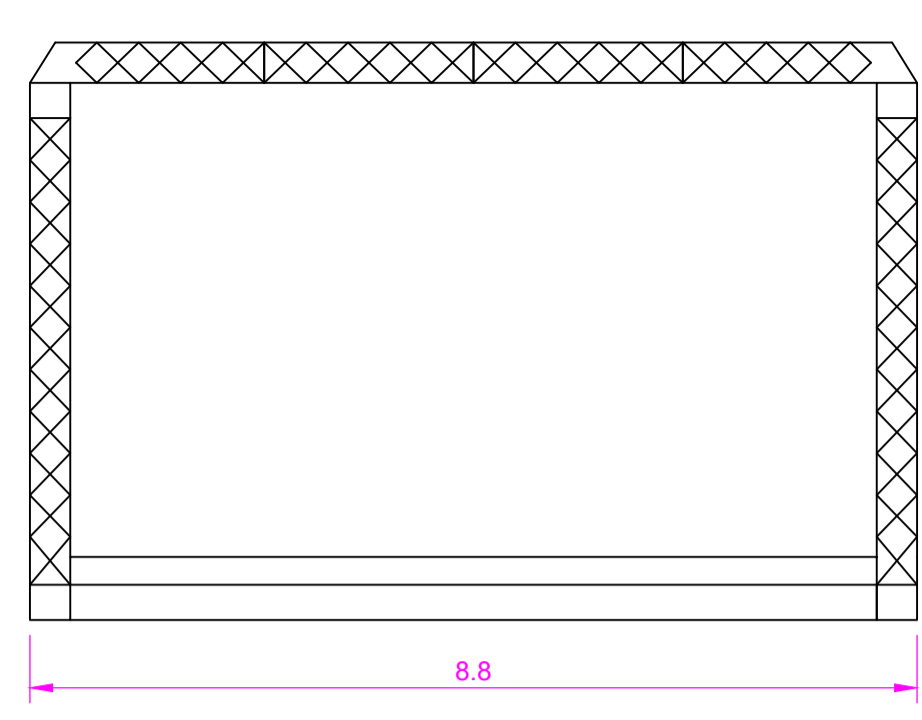
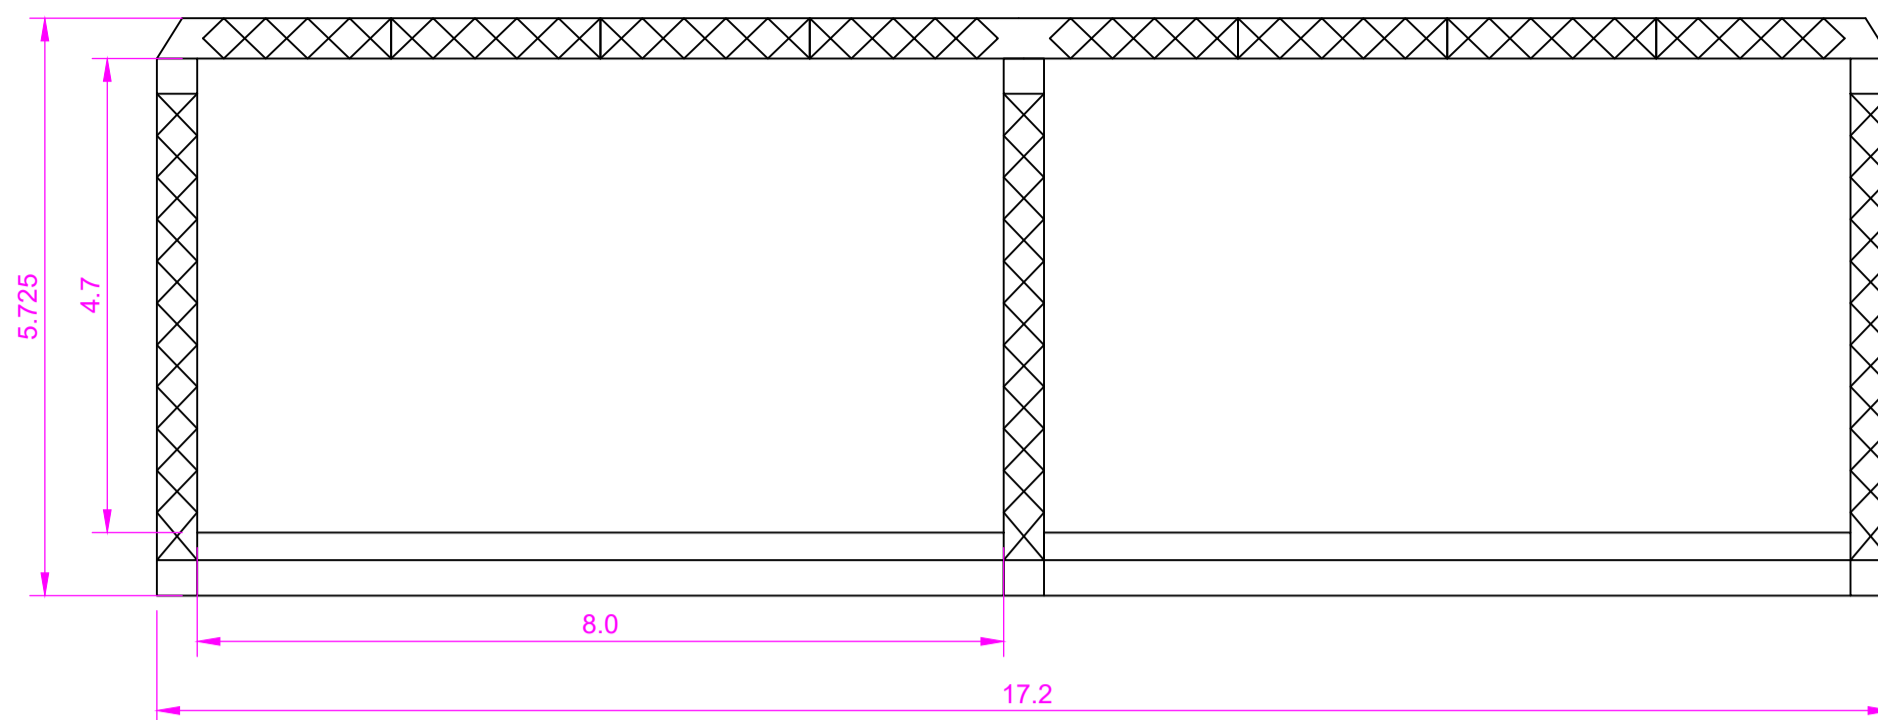
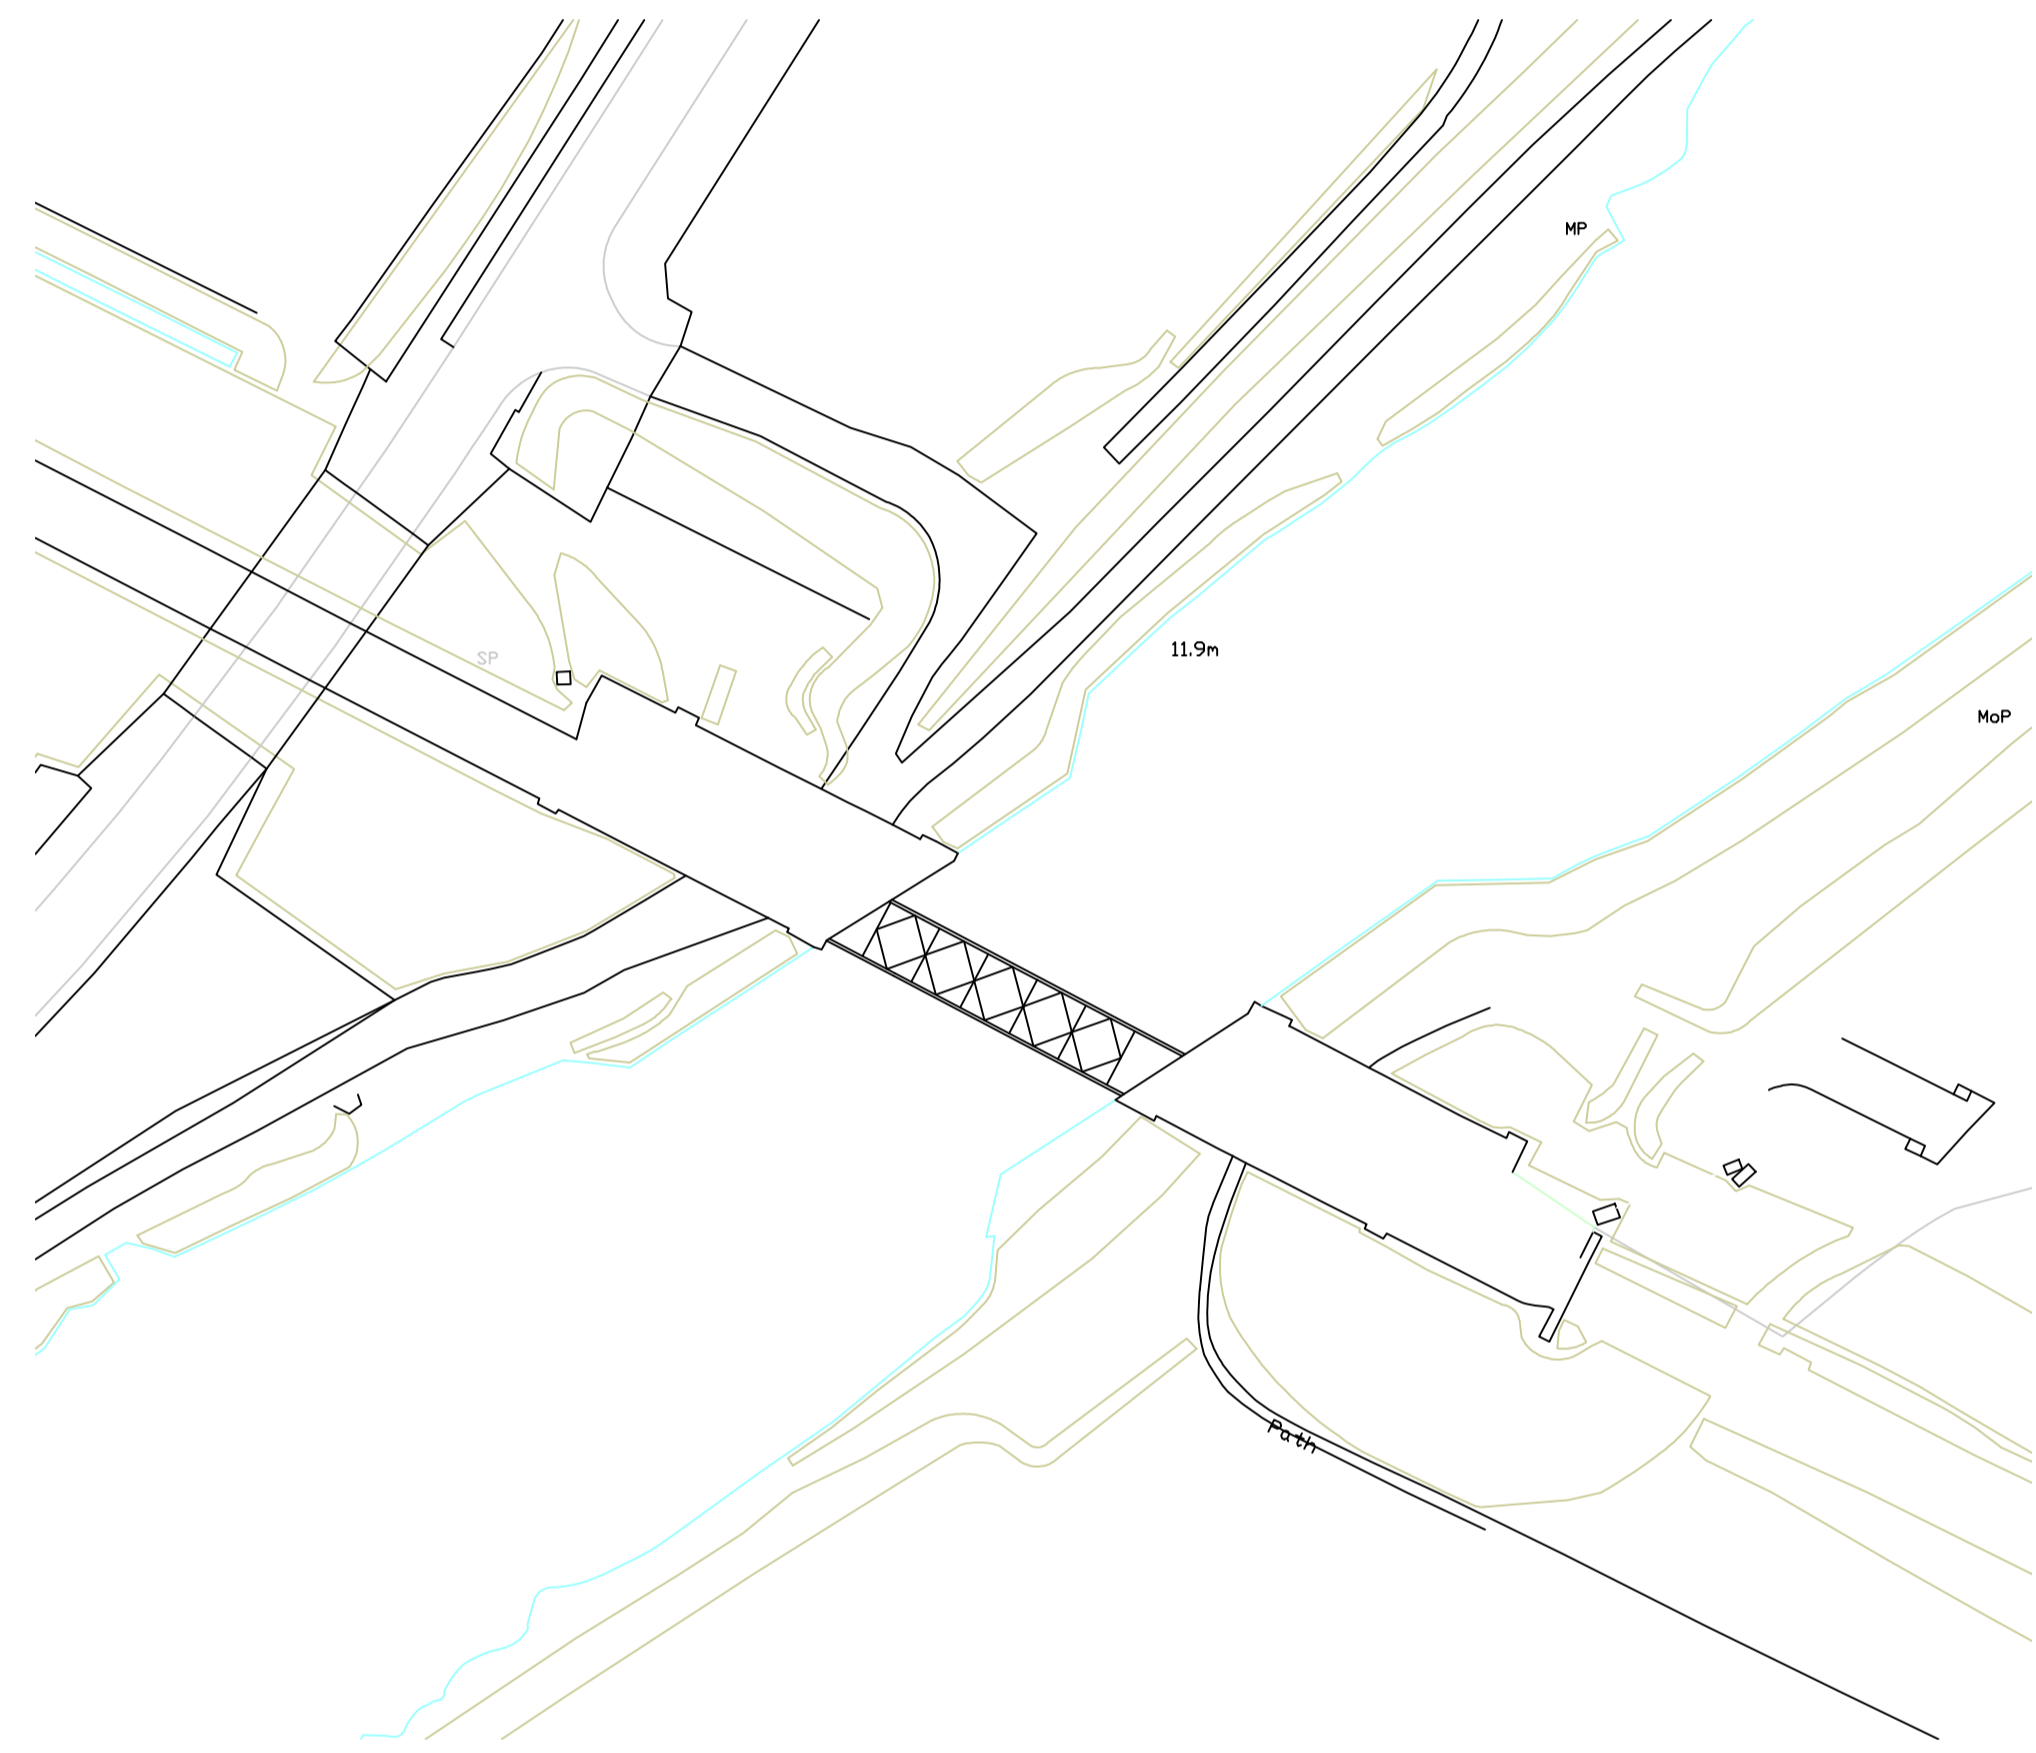
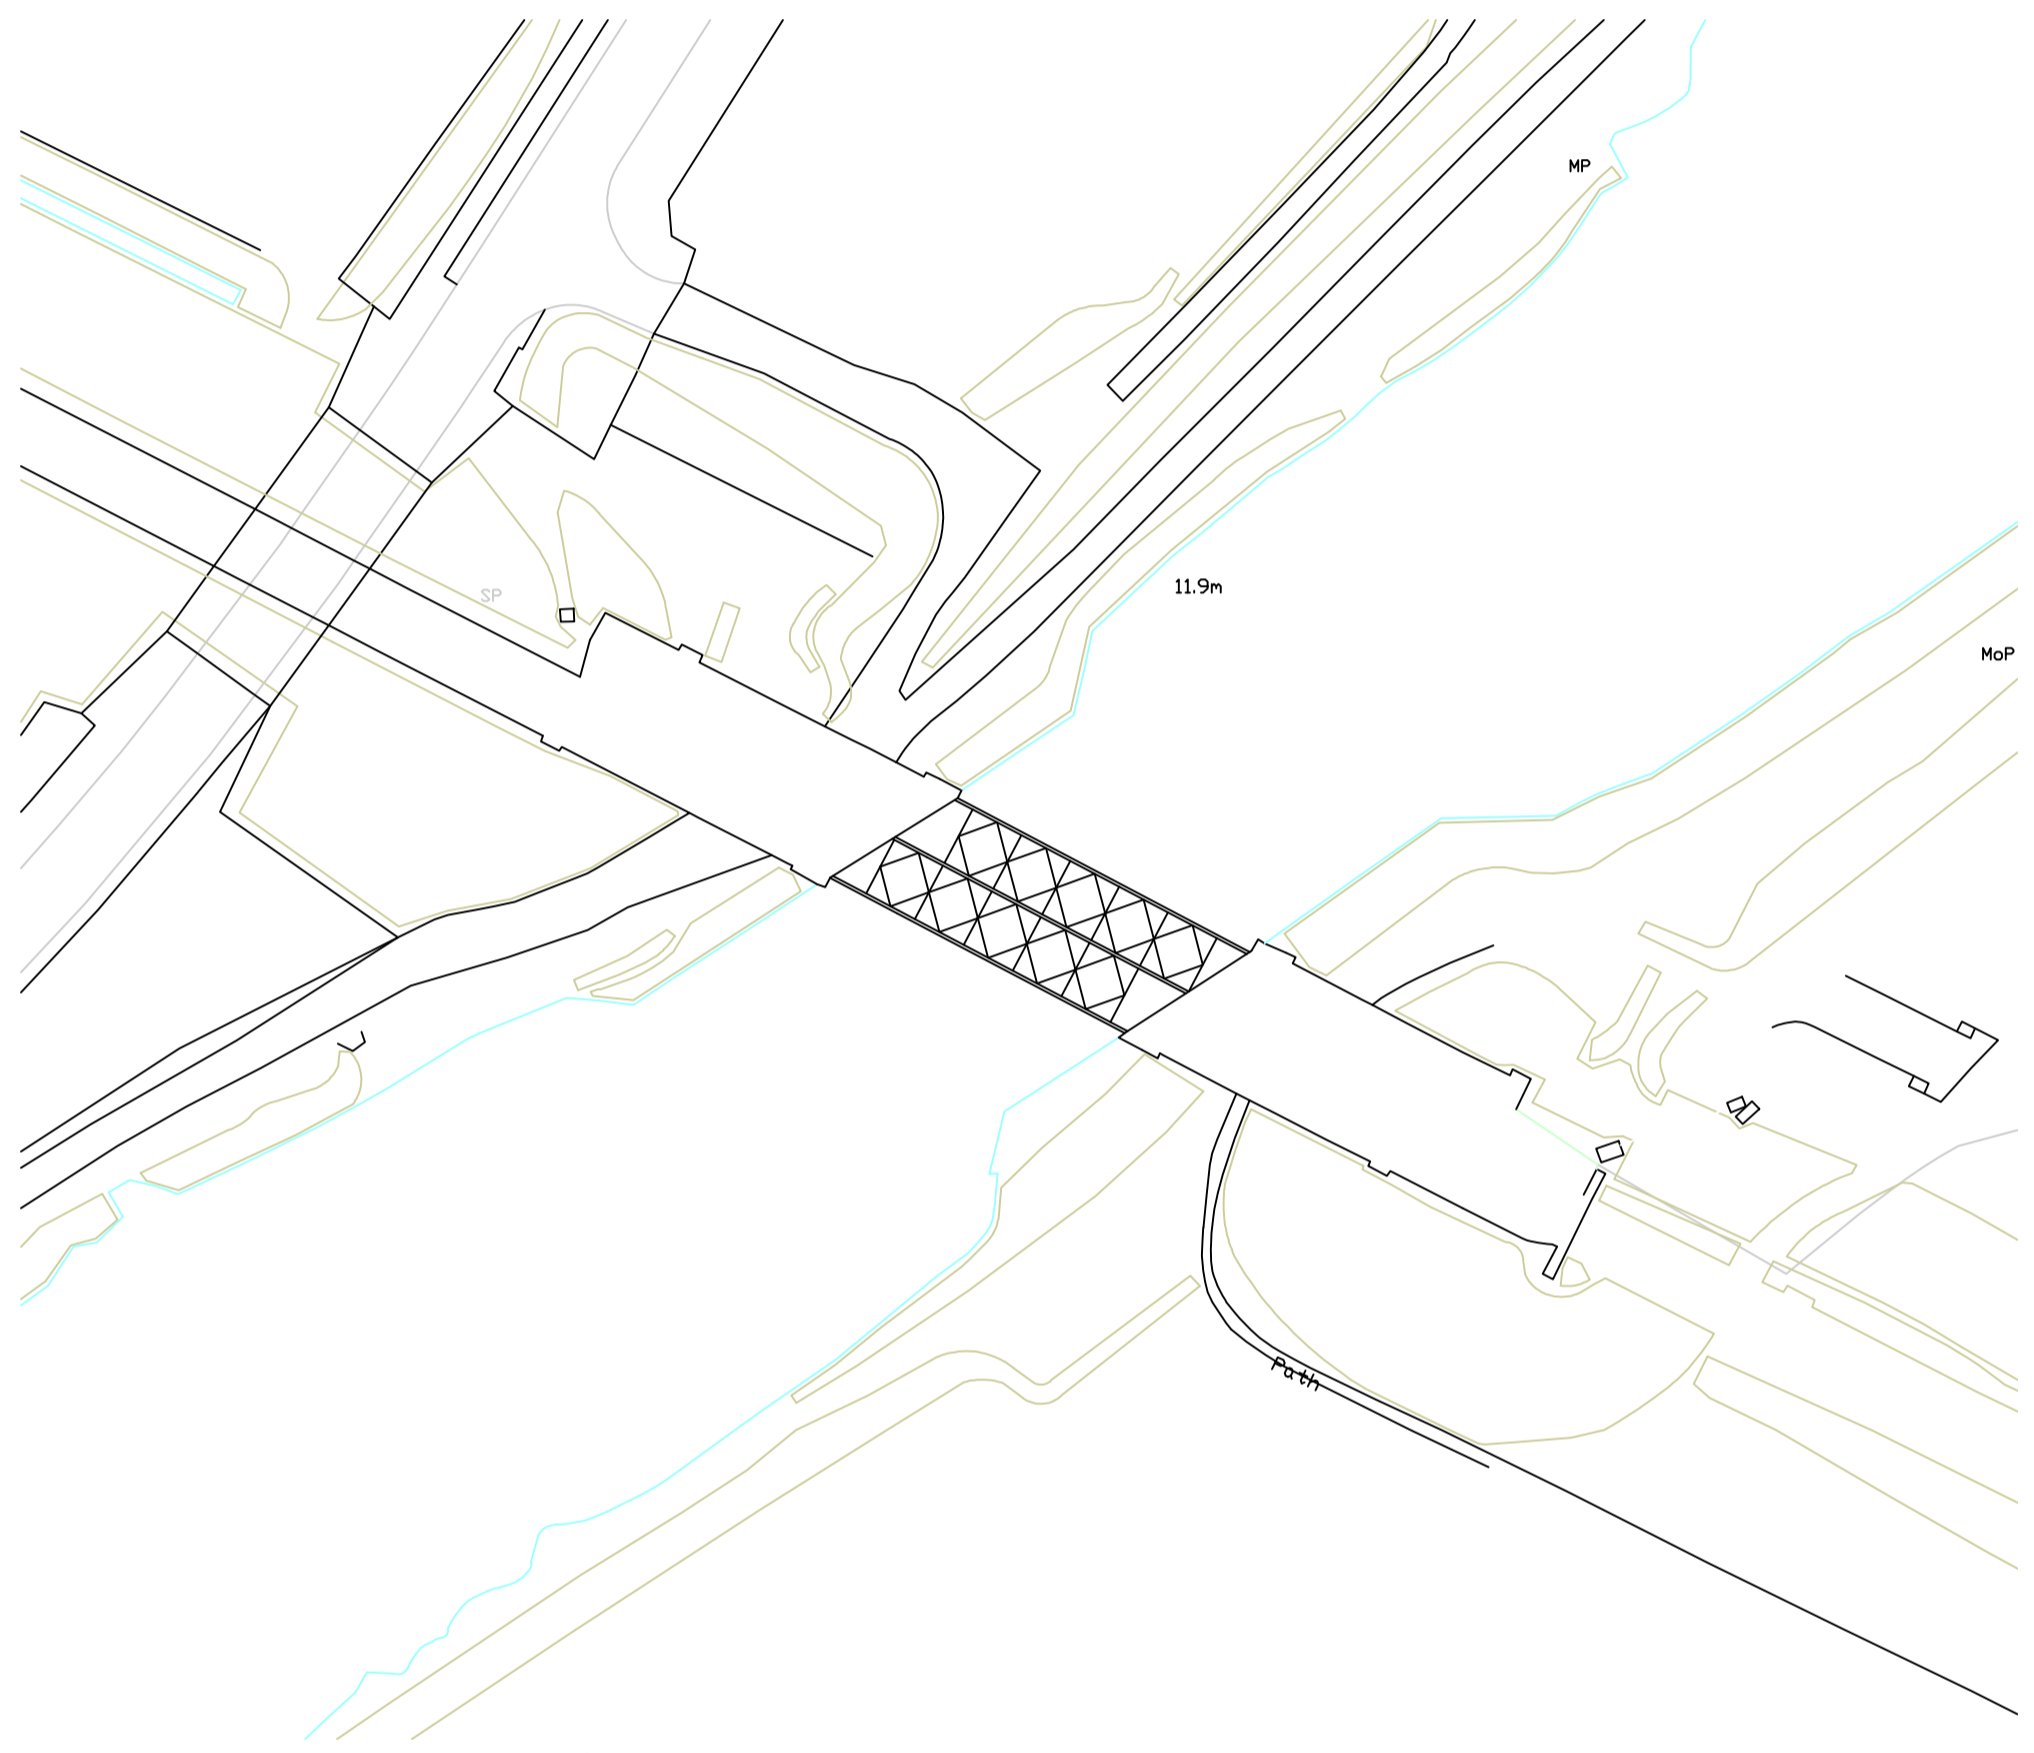
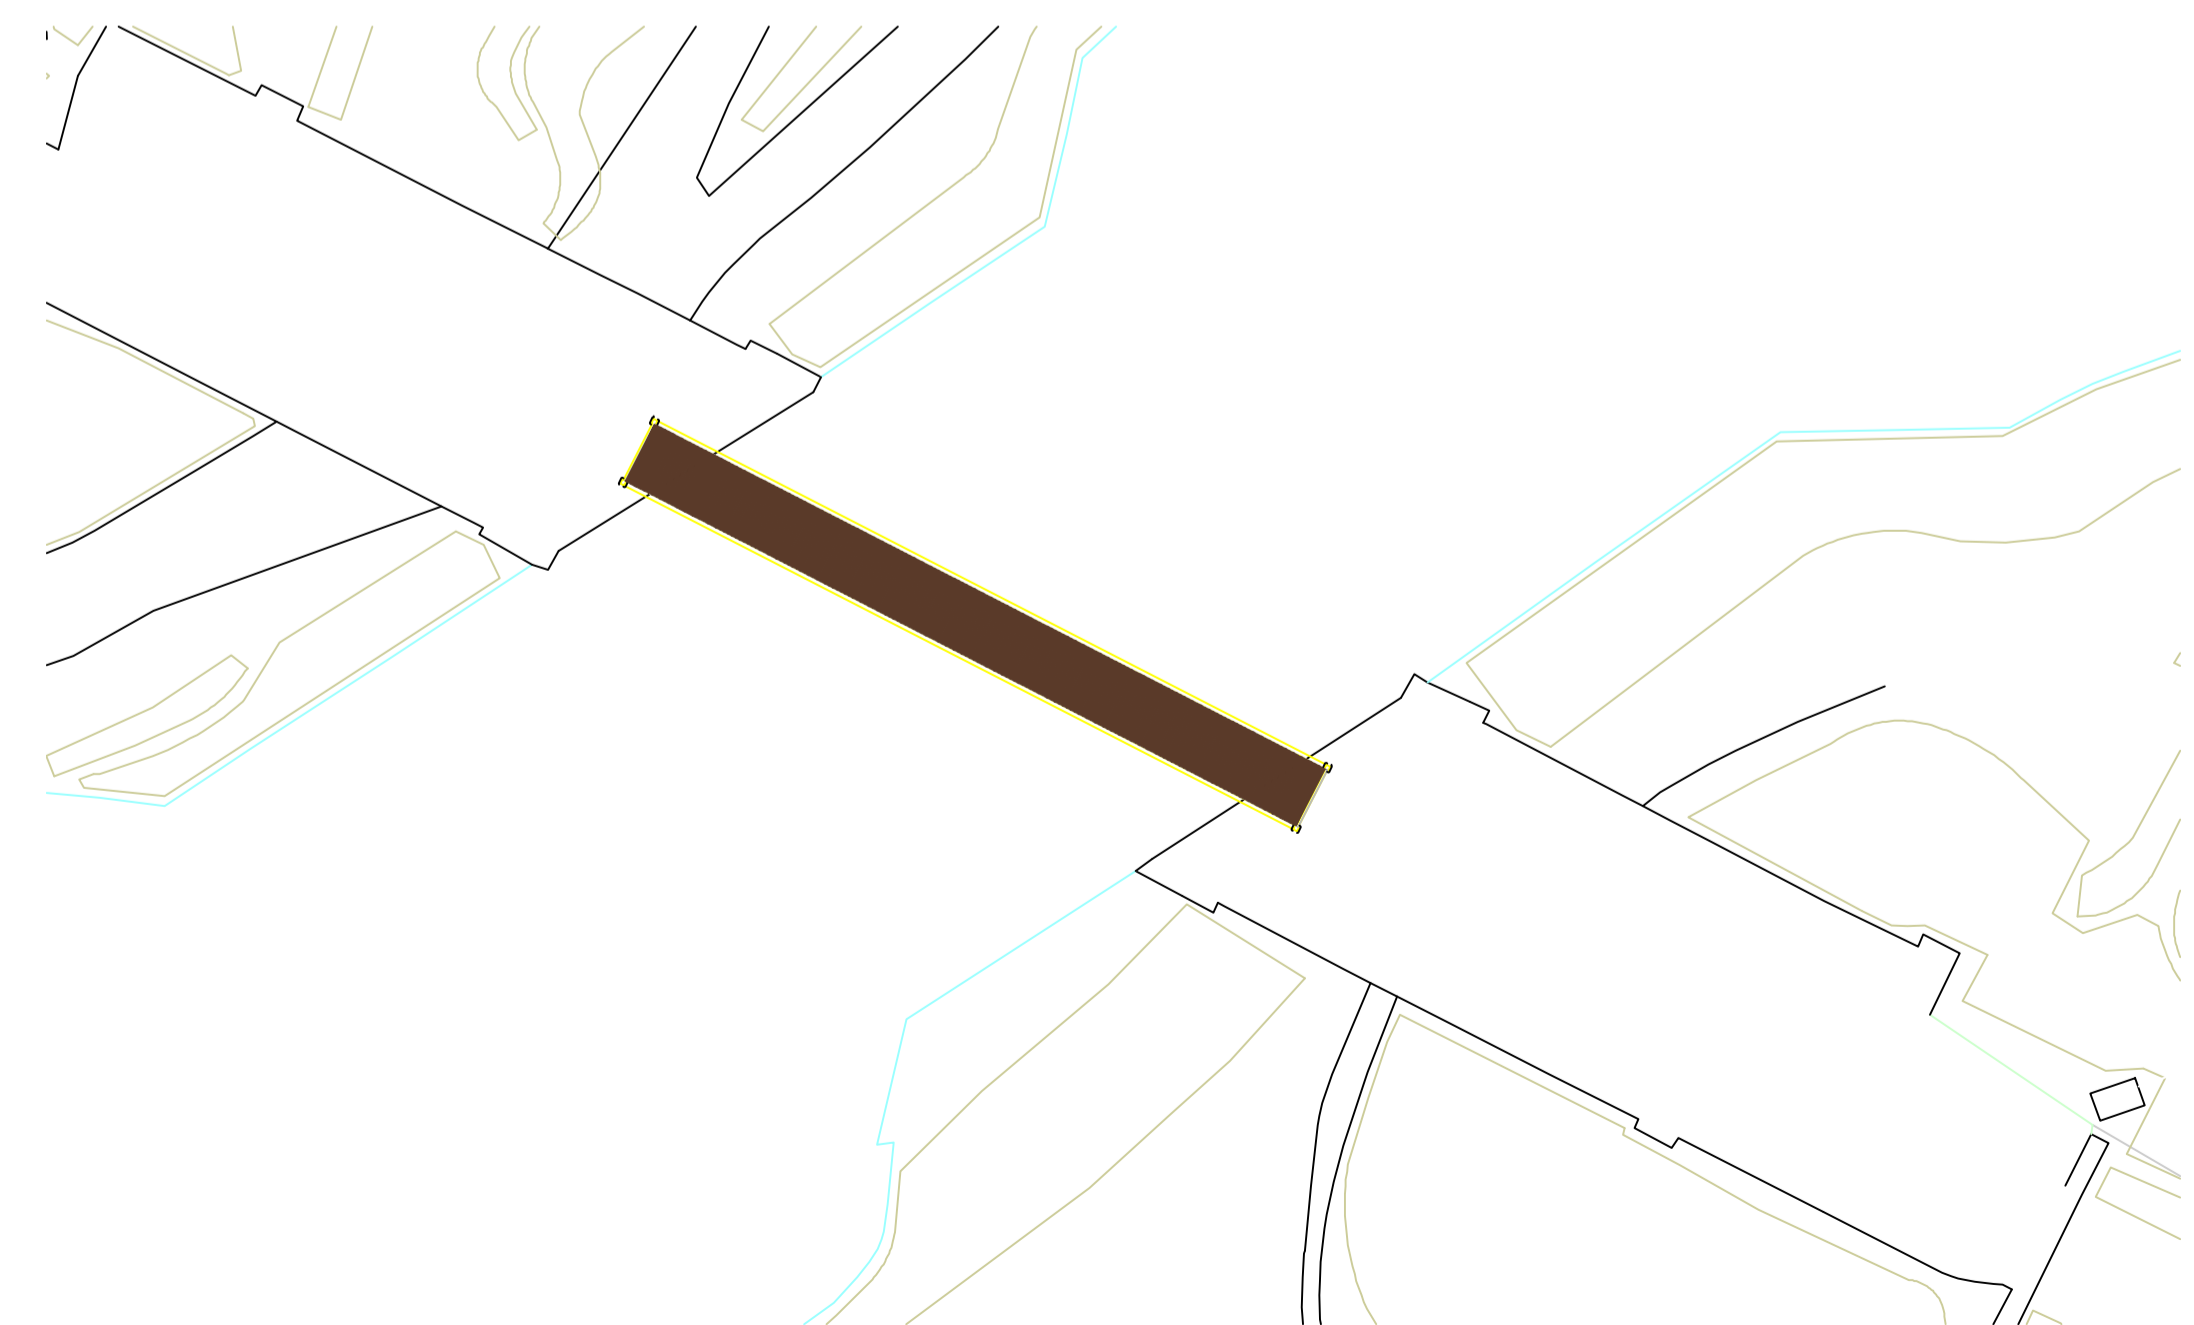
Drawing Title
**Cadishead Viaduct Option Details
Sheet 2 of 2**

Site visit Sept 2022		Underwater inspectin required to assess existing/potential scour	Inspection of masonry spans for assessment	£20,000	£112,800 (allows for painting topside of deck plates)	Inspection of masonry spans and half of span 3 for assessment	£30,000	incl.	Inspection of entire structure for assessment	£40,000	incl.
Site visit Sept 2022		General masonry repairs, re-pointing	Assessment of masonry spans, including check for stability of spans 2 and 4 when span 3 is removed	£75,000		Assessment of masonry spans and one remaining deck of span 3, including check for stability of spans 2 and 4 when span 3 is partially removed	£110,000	incl.	Assessment of masonry spans and both remaining decks of span 3.	£160,000	incl.
Metalwork											
DER 2020		6No. Pin bearings typically in fair condition. Lamination up to 15mm max. Corrosion 1-3mm to base of bearings. 30% loss of paint	Demolition planning	£50,000	incl.	Demolition planning	£50,000	incl.	No demolition	£0	incl.

Site visit Sept 2022		Containers placed to prevent access to span 3	Demolition and removal of existing 3No. Lattice girders and metal trough decking (P.P.O'Connor estimate)	£900,000	incl.	Part-demolition (P.P.O'Connor estimate)	£500,000	incl.	No demolition	£0	0
DER 2020		3No. Lattice girders. Fair condition, 15mm lamination and 40% paint loss. Connections and diagonals worse, with isolated loss of section	Design, fabricate and deliver to site 45m x 3m steel pratt-truss bridge. Capacity allows for 7.5T maintenance vehicles (CTS estimate)	£425,000	incl.	Design of new deck and refurbishment works	£200,000	incl.	Design of new deck and refurbishment works	£200,000	incl.
General comment DER 2020		Rivets generally fair, but poor to trough decking with loss of rivet heads	Enabling works, crane on prepared platform, assembly of Pratt truss from two halves. Utilizes prepared area used for demolition	£50,000	incl.	Construct new deck using metal troughing as non-participating formwork	£300,000	incl.	Construct new deck using metal troughing as non-participating formwork	£300,000	incl.

Site visit Sept 2022		corroded lattice girders	Parapet included in new structure	£0	incl.	Parapet mesh provision	£25,000	incl.	Parapet mesh provision	£25,000	incl.
Drainage											
General comment DER 2020		4No. Weep pipes between each cross girder, span 3, generally corroded throughout	Remove shipping containers and repair parapets where containers have been placed	£10,000	incl.	Remove shipping containers and repair parapets where containers have been placed	£10,000	incl.	Remove shipping containers and repair parapets where containers have been placed	£10,000	incl.
DER April 2020	7A	Drill holes to drain standing watertotrough decking at main girder 1.	Undertake drainage repairs	£6,000	incl.	Undertake drainage repairs	£6,000	incl.	Undertake drainage repairs	£6,000	incl.
			Uncertainty	£75,000		Uncertainty	£200,000		Uncertainty	£200,000	
			SUB-TOTAL	£1,736,000	£112,800	TOTAL	£2,191,000	£201,400	TOTAL	£2,141,000	£315,200

Previous exam reports	1B large 30mm wide fracture full vert height. Located D/S wing wall adjacent to tow path. Historic. Shows slight deterioration.			
Previous exam reports	1B Barrel fractures. Historic. No change since 2013.			
DER April 2020	4A Continue to monitor fractures to arch barrel soffits			
Span 1 - General masonry				
General comment DER 2020	Spandrels - All typically in fair condition,, minimum defects. Open joints.	undertake drainage repairs	£6,000	
Site vist Sept 2022	1S General masonry repairs and repointing			
General comment DER 2020	Pointing - in fair condition isolated areas of open joints typical 20mm, max 50mm			
DER April 2020	6A General masonry repairs, crack injection to span 1 frv south			
Span 1 - Drainage and Vegetation				
DER April 2020	7A Drainage refurb, downpipes and hoppers. remove vegetation, replace missing and broken pipes			
Pier 1 - General masonry				
General comment DER 2020	Piers - All in fair conditiuon. Typical defects dampness, calcite leaching, open joints, spalling and vertical fractures	Monitor fractures at 6-monthly intervals after opening the Greenway, with the intention of undertaking permanent repairs within 4 years Access by scaffold and rope	£3,000	£2,750

General comment DER 2020	Bedstones and Cills - Typically fair condition, some areas of dampness and calcite leaching. Isolated areas of spalling at elevations.			
DER April 2020	4A Continue to monitor fractures to vert fracture in Pier 1 ret wall			
Site vist Sept 2022	1S General masonry repairs, re-pointing			
Previous exam reports	2B area beneath barriers/containers Located above pier 1 not examined, inaccessible. No change since 2013

DER April 2020	3A	Full blast clean and metalwork repairs where req'd, and paint	Installation. Weight will be approximately 40 tonnes. Requires a 1000t crane lifting at maximum of 38m reach. Cost is for design manufacture and deliver of 40m x 3m Pratt truss bridge	£125,000	incl.	Metal repairs	£200,000	incl.	Metal repairs	£300,000	incl.
DER April 2020	7A	Trough decking in poor condition, loss of section throughout. Lamination up to 30mm. Paint loss 70%	Blast cleaning of existing metalwork n/a	£0	0	Blast clean metalwork and repaint (as advised by Volkerlaser)	£560,000	incl.	Blast clean metalwork and repaint (as advised by Volkerlaser)	£900,000	incl.
Site visit Sept 2022		severe corrosion to meal trough decking. Holes visible in many locations. Deck is unable to carry any imposed loading in current condition	Underwater inspection of piers 2 and 3	nil	nil	Underwater inspection of piers 2 and 3	nil	nil	Underwater inspection of piers 2 and 3	nil	nil

GENERAL MASONRY, ARCH BARRELS, DRAINAGE AND VEGETATION		WORKS THAT CAN BE DEFERRED		
Source	Item and comment	Proposed works	Est capital cost	Est maint. cost
North Abutment and Wing Wall (NE) - General masonry				
DER April 2020	5A Masonry repairs. Take down and rebuild part of NE wing wall	Reconstruct part of NW wing wall. Monitor remaining defects at 6-monthly intervals to ensure no movement of cracks after opening the Greenway, with requirement to undertake permanent repairs within 4 years Access by scaffold.or MEWP	£4,000	£4,400
General comment DER 2020	Wing wall (NE) - fair condition, but shows displacement up to 100mm			
General comment DER 2020	Abutments - Both east and west in fair condition, minimal defects. Open joints west abut and hairline fractures to east abut			
Span 1 - Arch barrel Clear span 14.3m, Height (approx) 5.0m				
General comment DER 2020	Arch rings - Generally fair. Multiple longitudinal fractures with isolated areas of open joints and calcite leaching. Face rings of stone construction also in fair condition. 1No. Diag fracture	Monitor remaining fractures at 6-monthly intervals after opening the Greenway with the intention of undertaking remaining repairs within 4 years. Undertake cross-stitching and crack injection to 30mm wide fracture. Access by scaffold or MEWP	£7,000	£5,550
