Project
Great Stone Road, Stretford
 Arboricultural Impact Assessment

Title
Drawing 2: Tree Removal and Protection Plan

Drawing Number
D6370.01.002B

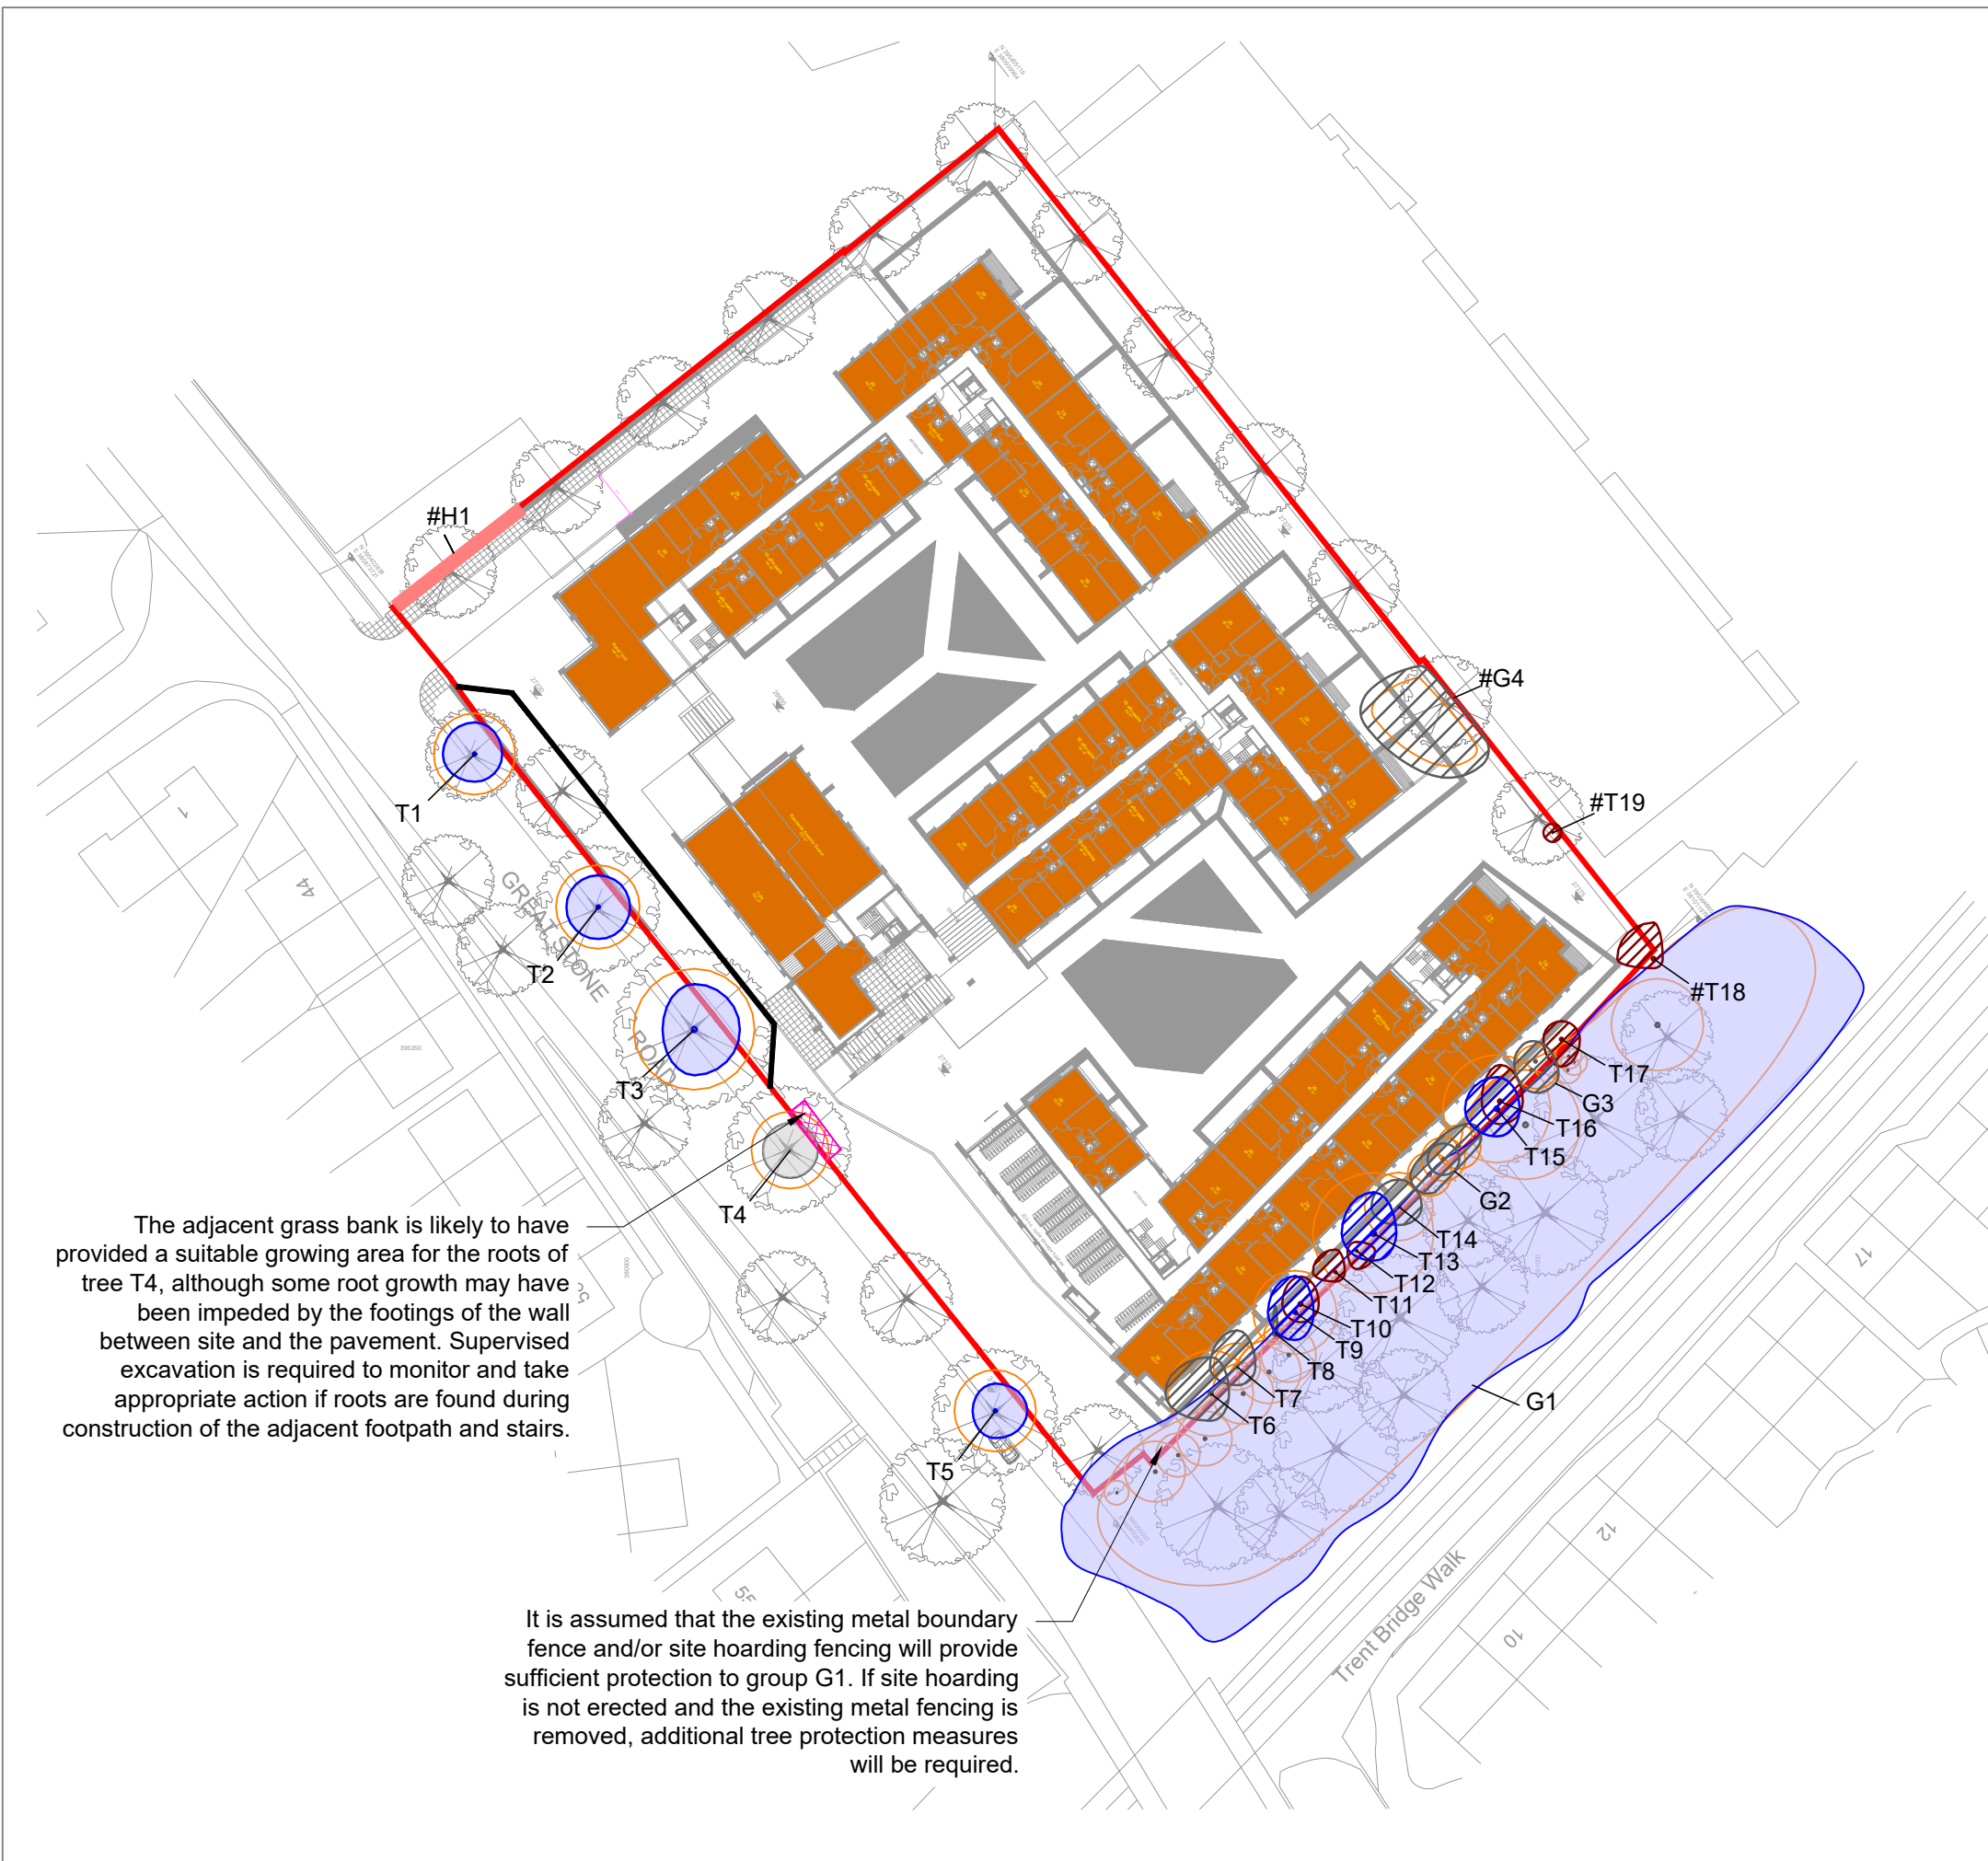
- T1 Individual trees
- G1 Groups of trees
- Application Boundary
- Approximate location (Feature not shown on topo)
- Tree Protection Fencing (c. 70.5m or 21 Heras Panels) (Must be installed prior to works commencement)
- Supervised Excavation (When the build programme has been drafted, the Site Manager will appoint an Arboricultural Consultant to supervise excavation works.)

Trees to be retained

- Category B (Moderate quality)
- Category C (Low quality)
- Category U (Trees with existing or potential conservation value)
- H1 Hedgerow (Not categorised)

Trees to be removed

- Category B (Moderate quality)
- Category C (Low quality)
- Category U (Unsuitable for retention)
- Hedgerow (Not categorised)

The adjacent grass bank is likely to have provided a suitable growing area for the roots of tree T4, although some root growth may have been impeded by the footings of the wall between site and the pavement. Supervised excavation is required to monitor and take appropriate action if roots are found during construction of the adjacent footpath and stairs.
