# Longford

Conservation Area Appraisal Consultation Draft June 2016

## Longford Park Conservation Area Conservation Area Appraisal Consultation Draft: June 2016

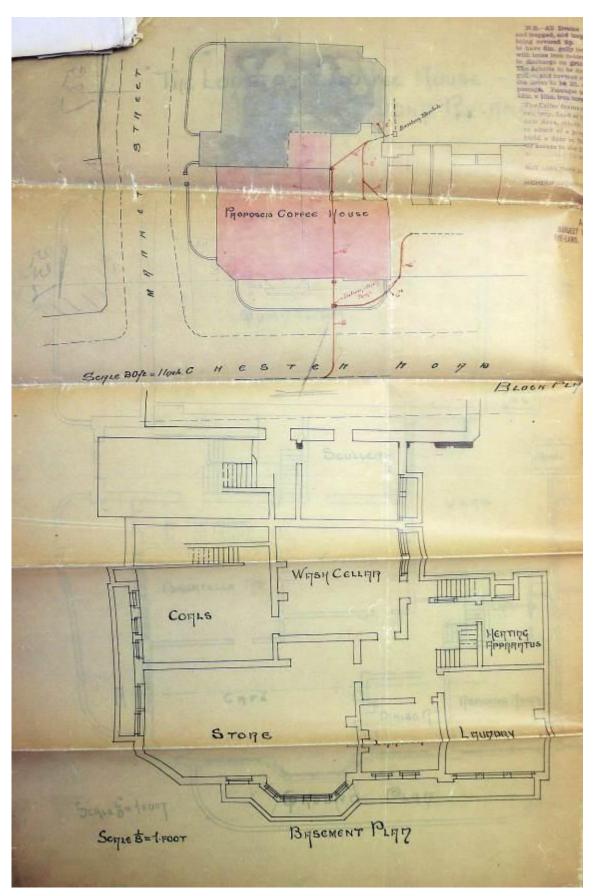
The basement and site drawings for Longford Coffee House submitted to Stretford Local Board in 1886, two years before Rylands' death (uncatalogued application to Stretford Local Board, dated 20 April 1886, Trafford Council)

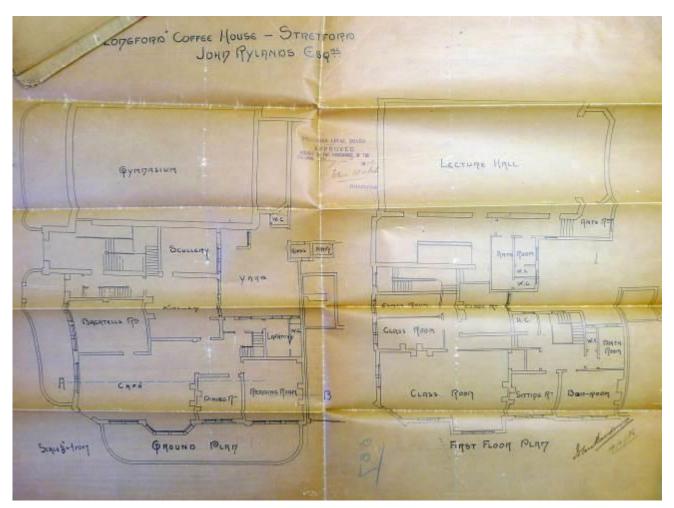
The plans for the first floor, Longford Coffee House, 20 April 1886 (uncatalogued application to Stretford Local Board, dated 20 April 1886, Trafford Council)

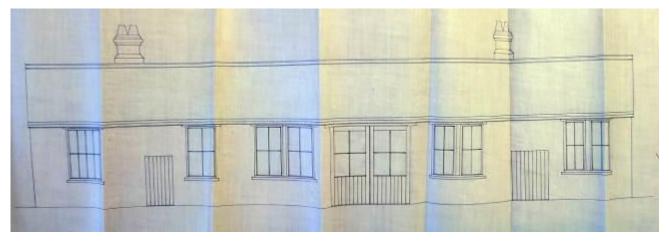
A detail of the design for a new workshop for the Longford Estate, 1893 (Uncatalogued application no. 724 to Stretford Local Board, dated 29 March 1893, Trafford Council)

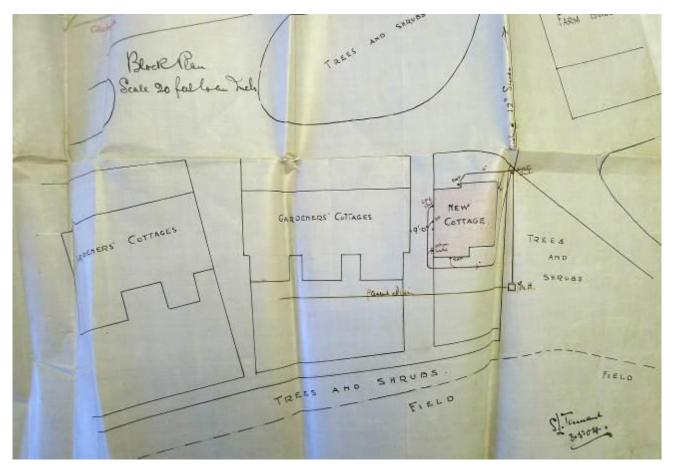
The location plan for the Dairyman's Cottage to be constructed next to existing Gardeners' Cottages, 1904 (Uncatalogued application no. 1410 to Stretford Local Board, dated 3 May 1904, Trafford Council)

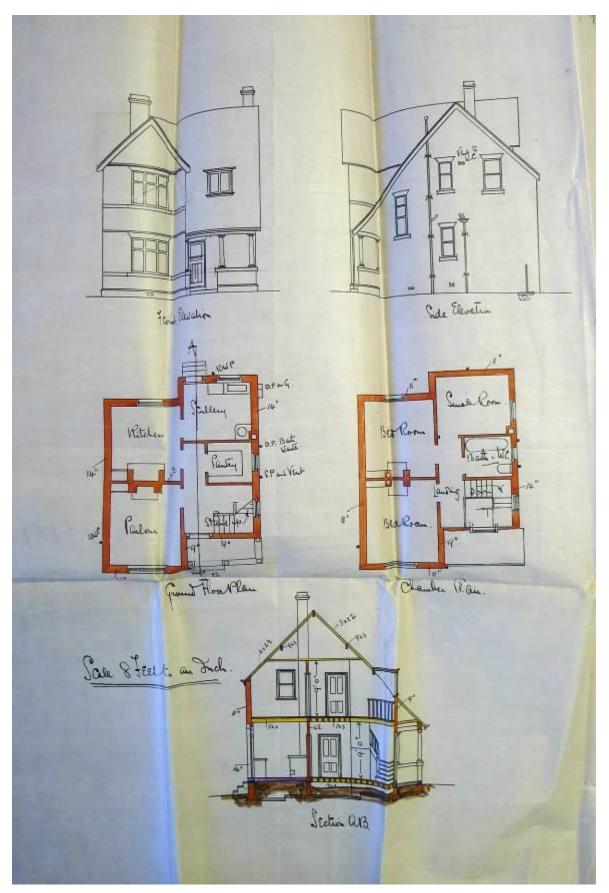
A detail showing the plans and elevations for the Dairyman's Cottage (Uncatalogued application no. 1410 to Stretford Local Board, dated 3 May 1904, Trafford Council)

4.8.7 Longford Cottages are a group of late 19<sup>th</sup>-Century cottages now in private ownership, which lie to the north of the Walled Garden. The easternmost block is constructed of red brick with slate roof and brick chimney stacks. It is compromised somewhat by modern windows and doors. The block to their west, constructed of red brick with buff brick on the side elevations has three distinctive front gables. A standalone cottage stands to the west end of the row, which was built as the Dairyman's Cottage.

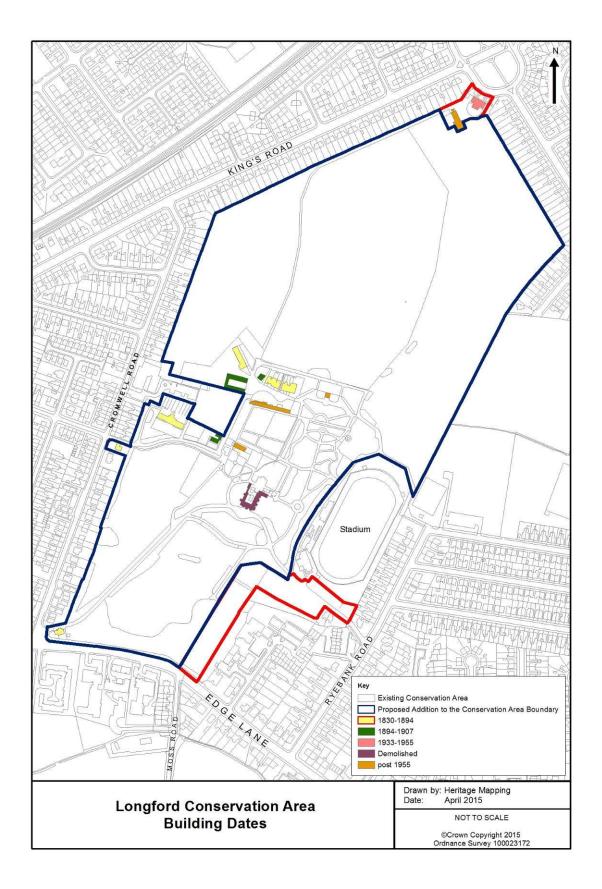
Map 2: Building Dates Plan

- Edwardian Bungalow (current café) Between 1894 1907
  - Former stables Between 1894 1907
  - Art Deco Shelter in East Walled Garden 1933
  - Firswood Library 1936

- Community Centre Late 20<sup>th</sup>- Century

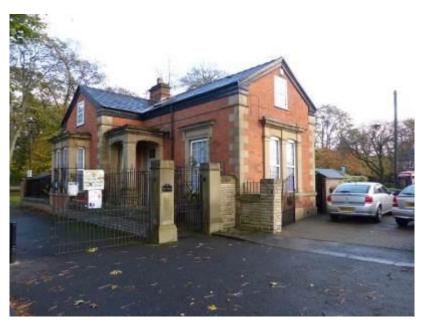
- 4.8.4 There are no listed buildings within the Longford Conservation Area. There are, however, are range of buildings of various ages and styles.
- 4.8.5 The Edge Lane Lodge appears to be contemporary with Longford Hall. Now a private house, it is situated at the south-west entrance to the park. It is constructed of red brick with sandstone quoins and dressings around the windows including a bay window on the north elevation. Modern windows have been introduced at first floor level on each gable along with a skylight.

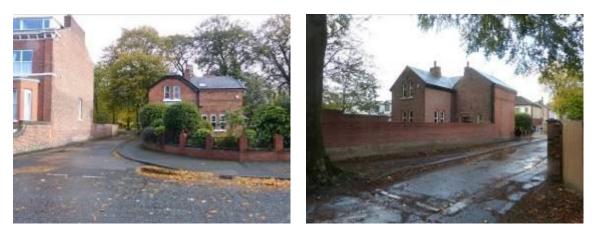
The Old Lodge Cromwell Road

4.8.6 Another former lodge building is situated at the Cromwell Road entrance to the west of the park. It is constructed of red brick in Flemish bond with a string course and pitched slate roof. It has gauged brickwork above the windows and doors although these are now mostly modern UPVC. A blocked up opening on the north elevation faces onto the access road into the park.

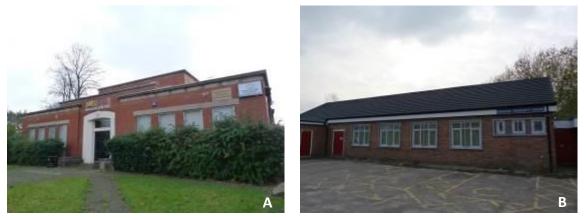
A Former Firswood Library

4.8.12 The former Firswood Library (now a Beacon Centre for the Church of God of Prophecy) in the proposed boundary extension is also an example of the Art Deco style. This has a central doorway with flanking sets of four windows and a higher central block beyond. Gate posts either side are also part of the same scheme. A community centre of a utilitarian design in red brick is located to the rear of the former library, constructed in the late 20<sup>th</sup>-Century.

- 7.1.3 Area A: To include the former Firswood Library as it is a key entry point to the park and has a sense of presence on the corner of the roundabout. The building has some architectural merit from its Art Deco design. The flanking gateway entrances, as well as the car park setting and community centre, have potential for enhancement to improve the character of the Conservation Area.

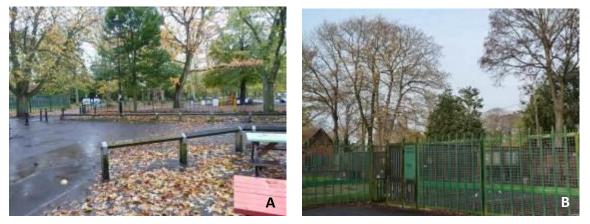
4.8.17 Longford Park displays many features typical of a public park such as painted railings, bollards, lighting and low wooden barriers. These are particularly prevalent in the central area of the park where most of the amenities are. A play area, Pets Corner and picnic benches associated with the café all occupy the space around the Edwardian Bungalow. The spiked railings around Pets Corner are in a poor state of decorative repair and are uninviting.

- A Centre of the park
- B Pets Corner railings
- 4.8.18 Benches and bins are situated throughout the park with some signage and orientation at the main entrances. Generally the street furniture and fencing is of unimaginative off-the-shelf design and there is no feeling of a site-wide co-ordinated scheme.

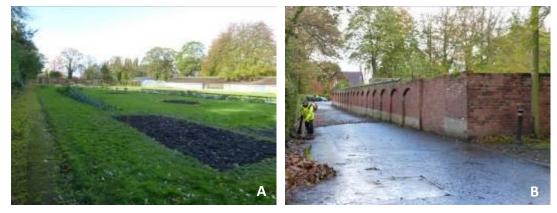
- 4.8.23 Extensive gardens and conservatories were a feature of the Longford Hall estate under John Rylands and some formal gardens remain in the park. The Walled Garden, which is now smaller than it was at its peak in the 19<sup>th</sup>-century, sits to the north of the site of Longford Hall. It now has community allotments across its southern half while the northern portion is taken up with bowling greens. Associated pavilions line the north wall of the garden.

- A Walled Garden
- B Walled Garden west wall

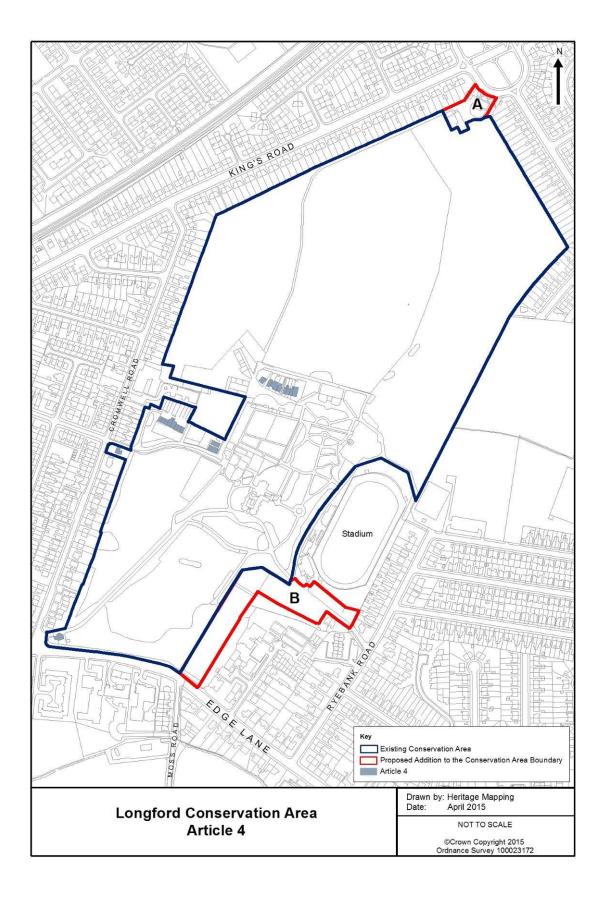
Map 4: Conservation Area Boundary, showing proposed extensions and Potential Article 4 Directions

- 7.1.4 **Area B:** To include the car park and tennis/basketball courts for completeness and in order that their enhancement is encouraged by inclusion the Conservation Area.
