Bowdon Conservation Area – Supplementary Planning Document SPD5.9

Conservation Area Appraisal – July 2016

Bowdon Conservation Area Conservation Area Appraisal

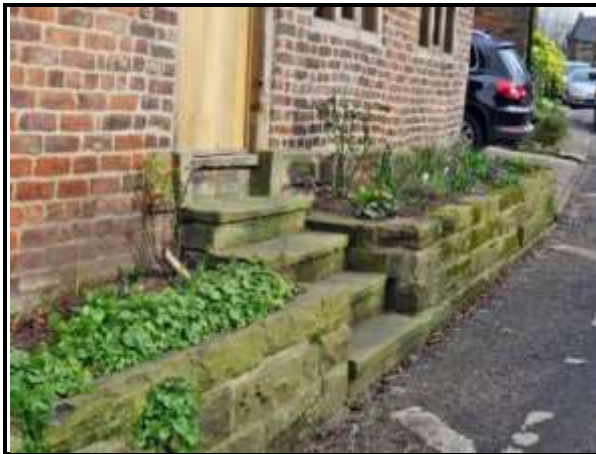
Photograph 45: Flower Beds & Lack of Pavement on Church Brow

4.3.39 The roads in this zone are of tarmac. Church Brow's surface is patched and the narrow pavements (where they exist) are damaged from vehicles mounting the pavements. The houses open on to the street but some householders have gone to considerable effort to create narrow flower beds which enhance the character of the area. There is a significant amount of signage and road markings at each end of Church Brow. This is one-way and not

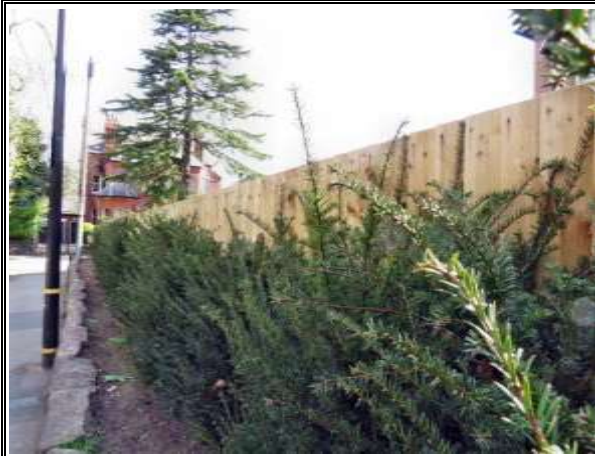
Photograph 131: Fence behind New Yew Hedge, Cavendish Road

a fence this traditionally was positioned to the rear of the shrubs, giving space to both grow and be pruned. Most openings are framed by substantial gateposts of stone, which are generally set flush with the line of wall; however some have been removed. A number of the gateposts have been painted or replaced with ones in a different style. Few if any of the original gates remain, so that it is difficult to be certain of the original style; however it the height of the many original gateposts suggests that they permitted a view of the house. Hillside has both added a concrete post and fence boundary treatment and large brick gateposts with tall timber gates, harmful to the character of the area.

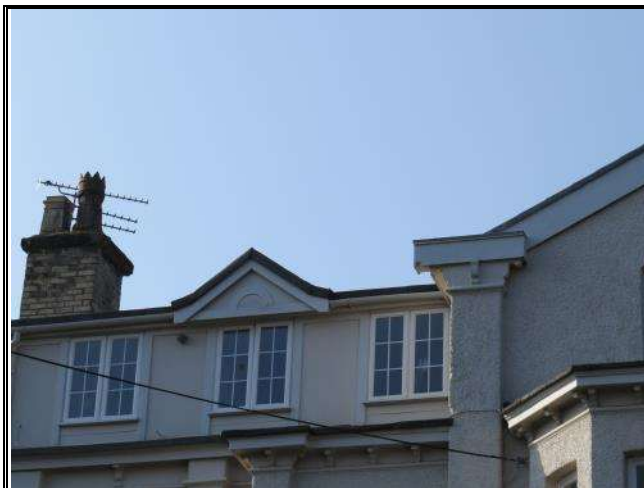
Photograph 139: Roof Extension, The Firs

6.2.1 In some cases although the main structure is intact, its character has been diminished through the addition of unsympathetic elements such as skylight windows on the front facades, especially where they stand up from the surrounding roof area, inappropriate dormer windows and other extensions to the top floor, satellite dishes or plastic rainwater goods. In other cases original architectural details have been lost such as decorative ridge tiles, bargeboards and finials, decorative ironwork such as balcony rails and through the replacement of original doors and windows with ones of lesser quality (photograph 140). These additions and alterations can have a cumulative, detrimental effect on the character of the Conservation Area.

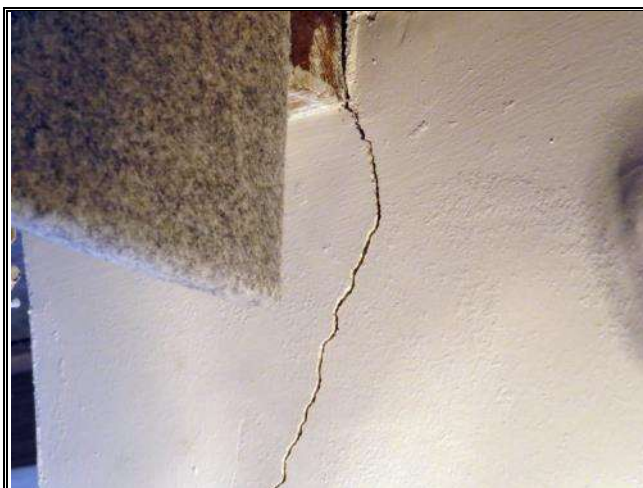
Photograph 143: Cracks in Plaster Reportedly Caused by Traffic, 7 Church Brow

6.2.4 Traffic is an issue which impacts on buildings in different ways in some parts of the Conservation Area. On Church Brow the vibration caused by heavy vehicles and busses is causing mortar to fall from the ridge tiles and cracks to appear in some walls of listed buildings (5 and 7 Church Brow). Several roads are relatively narrow and carry a large volume of traffic. Possibly due to this, several basements have been converted into garages. While the need for off-street parking is real, poorly designed basement garages can significantly alter the original proportions of the buildings and large, garage doors detract from the rhythm of the building and the street (67-69 Stamford Road). Elsewhere garages have been built to the rear of properties where they are generally out of sight of the properties but are seldom in keeping with the character, such as at the end of West Road (photograph 144), in front of Richmond Lodge/Hill and to the rear of 75-85 Stamford.
